AGARD REPORT 809

POD Assessment of NDI Procedures Using a Round Robin Test

This report was prepared at the request of the Structures and Materials Panel of AGARD

Published January 1995

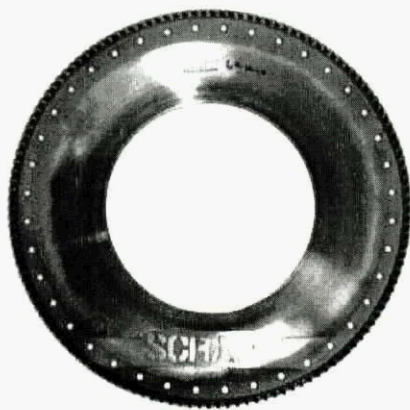
The test components used in this study were service-expired compressor disks and spacers from the J85-CAN40 engine (Figures 1 and 2). Although, they were originally operated under the safe-life philosophy, these parts had remained in service beyond the safe-life-limit due to logistic problems with part replacement. A total of seven sixth stage compressor disks and six fourth stage spacers were employed. The disks and spacers are fabricated from precipitation hardened martensitic stainless steel (AM355). Each disk has 40 bolt

Figure 1. A compressor disk of the type used in this study.

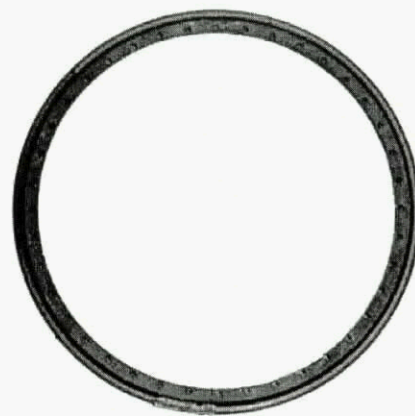
Figure 2. A compressor spacer of the type used in this study.

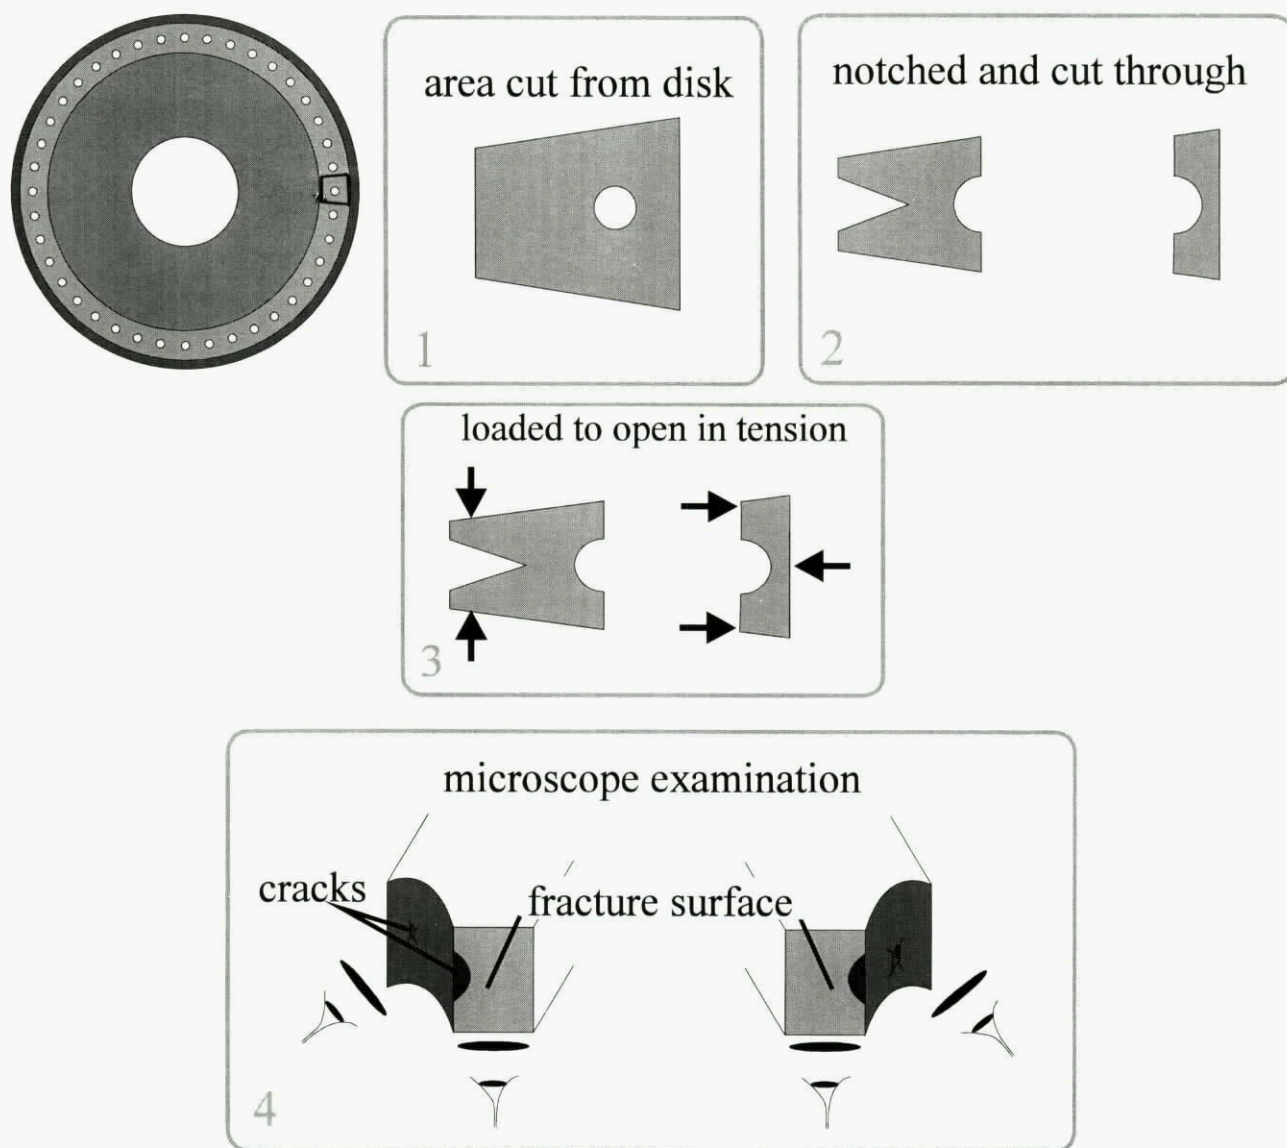
After completion of all NDI, the existence of cracks in the bolt holes was verified by destructive testing. The destructive crack verification was carried out at IAR/NRC on every component except for three disks (No. D, F and G). These disks have not been returned to Canada. The crack verification process is schematically illustrated in Figure 3. First, approximately 2cm x 3cm samples were cut from the region surrounding each bolt hole using a laser cutting technique. Each sample was then sectioned into two pieces along the diameter of the bolt hole. In the inward piece (the larger section), a notch was introduced in the side opposite to the bolt hole and the sample was then pried open by closing the notch in a vice. The second piece was loaded in three-point bending until failure. In both cases, crack faces were under tension during loading. To monitor the pry opening process, the sections were examined periodically under an optical microscope to check the crack opening and if multiple crack sites existed. After pry opening, the fracture surfaces were examined under an optical or a scanning electron microscope (SEM) as required depending on the crack size. Under the microscope, the service-induced LCF cracks were easily recognized from the rupture failure due to their smooth and oxidized surfaces and the crack size was measured. The specimens that did not reveal a crack on the fracture surfaces were further examined on the bolt hole surface to make sure that a crack was not missed during the pry opening operation.

Figure 3. Schematic illustration of sectioning, pry opening, and microscope examination of bolt hole specimens.

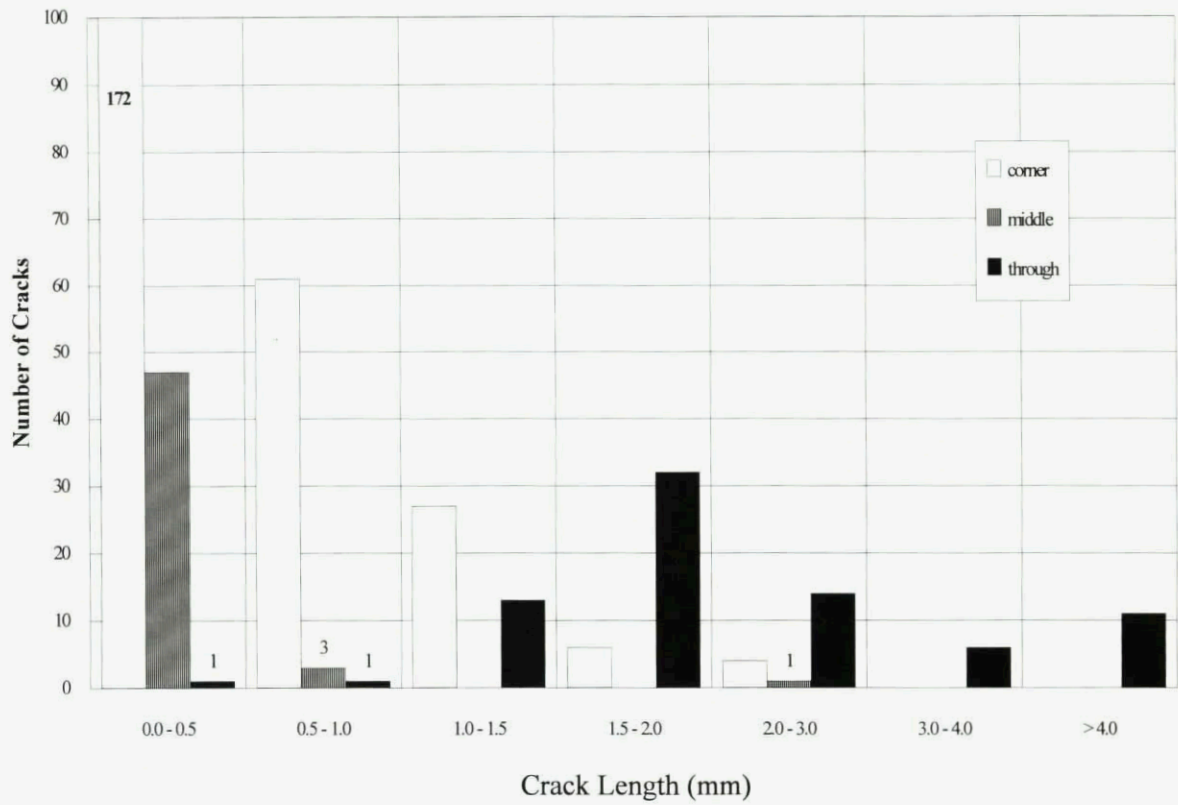
Destructive tests and examination of fracture surfaces indicated that most cracks initiated near the edges of the holes and formed corner cracks. Often, initiation occurred at the bore of the holes and grew radially inward towards the centre of the component. There were cracks which did not touch the top or bottom surfaces and these were termed middle cracks as well as cracks which touched both surfaces and were referred to as through cracks. Examples of different crack types are provided in Figures 4 and 5. Figure 6 provides the distribution of different crack types as a function of crack length indicating that the majority of cracks were small (less than 0.5 mm in length) corner cracks. Most holes had a single crack but multiple cracks, as many as seven, were also seen in many holes. Some cracks did not occur along the radii of the discs; many of these were initiated at what appeared to be voids or inclusions in the material and were often accompanied by larger cracks on the radii. Some totally internal cracks as well as outward propagating cracks were also seen.

Figure 6. Histograms showing the distribution of crack types as a function of crack length

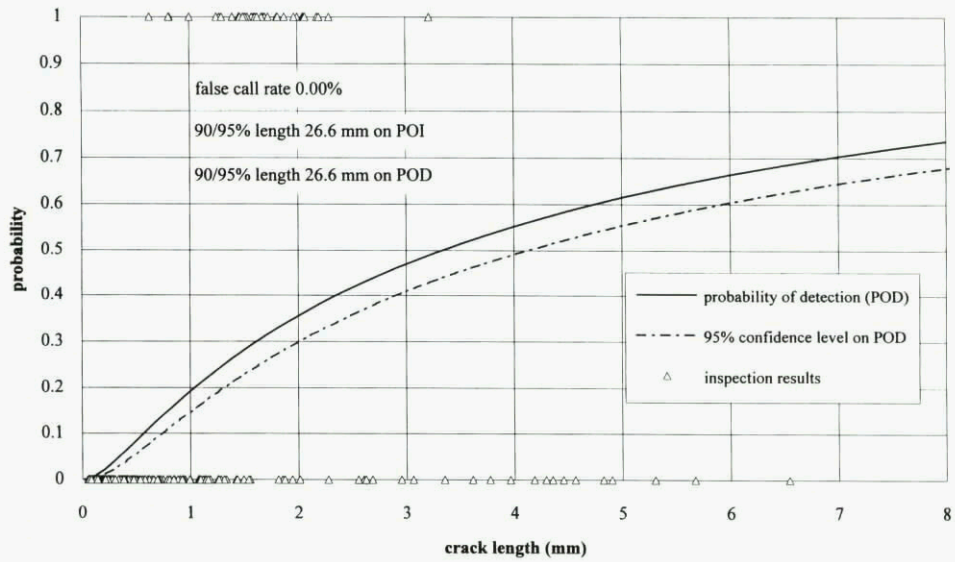
These inspections produced low false call rates but missed a large number of cracks as seen in the POD data (Figures 23,24). The largest cracks missed were 6.6 mm for the optical technique and 5.3 mm for the X-ray method. The 90/95% crack length found for the optical method was 26.7 mm and for the X-ray technique was 16.5, indicating that these methods are not appropriate for detecting LCF cracks in engine components of the type investigated here. The OMI inspections suffer because of the component surface roughness, tightness of cracks and the difficulty in viewing the bore surface. X-ray inspections of these components are also difficult, due to component material and geometry and the small crack sizes.

Figure 23. Dependence of POD on crack length, OMI organization VI

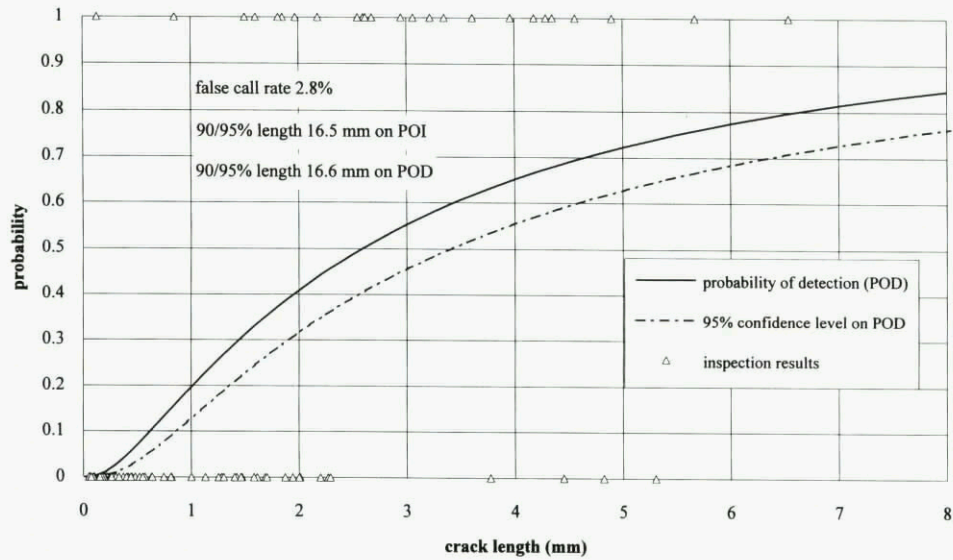
Figure 24. Dependence of POD on crack length, XRI organization IV

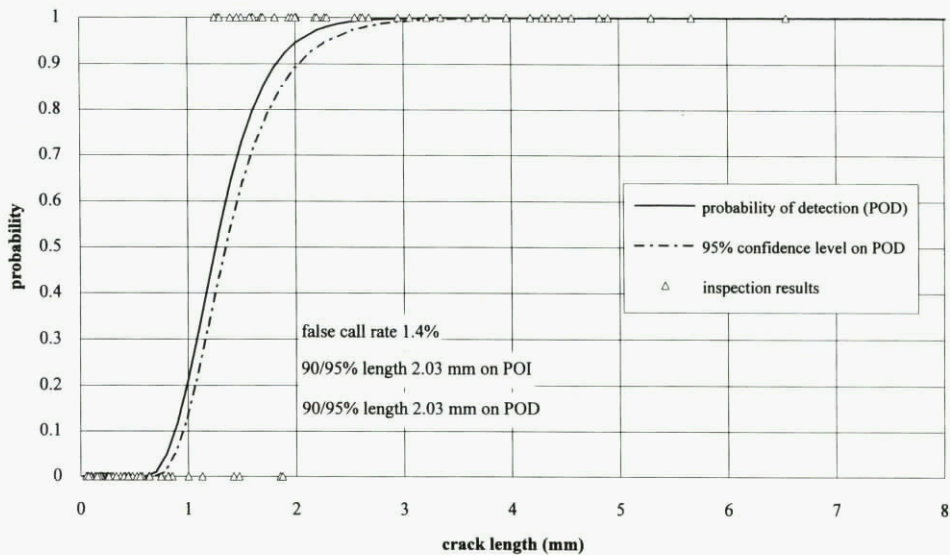
Although an attempt was made to inspect all components using the ultrasonic leaky-wave approach, only results for the disks were considered complete since the geometry of the spacers did not allow inspection of inner surfaces by this method. Therefore, only the data for disks were analyzed and the POD curves are shown in Figure 25. The false call rate was 1.4%, the largest crack missed was 1.8 mm and the 90/95% crack length was 2 mm. These results are very similar to those obtained in the previous investigation using similar disks [1,9].

Figure 25. Dependence of POD on crack length, ULI organization IV

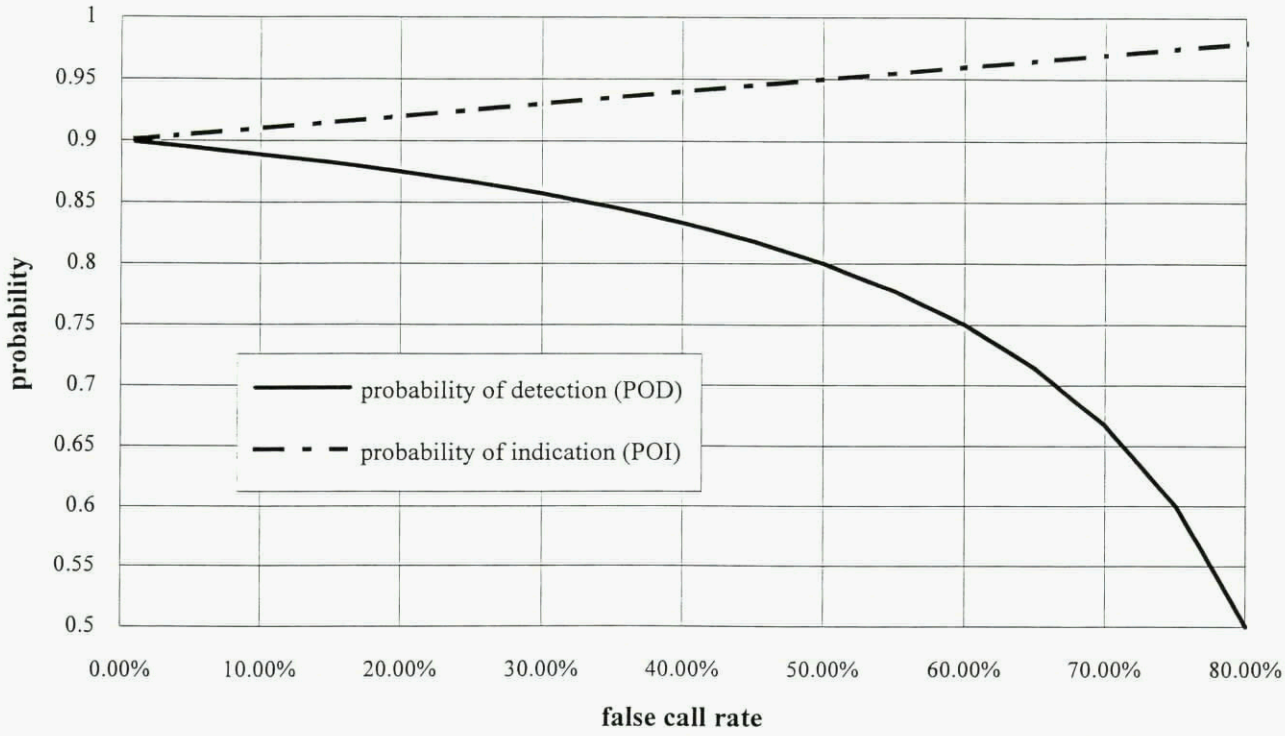
If noise is present in the response signal, false indications can result if noise response from a crack-free site is interpreted as being caused by a crack. False calls are undesirable for economic reason, but often there is a trade off between the false call rate and the ability to detect small cracks. As shown by the POI and POD curves as well as the associated 90/95% crack length values, for a given inspection procedure, high false calls only marginally improve the chance of identification of cracks. However, the true probability of detection (POD) decreases more with increasing false calls as illustrated in Figure 26 for a typical inspection with a 90% true POD and no false calls. This indicates that every inspection process has a certain detection limit indicated by the signal-to-noise ratio which is governed by many factors including the physics of the procedure, instruments and settings employed, signal processing methods, the test material and geometry, the operator, etc. Hence, any attempt to increase the number of hits by such means as using high instrument gain or low threshold level and deliberately identifying noisy signals as cracks without improving the signal-to-noise ratio will only marginally increase the probability of indication but not the true probability of detection.

Figure 26. The effect of false call rate on probability of detection (POD) and probability of indication (POI)
