AGATE Composite Airframe Impact Test Results

Marilyn Henderson
National Institute for Aviation Research
Wichita State University

Report Reference Number: AGATE-WP3.4-034026-088, Rev A
Work Package Title: WBS3.0 Integrated Design and Manufacturing
Date of General Release: March 1, 2002

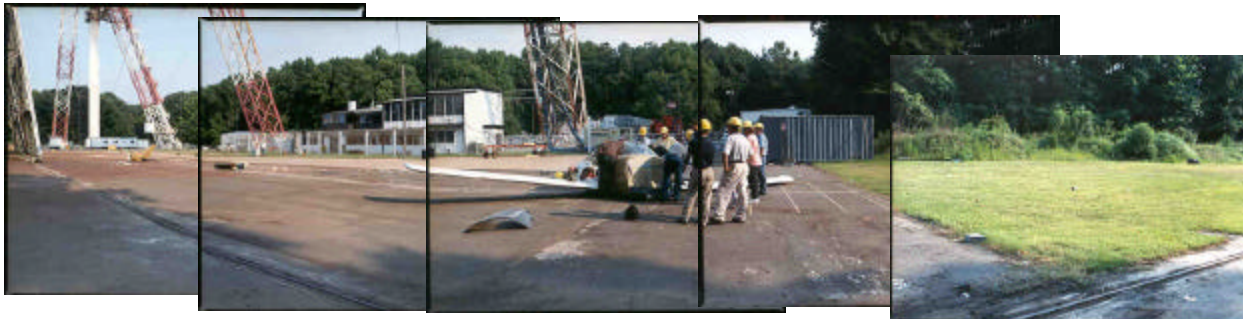
Fig. 31 – Series of Photos from One Side Showing Drop Test Site in Detail

These images show that the engine mount failed and that the tail broke off the fuselage early in the event.

Figs. 31-35 document the debris field from several different angles. Fig. 31 shows the drop test site from one side while Figs. 32-35 show the drop test site from above.

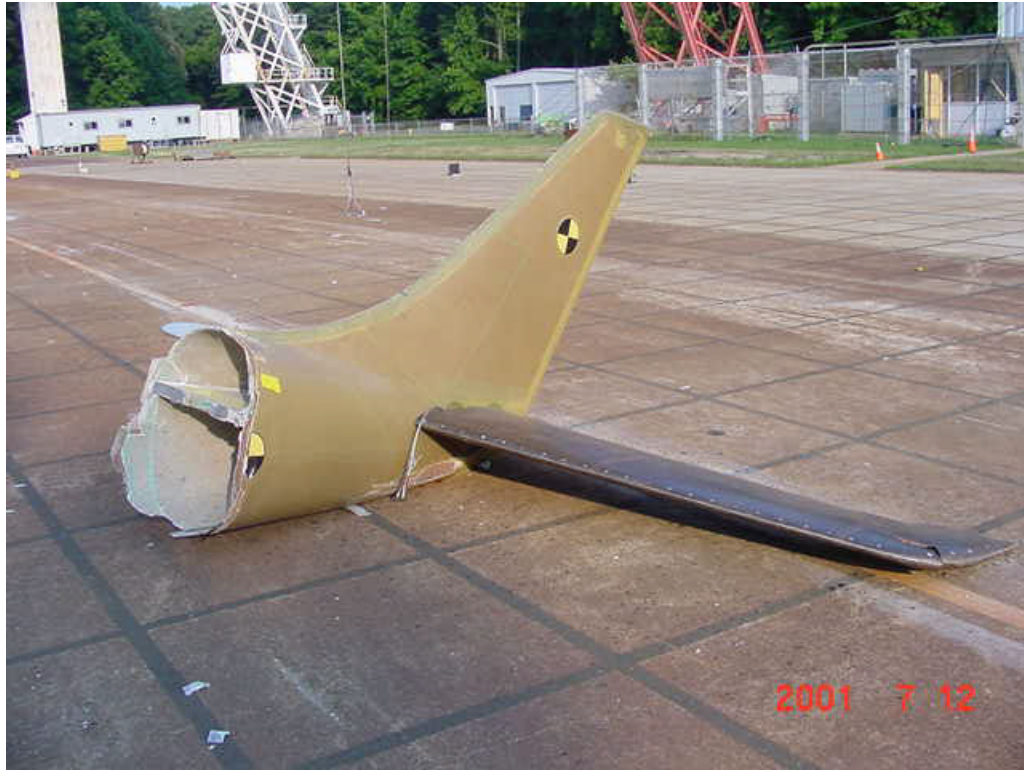
Fig. 40 – Photo - Tail

The condition of the fuselage is documented in Figs. 36-39 from a number of different angles. It is noted that the cabin of the aircraft remained intact and did not suffer a great deal of damage above the cabin floor level. The most notable damage was a minor face sheet wrinkle under the windshield shown in Fig. 38. This is the only portion of the fuselage above the lower longeron that sustained any damage. The empennage is shown in Fig. 40. It separated from the fuselage at a fuselage station containing a number of discontinuities. The core thickness changes at this location. A shelf terminates and fuselage frame is located at this location. This fracture in no way posed any risk to the occupants. Furthermore, it no doubt occurred as a result of a bending moment that greatly exceeds the ultimate load associated with the production aircraft's flight and maneuver loads.

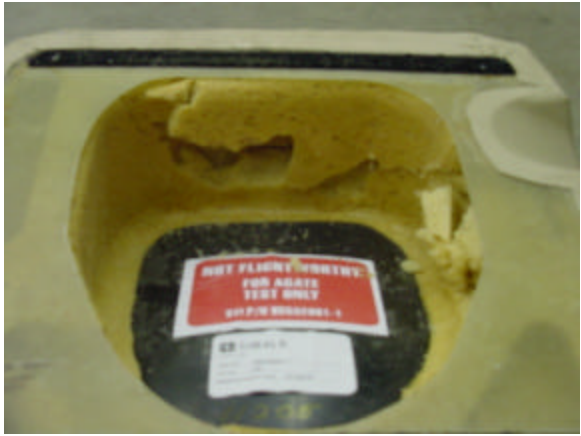
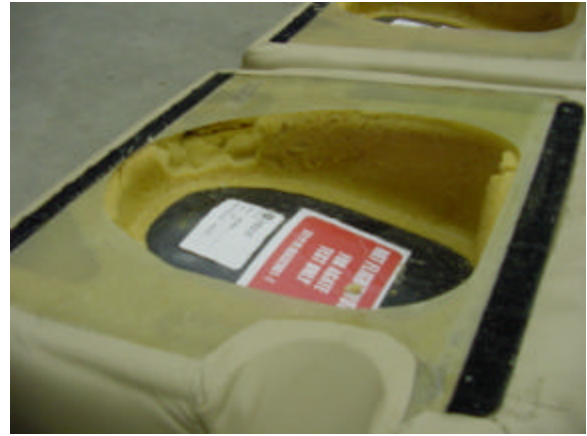
Fig. 48 – Photo – Left Rear Seat

The post-test condition of the interior is documented in Figs. 44-49. The final resting position of the ATD's is documented in Figs. 44 and 45; the post-test seat condition is documented in Figs. 46-49. The seat damage is particularly interesting in view of the favorable lumbar loads presented later in the report.

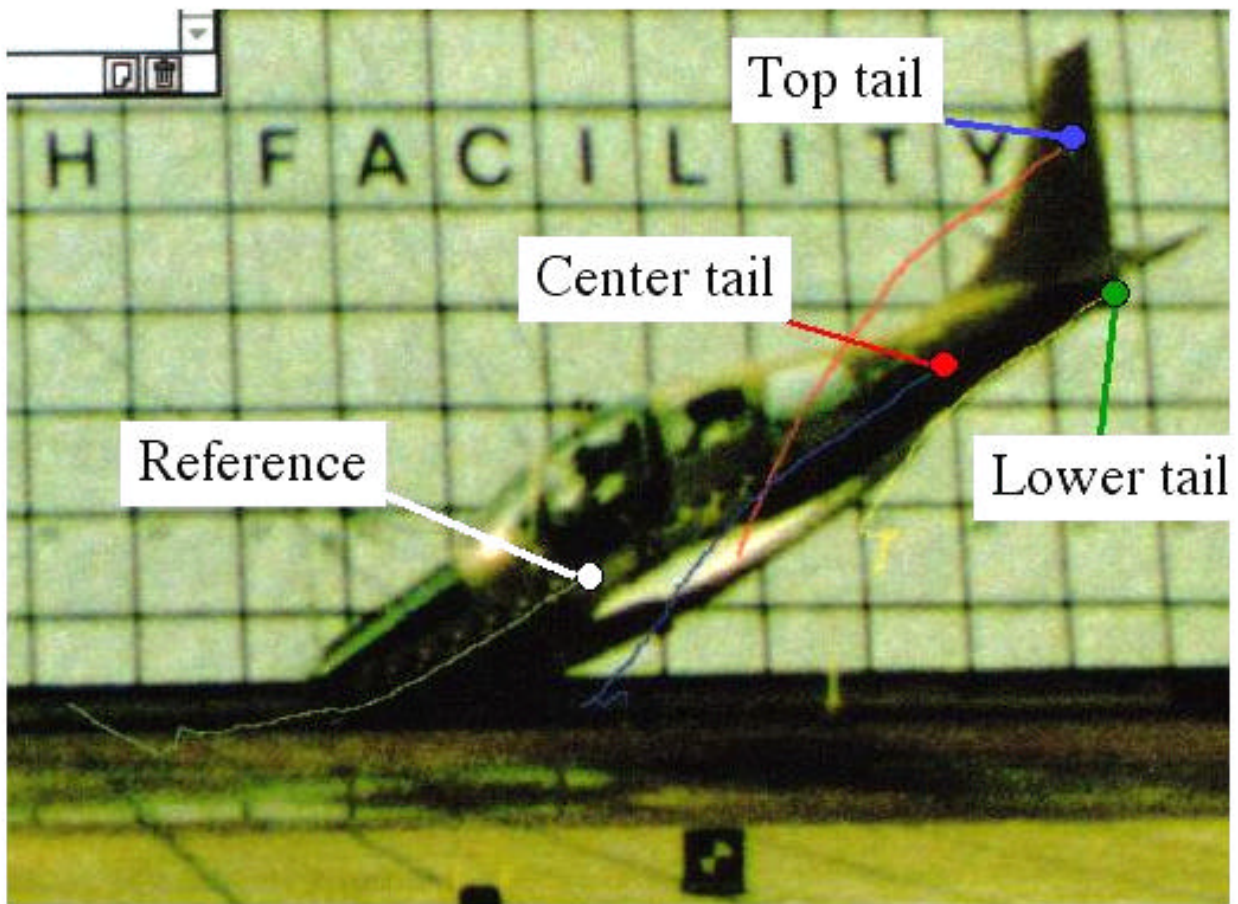
Fig. 50 – Photograph with Motion Tracking Results

Motion tracking of the AGATE aircraft was performed using digitized images from the NASA high-speed film cameras. Four points were selected for tracking. Three of the four points were AGATE supplied yellow and black targets. The lower tail (green) was also selected because it is a high contrast point. A photograph of the aircraft just before impact, at time $t=0$ in the accompanying time histories, is shown in Fig. 50. The circle colors correspond to the line colors in the time histories, with the exception that the white dot in the figure corresponds to the black lines in the data figures. The software program "Commotion" was used to perform the motion tracking. This image was exported from Commotion. Faint lines on the figure indicate the paths that the various points followed. Note that the 0.1 seconds of data plotted in the figures in this section cover only a portion of the paths shown in Fig. 50. The white point above the wing was selected as a reference for angular information because it is close to the aircraft center-of-gravity. The aircraft impacted the surface at 0.040 seconds.

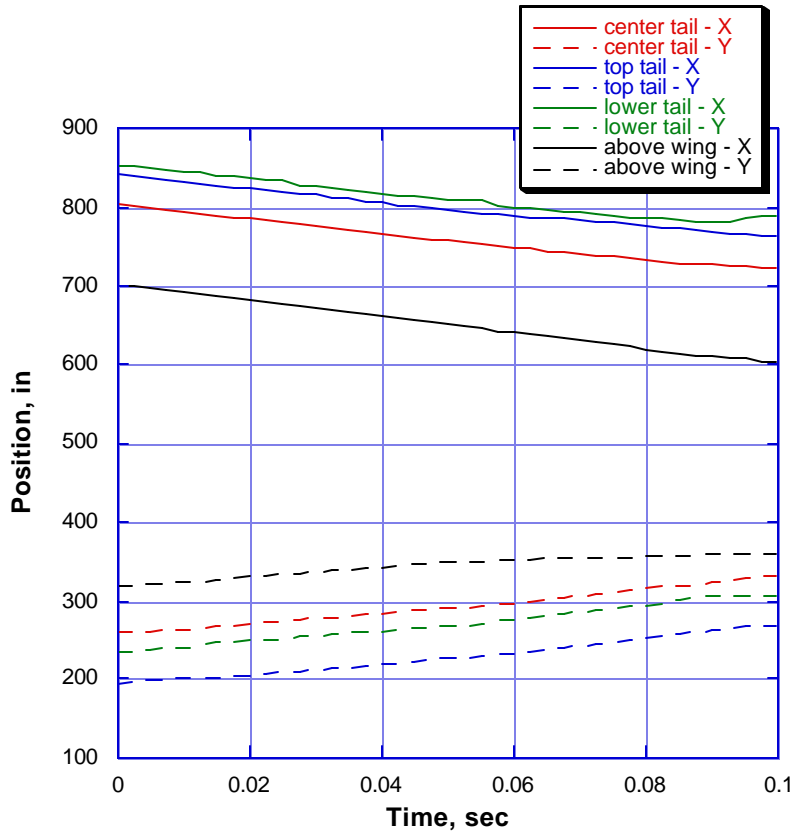
Fig. 51 – Positions of Tracking Points

Fig. 51 shows the x- and y-positions of the targets as a function of time. Note that the absolute position values are not significant since they are based on the digitized image with a conversion from pixels to inches. The conversion was accomplished by correlating the distance of the targets in pixels with the known distances in inches between the targets. No correction for lens distortion or parallax was included. These effects were considered to be minimal. During the motion tracking the aircraft remained near the center of the image. In addition, the flight path of the aircraft was perpendicular to the line-of-sight of the camera. The average slope (0 to 0.040 s) for the x – positions (solid lines) is 79 ft/s and for the y-positions (dashed lines) is 53 ft/s with a resultant of 95.1 ft/s. The recorded radar information indicated that the longitudinal velocity was 82 ft/s. Assuming the flight path of -30° (this is not the pitch angle) then the vertical velocity is 47.4 ft/s and the resultant velocity along the flight path is 94.7 ft/s.

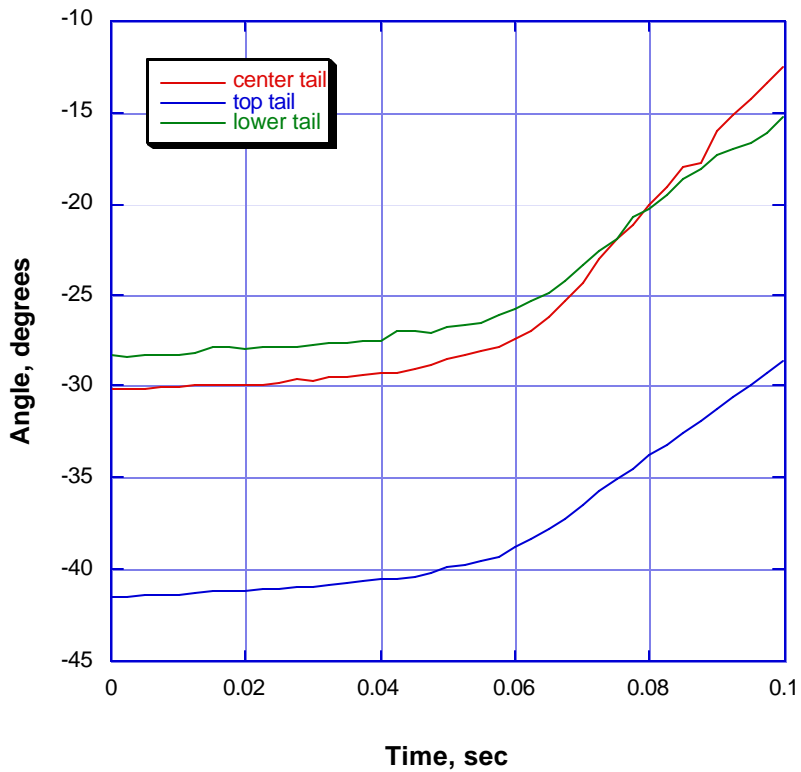
Fig. 52 – Relative Angles of Tracking Points

Fig. 52 shows the corresponding relative angle between the three tail points and the reference point above the wing. One intended use of these angles is as an estimation of the rigid body orientation of the fuselage just prior to and during impact. The absolute angles of the tail points will vary, however, if the aircraft is acting as a rigid body, then the slopes of the curves (pitch rate) should be nearly the same. The center tail point (red) is on the same water line as the reference so that at impact the angle should be close to the desired pitch of -30° . At 0.040 seconds, the angle is -29° . A manual estimation of the impact attitude was determined to be -28° . In addition the angles at impact at the top of the tail (blue) and lower tail corner (green) deviate from -30° as expected based on the position relative to the waterline of the reference position. These curves would be readily fit with an algebraic expression. Then the algebraic expressions could be utilized to convert between the measured data in the aircraft reference frame and the simulation results in the global reference frame. The slopes of the angles from 0 to 0.040 s, in degrees/second, are: center tail **24**; top tail **24**; and lower tail **23**. These values agree well with the predicted pitch rate computed prior to the test (**26** degrees/second) using a rigid body analysis code "Working Model". The slopes from 0.070s to 0.10 s are: center tail **388**; top tail **260**; and bottom tail **266**. The divergence of these slopes could indicate that the tail is starting to fail and that the assumption of rigid body motion is no longer valid. Note that the center tail target (red) was located where the tail separated from the aircraft. The target was actually split into two sections.

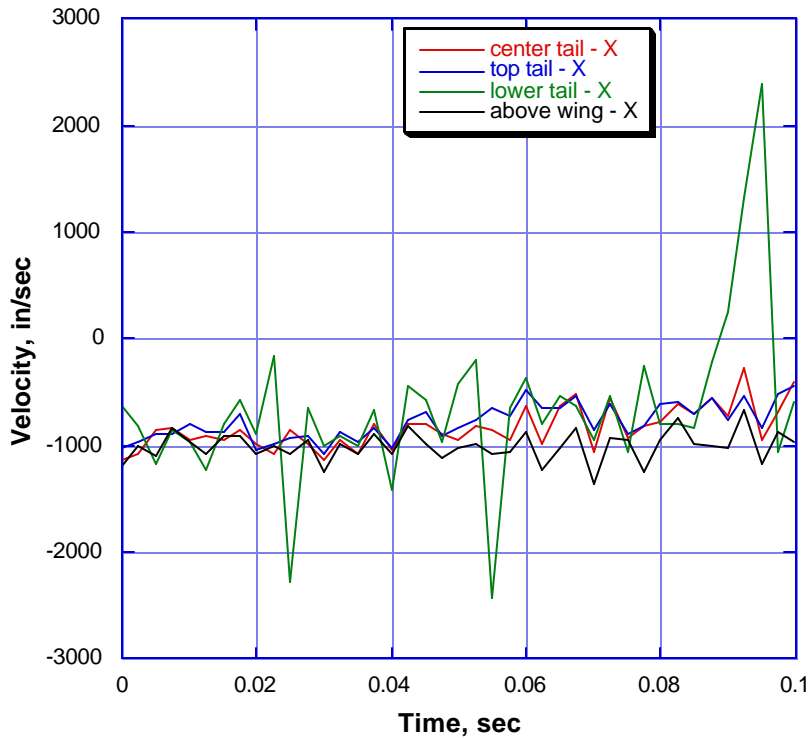
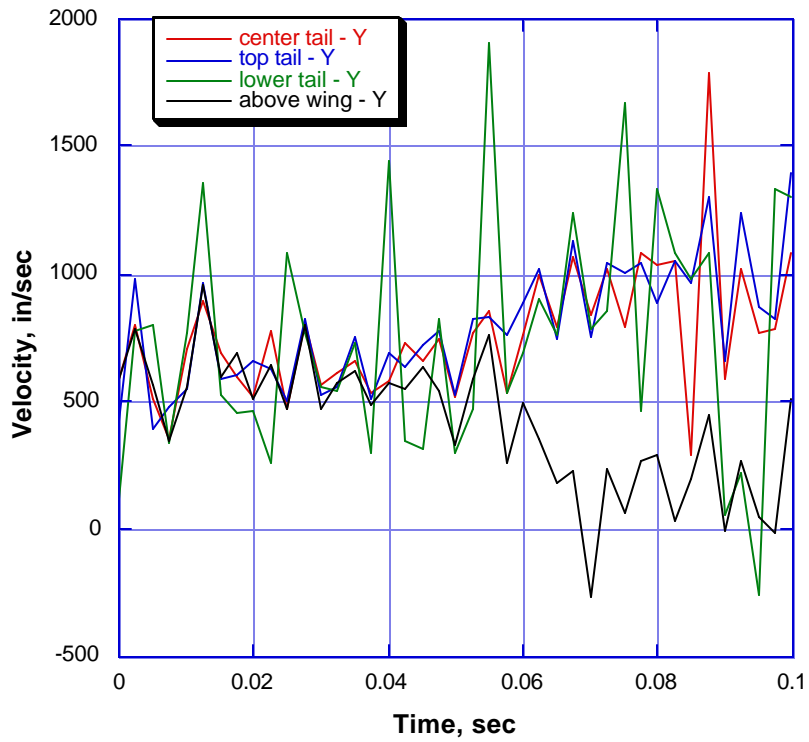
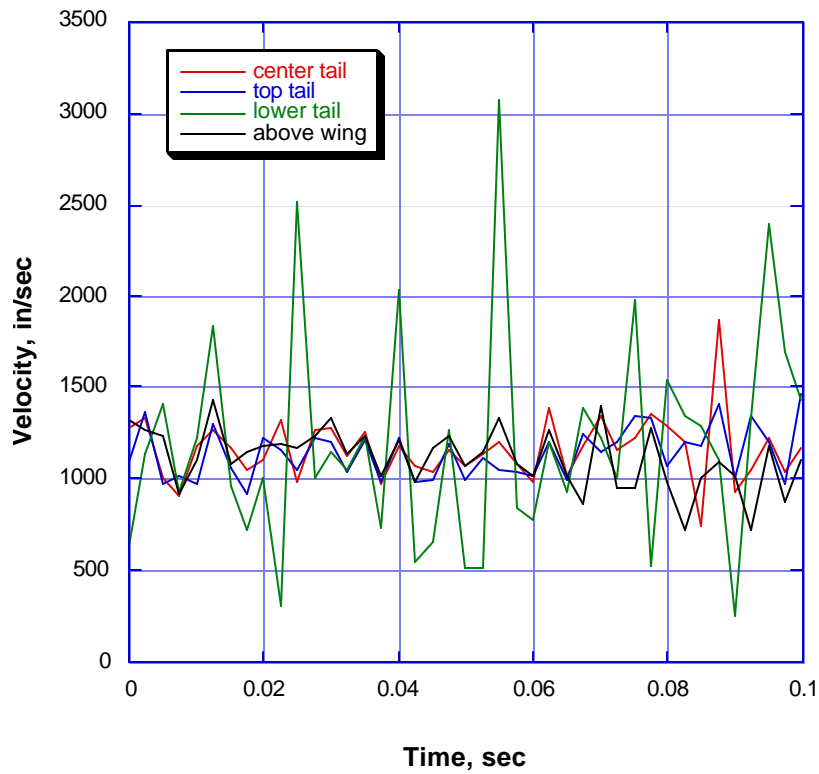
Figs. 53 through 55 show the velocities of the target locations as a function of time. These velocities were computed by simply differentiating the position curves and therefore have all the problems associated with derivative computations. The velocities have been plotted to highlight some changes that are not as apparent in the position curves. An estimate of the horizontal velocities, see Fig. 53, indicates that for the first 0.040 s the velocity is nearly constant at 959 in/s or 80 ft/s. After 0.040 s the longitudinal tail velocities increase slightly while the location above the wing remains nearly constant. The vertical velocities presented in Fig. 54 are about 629 in/s (52 ft/s) for the first 0.040 s. After 0.040 s the wing location diverges from the tail locations as the wing location is the first to be nearly stopped by the impact surface. The total velocities are plotted in Fig. 55. The average velocity over the first 0.040 s is 97 ft/s. Note that the small number of points used in conjunction with the noisy plots will result in numerical inaccuracies.
