**ATSB TRANSPORT SAFETY BULLETIN**  
Aviation Level 5 Investigations AB-2010-020  
Final

# **Level 5 Factual Investigations:**

## **1 December 2009 to 30 March 2010**

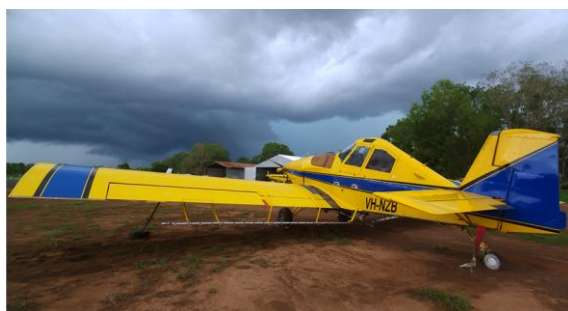
Figure 1: VH-NZB

On 25 November 2009, an Ayres Corporation S2R-T34<sup>1</sup> aircraft, registered VH-NZB (Figure 1), was being operated on a ferry flight from Parkes, New South Wales (NSW) to Batchelor, Northern Territory (NT), with an initial intermediate stop at Longreach, Queensland (Qld). While on final approach to Longreach, without warning, the aircraft's nose pitched upward and an aerodynamic stall resulted. The pilot, the sole occupant, regained control and the aircraft landed safely.

A subsequent engineering investigation by the aircraft's maintenance provider determined that the elevator push rods had been fitted in the reverse order during recent maintenance, thus
