ATSB TRANSPORT SAFETY BULLETIN
Aviation Level 5 Investigations AB-2010-036
Final

Level 5 Factual Investigations: 1 April 2010 to 30 June 2010

Issue 2

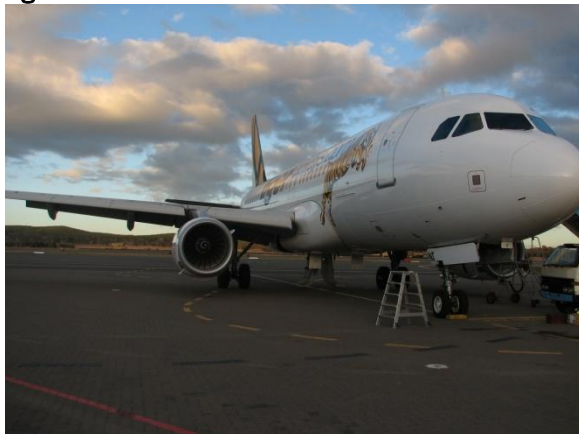
Figure 1: VH-VND

A post-flight examination of the cabin located the source of the burning smell as being from a fluorescent light ballast resistor in the cabin. Closer inspection found the presence of the electrical burning odour at the light's ballast resistor connection.
