Aviation Short Investigation Bulletin Fourth Quarter 2011

Issue 8

ATSB Transport Safety Report
Aviation Short Investigations
AB-2012-019
Final

AB-2012-019

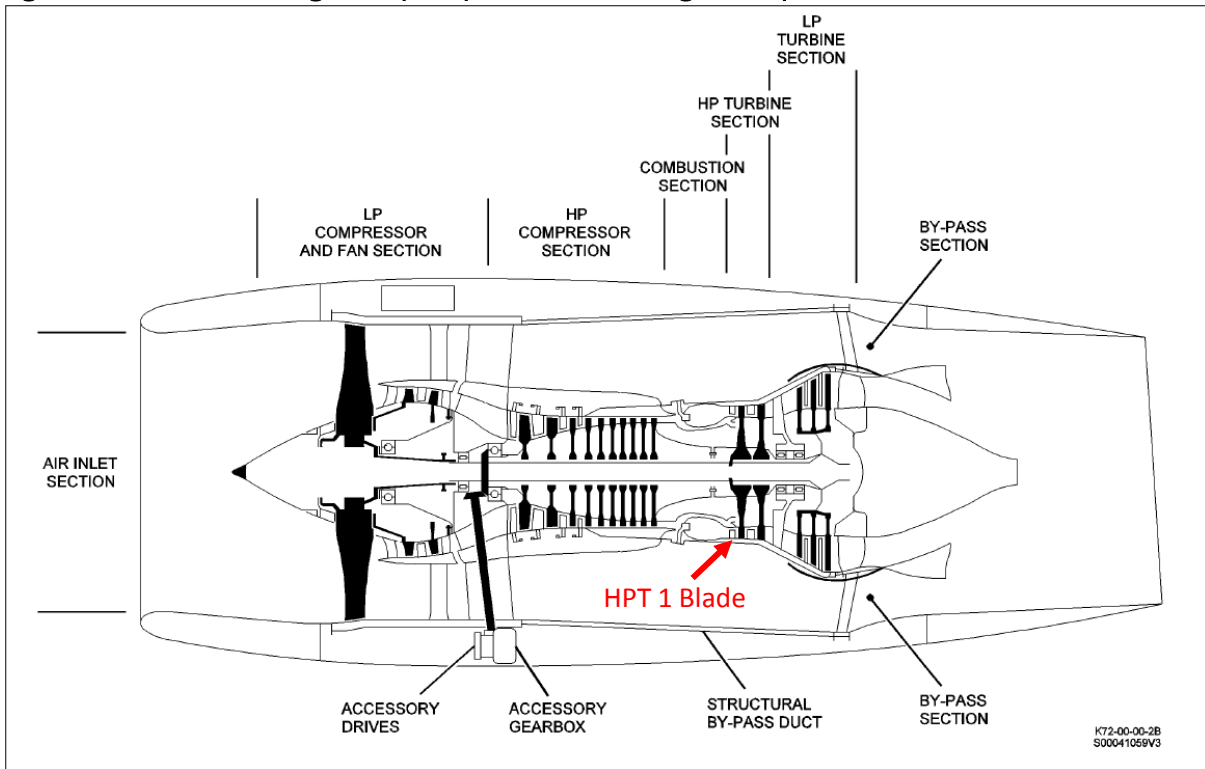
Figure 1: Schematic drawing of the principal BR 700-715 engine components

The aircraft was fitted with two Rolls-Royce BR 700-715 series engines. A subsequent examination of the left engine revealed metallic debris in the tailpipe and physical bulging of the high-pressure turbine (HPT) module. A detailed internal (borescope) inspection confirmed multiple failures of high-pressure turbine, stage-1 (HPT1) blades, with subsequent, downstream damage through to the third stage of the low-pressure turbine (LPT, Figure 1). Damage upstream of the HPT1 blades at the nozzle swirler inlet and nozzle guide vanes was also found. The engine was then shipped to the manufacturer for a teardown examination, which was witnessed by the BFU (German Federal Bureau of Aircraft Accident Investigation) on behalf of the Australian Transport Safety Bureau (ATSB).

During the teardown examination, the LPT section proved difficult to remove due to case deformation. In the HPT module, four of the second stage blades had failed at $\frac{1}{3}$ or $\frac{1}{2}$ their height. All of that stage's blade shrouds were missing. Examination of the first stage of the HPT module found all of the blades had fractured. Further observation identified that only one HPT1 blade had fractured below its root platform (Figure 2). Microscopic examination revealed that blade's failure had initiated at the inner shank wall on the pressure side⁴.

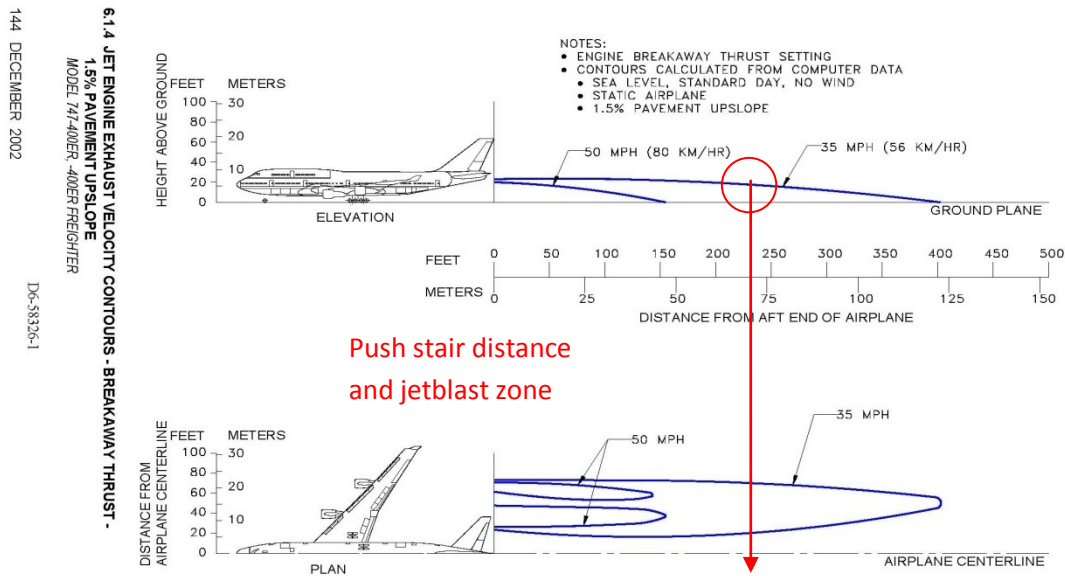
Figure 2: Jet Engine Exhaust Velocity Contours

The CASA, *Manual of Standards, Part 139 - Aerodromes, at 6.6.2 Jetblast and Propeller Wash Hazards*, recommended that the maximum jet engine exhaust velocity should not exceed 32 kts (60 km/h) where passengers are expected to walk or people are expected to congregate. Where personnel are working on an aircraft the recommended maximum exhaust velocity is 43 kts (80 km/h).

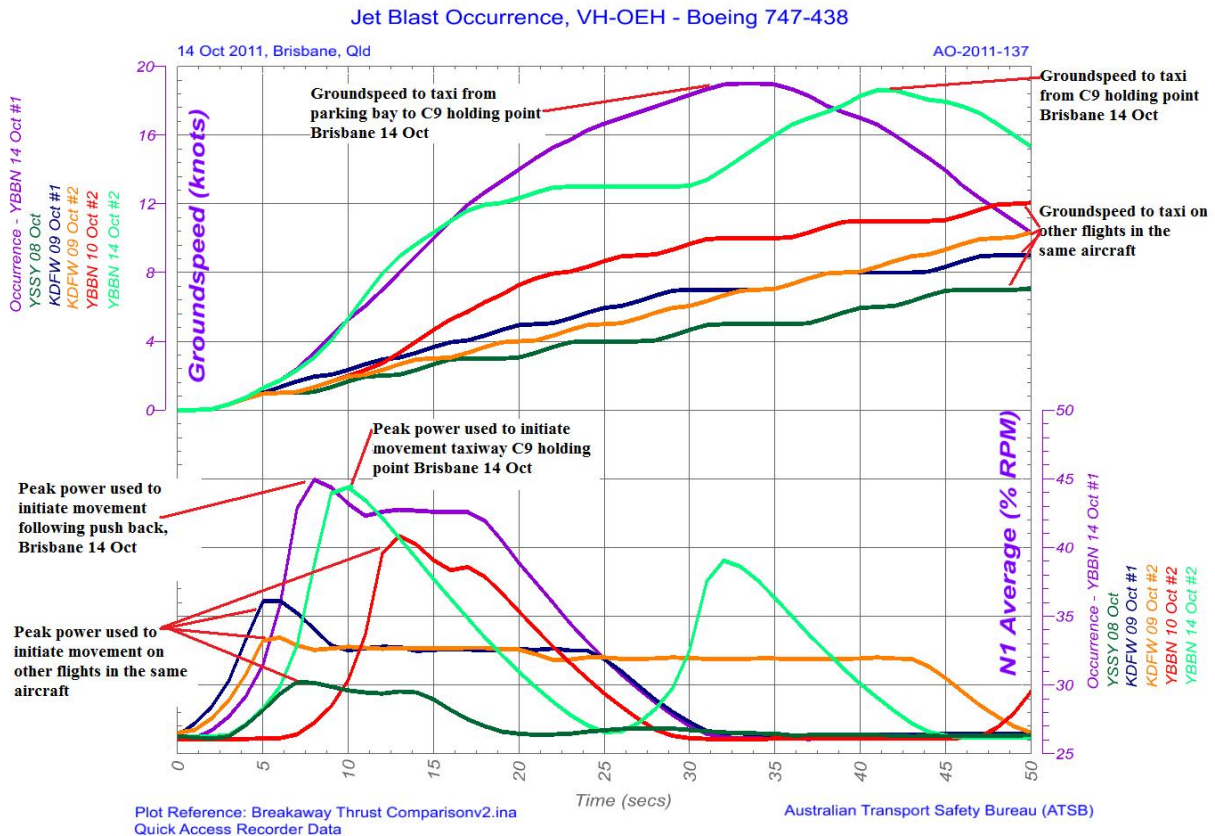
Figure 3 - Breakaway Thrust Comparison VH-OEH

Data from OEH's flight data recorder was reviewed by the ATSB, to determine the breakaway thrust used during the taxi. The average engine low pressure compressor speed (N1), and aircraft ground speed, were compared to data from four previous flights. Figure 3, shows a graphical representation of the values obtained with the purple and light green traces representing this occurrence:

On this occasion OEM was relatively lightly loaded, with a takeoff weight of 234,417 kg compared to a maximum takeoff weight of 412,769 kg. That takeoff weight was the lightest compared to the other flights depicted in figure 3.

There was a 26 cm increase in height from the taxiway C9 holding point to the centreline of taxiway Bravo intersection. Data on the slope of the surface on the other flights depicted in Figure 3 was not available.

On review there was no clear evidence that passengers, crew or ground handling staff were being adversely affected by the blast. Furthermore the operator's internal investigation into the occurrence determined that the maximum recorded N1 thrust used during the taxi and turn was only 27%. The flight crew operating manual stated that a

maximum N1 used for taxi in the A320 was 40%. The event, however, reaffirms the importance of appropriate power settings during ground manoeuvring.

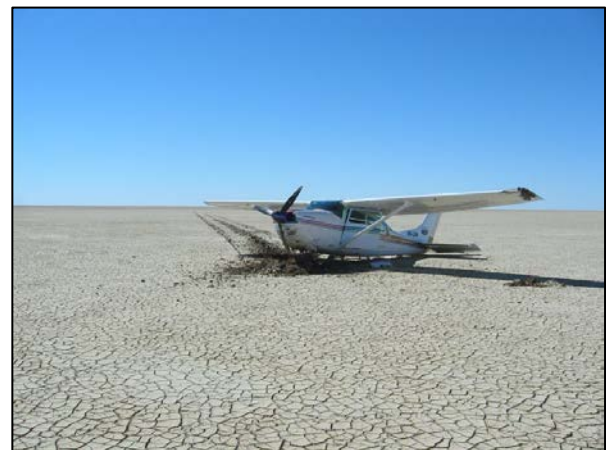
Figure 1: VH-LAN after landing

After all occupants had exited the aircraft, the pilot conducted a cursory examination of the engine and noted damage to the number-4 cylinder and its associated fuel injector.

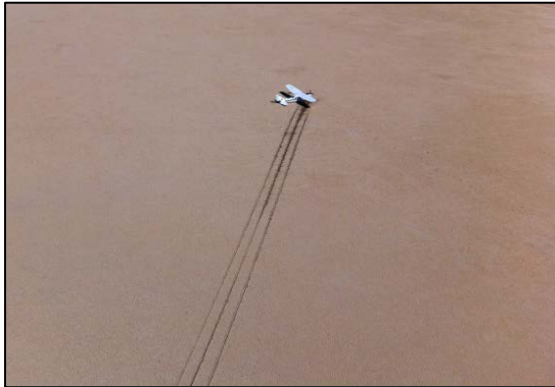
Figure 2: Aerial view of landing roll

The cylinder head and the fuel injector supply line had fractured and separated. The aircraft was eventually recovered and the engine removed for further examination.

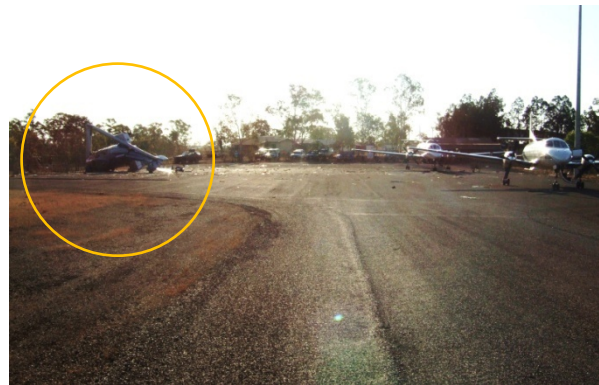
Figure 5: View of Port Keats Airport apron from taxiway after accident (Helicopter circled)

The light pole bent where the main rotor blades had struck it. The upper section fell onto the helicopter with electrical wiring exposed, but unpowered. The left side of the cockpit was pushed inwards from contact with the light pole. The helicopter's tail section was also damaged.
