# Aviation Short Investigation Bulletin

Issue 9

AB-2012-044

**Publication date** 24 May 2012

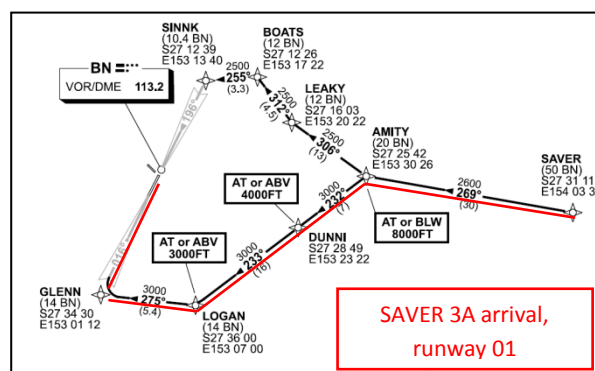
Figure 1: Brisbane SAVER 3A Arrival

About 30 seconds later the captain informed ATC that their current track would now take them into the weather cell and requested a right turn. ATC informed the crew that a right turn was not available due to traffic on the localiser and repeated the clearance to stay on their current heading.

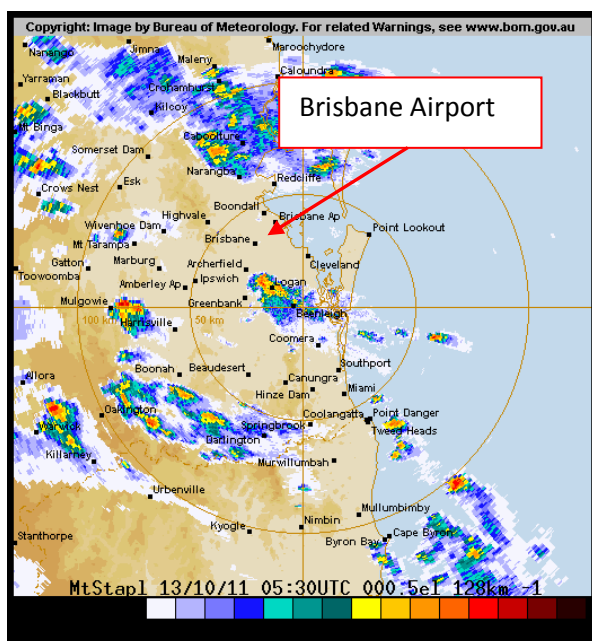
**Figure 2: BOM Brisbane weather radar image (1530 EST)**

The controller also requested they inform him when they could turn left. The flight crew recalled that the aircraft weather radar showed an intense weather cell with heavy rainfall to the left of their track.

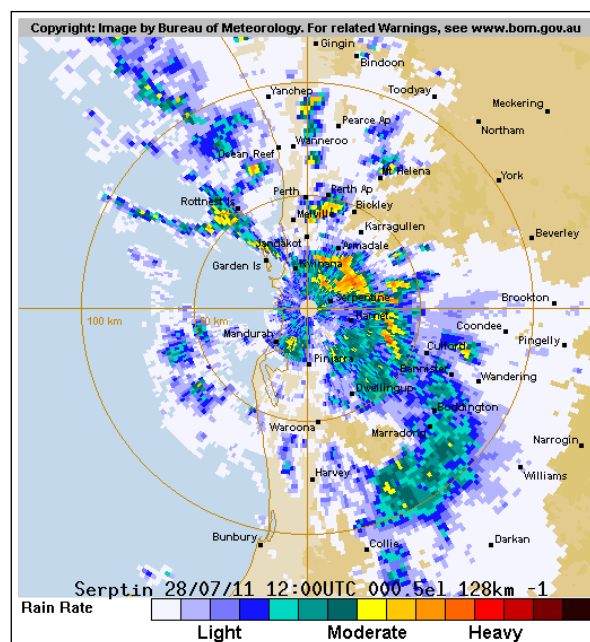
Figure 1: Perth weather radar image (2000 WST<sup>2</sup>)

The crew were aware that the arrival into Perth would coincide with the passage of a cold front with thunderstorms and associated severe weather (Figure 1). Expecting air traffic control (ATC) delays, the crew ensured adequate fuel uplift at Meekatharra. They also secured the cabin earlier than normal, briefing the cabin attendant and passengers on the expected turbulent flight conditions.

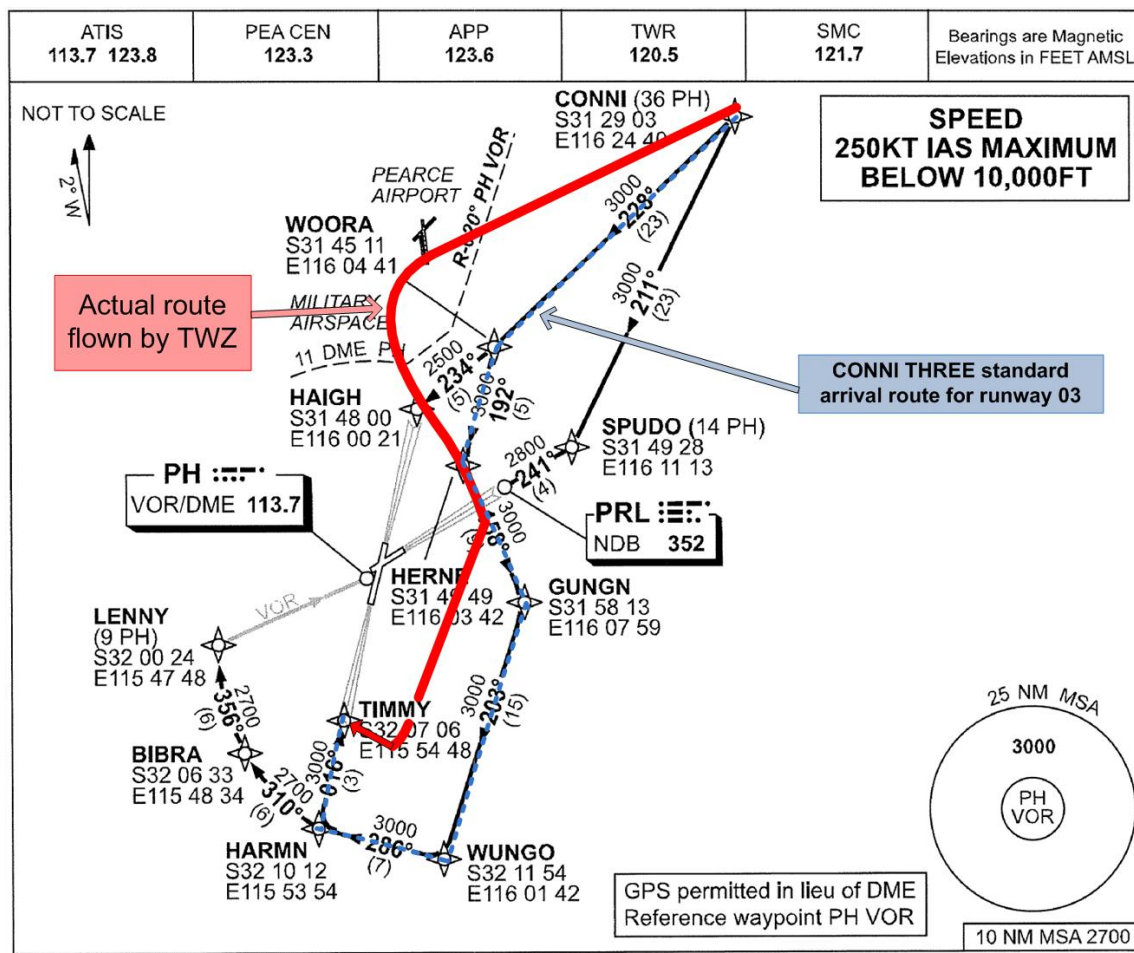
Figure 2: CONNI THREE STAR showing approximate flight path of TWZ into Perth

Prior to descent, the crew were issued a clearance by ATC to carry out the CONNI THREE standard arrival route (STAR) (Figure 2) for an instrument landing system (ILS) approach to runway 03. After passing waypoint CONNI, the crew requested and were approved to divert 10 NM right of track to avoid weather. The STAR was subsequently re-joined at waypoint HERNE, but shortly thereafter

As the approach continued in conditions of moderate to severe turbulence, the crew noted that the autopilot was slow to establish on the localiser, due in part to the strong west-north-west wind being experienced. As a result, the FO disengaged the autopilot and manually controlled the aircraft. At about that time, the flight director approach mode 'dropped out', compromising the FO's situation awareness. The flight director was reengaged, but the aircraft had descended below the glideslope to 2,600 ft. That state was corrected, but the aircraft then became high on the glideslope. A high rate of descent was then used in an attempt to re-capture the glideslope, resulting in the flap 25 limit speed being exceeded by about 8 kts.

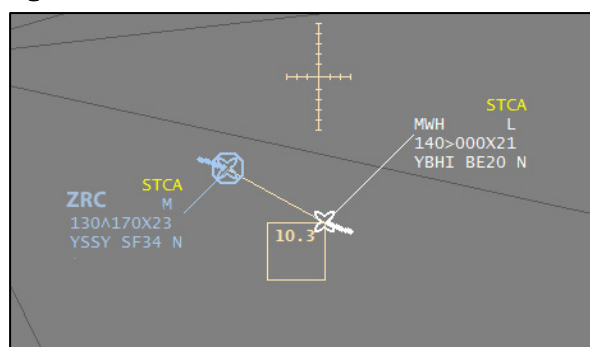
**Figure 1: Position of aircraft at 0720:22**

Review of the Airservices Australia radar data indicated that at 0720:22, a short term conflict alert (STCA)<sup>5</sup> on The Australian Advanced Air Traffic System (TAAATS) activated. At that time, ZRC was climbing through FL130 and MWH was maintaining FL140, with 10.3 NM between them (Figure 1).

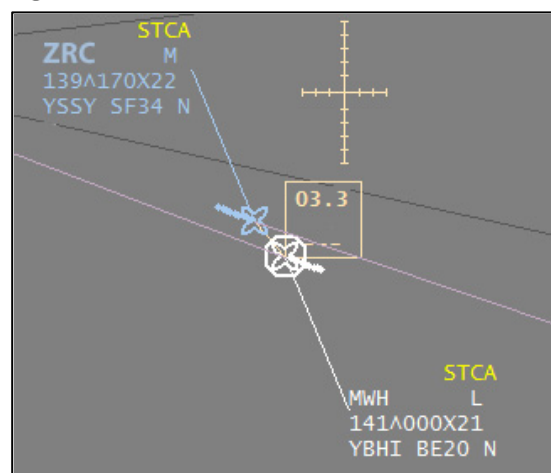
**Figure 2: Position of aircraft at 0721:25**

At 0721:25, separation reduced to 3.3 NM laterally and 200 ft vertically (Figure 2)

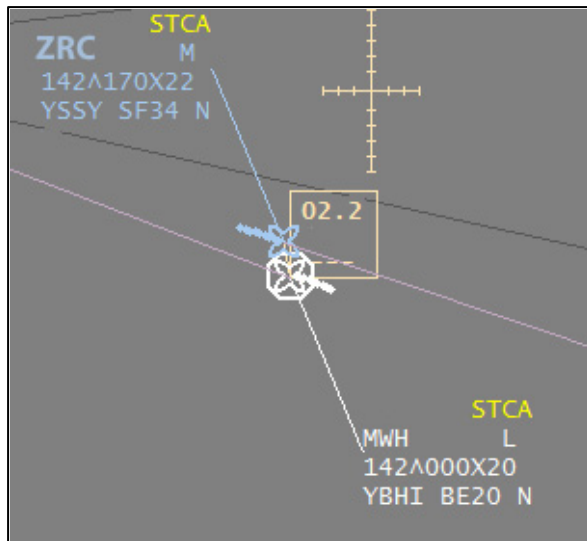
**Figure 3: Position of aircraft at 0721:38**

At 0721:38, with both aircraft at FL142, lateral separation reduced to 2.2 NM (Figure 3).

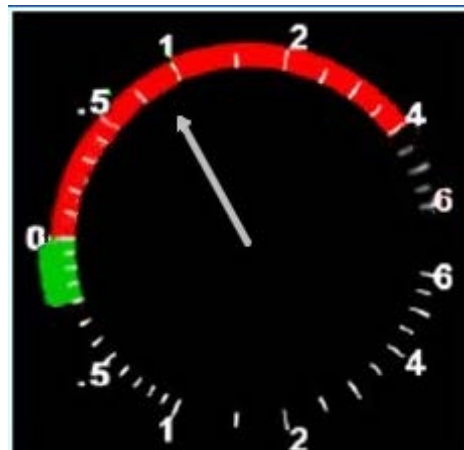
**Figure 4: Illustration only of VSI with TCAS lights**

In ZRC, TCAS RA guidance is incorporated into the aircraft's vertical speed indicator (VSI). Two rows of coloured lights, one green and one red, were positioned around the VSI scale and were used to indicate whether to climb, descend or remain level. When a TCAS RA is received, certain segments of the green lights and red lights will illuminate. The pilot is then required to manoeuvre the aircraft to place the VSI in the area represented by the green lights only; the red area should be avoided (Figure 4).

The FO reported that, prior to receiving the TCAS RA; he believed that they were above MWH. Consequently, when the 'adjust vertical speed, adjust' announcement was heard, he anticipated the RA command and commenced a climb before interpreting the VSI. When the FO referenced the VSI, he initially observed red lights illuminated up to the 4,000 feet per minute climb rate, with no further indications noted. The FO momentarily thought that this confirmed his action to climb. However, he then noted the green lights illuminated in the lower arc, indicating a descent was required.

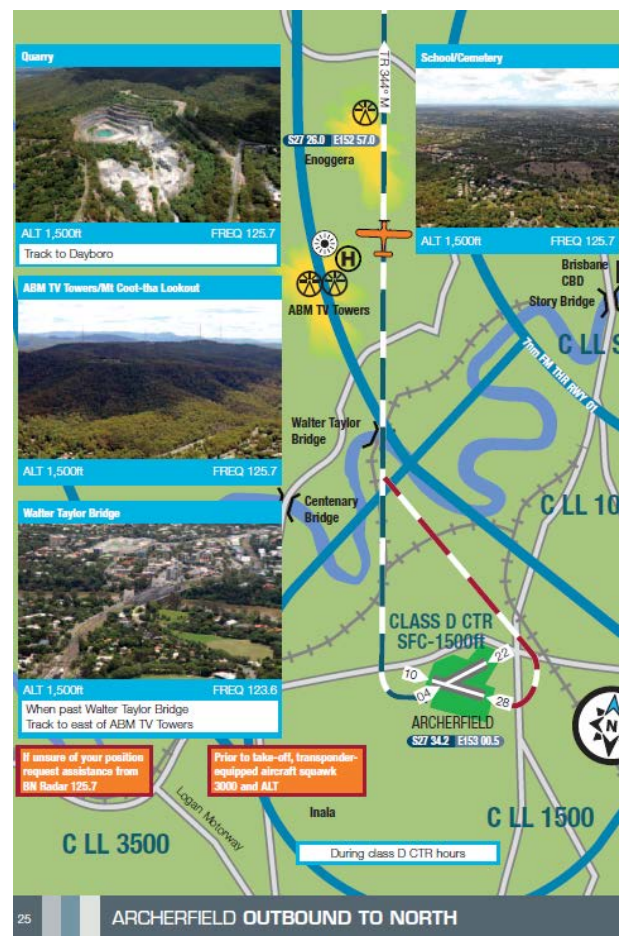
**Figure 1: Outbound to North – Archerfield Visual Pilot Guide 2010**

At about 1419, the pilot of UPF notified Archerfield Tower of his location abeam the TV Towers and then transferred to the Brisbane Centre frequency. He then tracked towards the north-western side of Lake Samsonvale and commenced a climb to 1,500 ft.

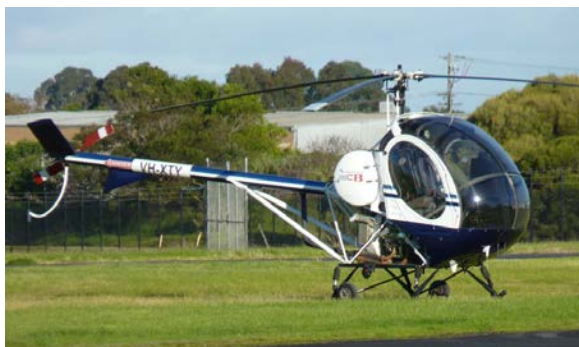
Figure 1: VH-XTY, Schweizer 269C-1

During the afternoon of 5 December 2011, an instructor and student were conducting emergency procedures training in the circuit at Moorabbin Airport, Victoria, in a Schweizer 269C-1 helicopter, registered VH-XTY (Figure 1). The flight was to include low-level autorotations to simulate an engine failure during the takeoff and approach.

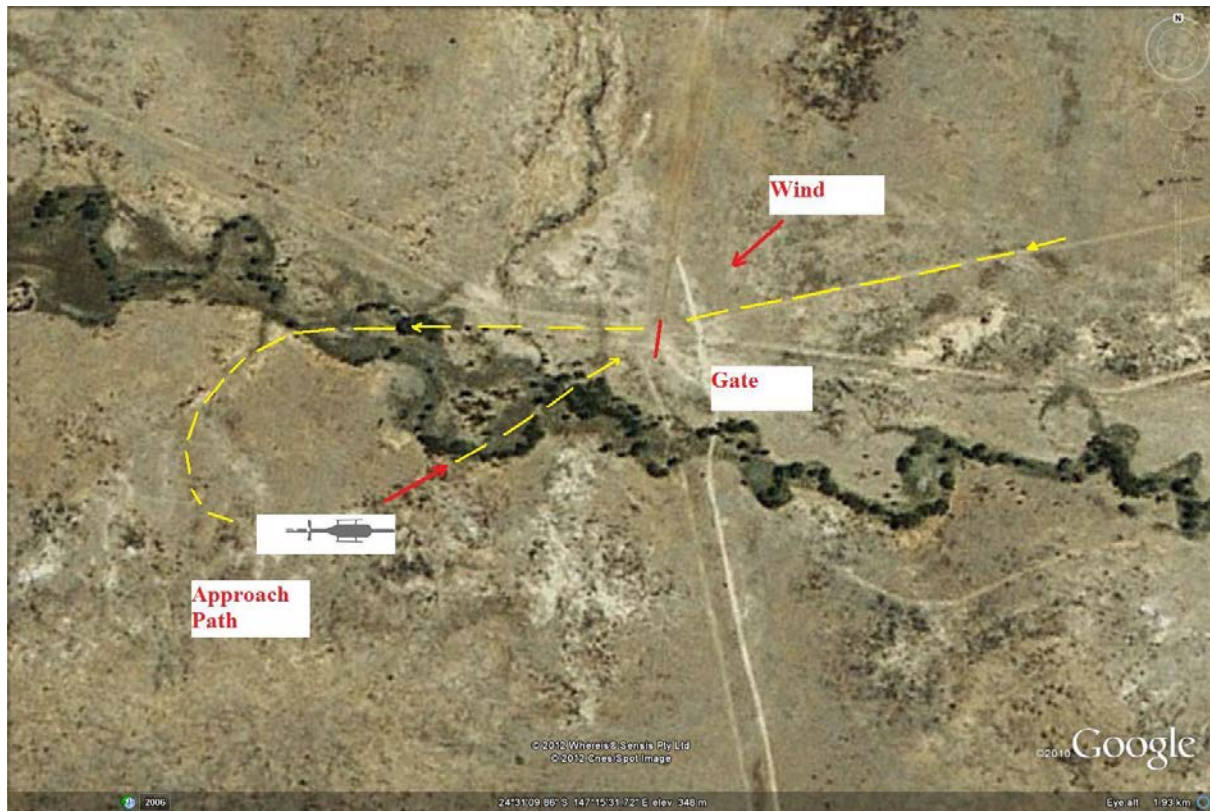
Figure 3: Approach path to the gate

Having landed at the particular gate on at least six previous occasions, the pilot was familiar with a clear landing area located nearby. The pilot flew over the gate from the north-east and made a 180-degree turn back into wind to approach an area clear of saplings and long grass (Figure 3). The pilot
