Aviation Short Investigation Bulletin

Issue 17

AB-2013-050

Final – 23 April 2013

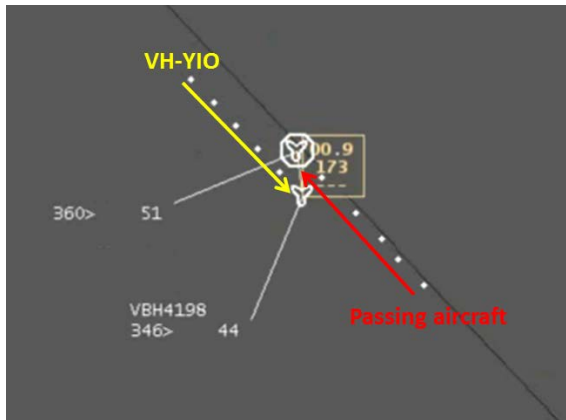
Figure 1: Aircraft positions at time of passing Figure 2: Incident location

At 1639, the aircraft became established in the cruise and the seat belt sign was turned off. Shortly after, the crew observed opposite direction traffic on the aircraft's traffic alert and collision avoidance system (TCAS), about 1,000 ft above and slightly to the left. The crew observed the aircraft pass to the left. Airservices Australia surveillance data indicated the aircraft passed at about 1640, with about 0.9 NM lateral and 1,400 ft vertical separation (Figure 1).

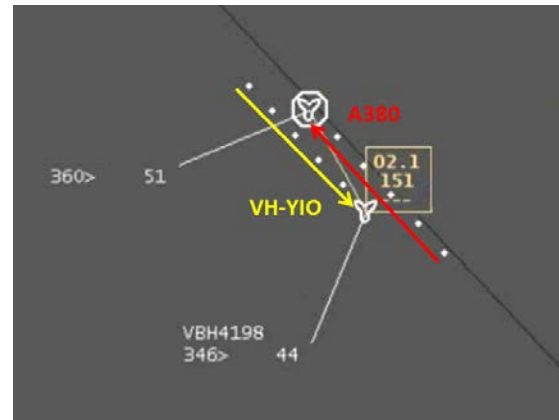
Radar surveillance data indicated that, at the time of the event, there was about 2.1 NM lateral and 1,400 ft vertical separation (Figure 2) between the aircraft and the correct ATC separation standards were being applied at the time.

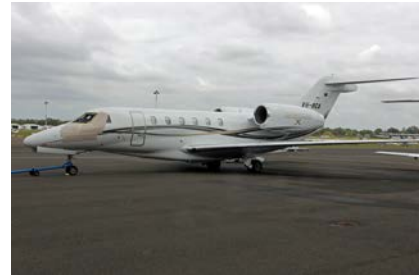
Cessna Citation 750, VH-RCA

Shortly after levelling at FL450, the crew reported that a WSHLD HEAT INOP L (windshield heat inoperative left) message was displayed on the EICAS³. The crew consulted the appropriate checklist, with the only action to leave icing conditions as soon as practical. The pilot flying (PF) reported that the left windshield was warm to the touch and that approximately 2 minutes later, the windshield outer ply shattered with a loud bang. The left and right windshield heat switches were subsequently switched to OFF. The flight crew completed the emergency depressurisation checklist, donned their oxygen masks and deployed the passenger oxygen masks. An immediate descent was commenced along with a turn towards Nadi International Airport, Fiji, which was one of the planned alternate airports. The PF declared a Mayday⁴ which was acknowledged by Nadi radio. Once the descent was established, the pilot not flying (PNF) ensured passengers were on oxygen and briefed them on the situation. The cabin was prepared for a possible ditching, with the passengers directed by the PNF to don their life vests and review the safety briefing card. The PF reported that the windshield cracking remained constant during the descent and did not progress further. The cabin did not depressurise, and once at FL140 and with the cabin altitude stabilised, the passengers were directed to remove their oxygen masks. The mayday was downgraded to a PAN⁵ and the flight continued to Nadi without further incident. There were no injuries to passengers or crew.

The aircraft returned to Sydney on 26 January 2013 with no passengers on board. Subsequent examination of the left electrically heated glass windshield (part number 9914380-11) by the ATSB showed that the outer ply had shattered across the entire surface (Figure 1). A brown discolouration was observed towards the top right of the windshield (facing forward) along with staining around one of the soldered contacts (Figure 2). The damage was confined to the outer layer of the windshield.

The windshield from VH-RCA had likely been affected by moisture ingress resulting in a degradation of the electrical connection between the bus bar and the heating film. The ATSB is satisfied that the issues leading to the non-structural failure of windshield part numbers 9914380-11/-12 have been addressed by the manufacturer.

The above changes were incorporated into part number 9914380-13/-14 which was released to service in early 2008. There have been no reported cases of either of these failure modes in the -13/-14 windshields.

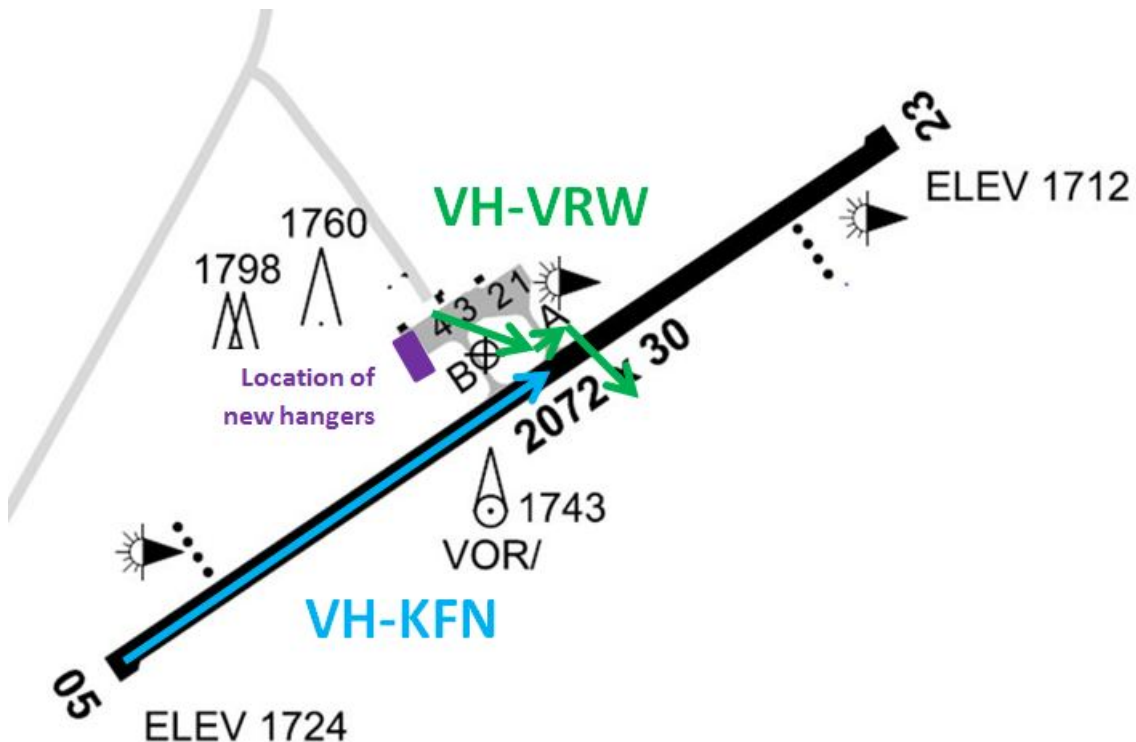
Figure 1: Track of VH-KFN (blue) and VH-VRW (green)

At about the same time, the crew of a Beech 1900C, registered VH-KFN (KFN), taxied for departure on runway 05. The crew made all necessary very high frequency (VHF) radio transmissions on the Common Traffic Advisory Frequency (CTAF). At 1300 Western Standard Time¹³, as the aircraft commenced the takeoff roll, the pilot in command (PIC) of KFN heard the pilot of VRW transmit a taxi call but did not expect the helicopter to commence a takeoff.

Radio transmissions at Newman are recorded for administrative purposes. A review of the recording for a period immediately before and after the incident showed that both KFN and VRW made all necessary radio transmissions prior to entering the runway. However, transmissions by KFN once on the runway were not recorded, though those made by VRW in the vicinity of the runway were. Recorded transmissions by VRW after the incident were clearly part of a conversation with KFN, though KFN's transmissions were not recorded.

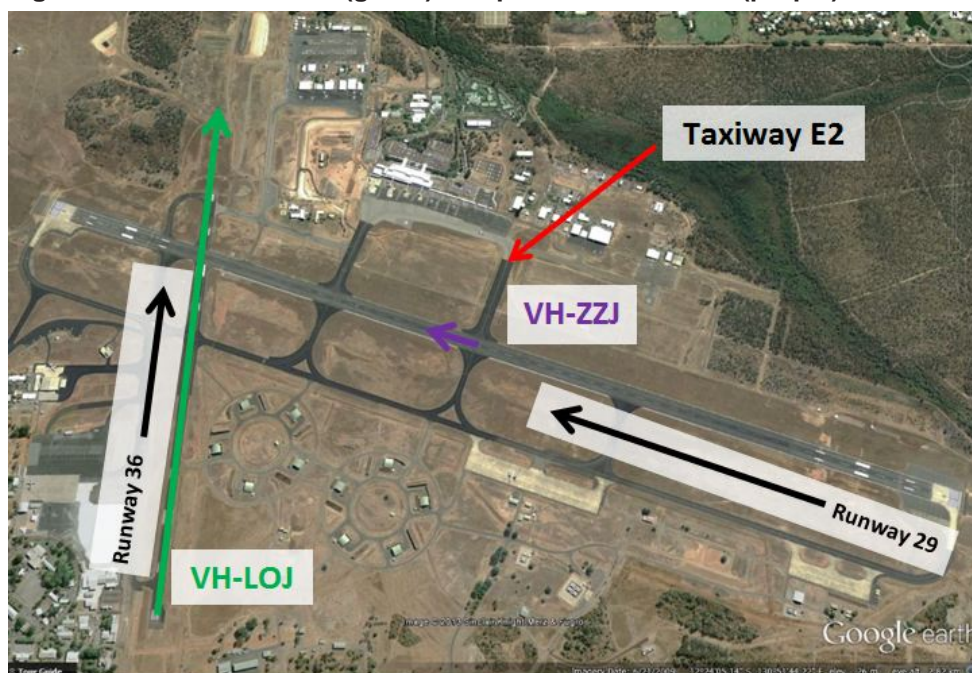
Figure 1: Track of VH-LOJ (green) and position of VH-ZZJ (purple)

Air traffic services at Darwin are provided by the Department of Defence (Defence). The Defence investigation found that an unsafe takeoff clearance had been issued to LOJ, resulting in a runway separation breakdown. Further, the ADC failed to monitor both ZZJ and LOJ during the takeoff, a critical phase of operation. The actions of the pilot of ZZJ, by delaying the takeoff, reduced the potential severity of the incident.

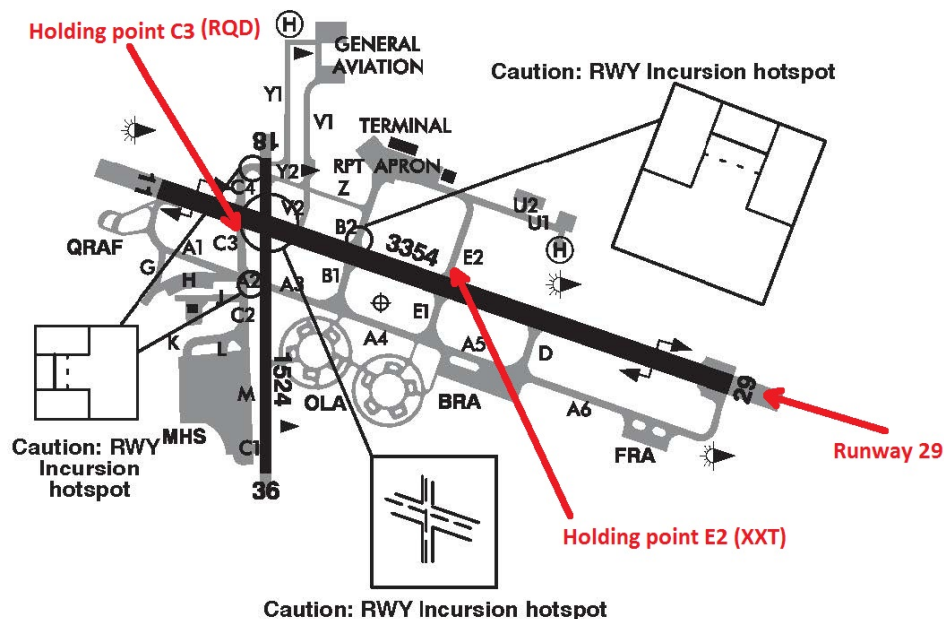
Figure 1: Darwin Airport

RQD vacated runway 18 to the left via taxiway Alpha and held short of runway 29 at holding point Charlie 3 (C3) (Figure 1), in accordance with instructions issued by the surface movement controller (SMC). At the same time, a Cessna 310, registered VH-XXT (XXT), was holding at taxiway Echo 2 (E2) for an intersection departure from runway 29.

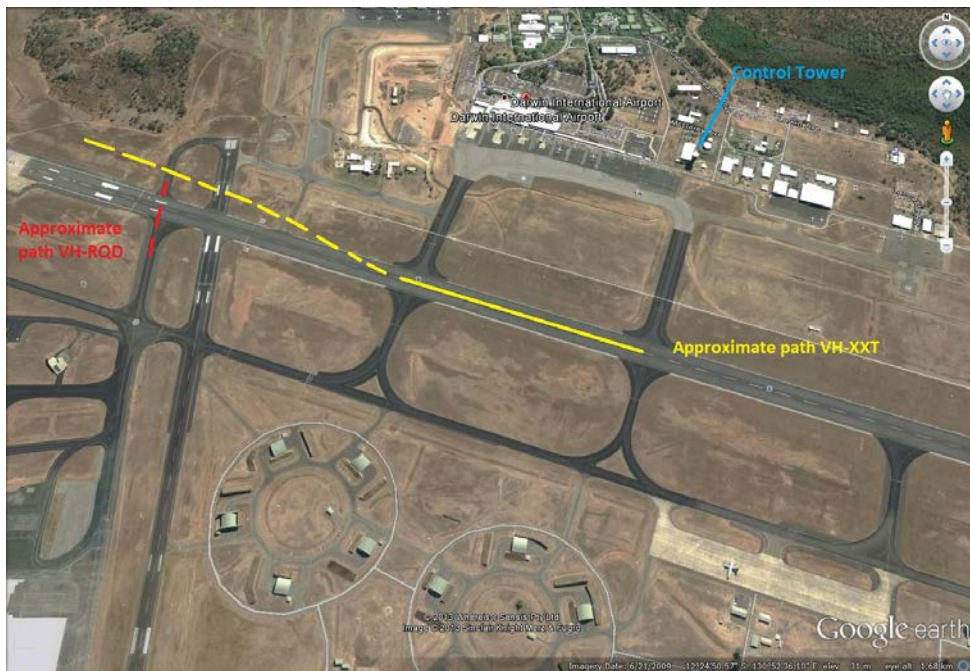
Figure 2: Approximate path VH-XXT and VH-RQD

It was estimated both visually and by radar that XXT then overflew RQD crossing the runway by between 150 ft and 500 ft (Figure 2).

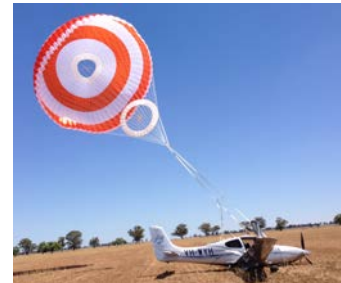
WYH at the accident site

At about 1359, WYH overflowed Gilgandra and continued on towards Dubbo, at which point the oil pressure gauge indicated about 12 psi. The approximate flight time remaining to Dubbo was 11 minutes. At 1401, the engine failed and the pilot could hear something rattling around in the engine cowling. The pilot turned the aircraft towards Gilgandra aerodrome and broadcast a mayday call, indicating that the engine had failed and he intended to land at Gilgandra aerodrome. The pilot then shut down the engine. It became evident that a landing at Gilgandra aerodrome was not achievable and he looked for a suitable landing point away from roads, trees and possible power lines. The pilot broadcast a call on the Melbourne Centre frequency advising that they

The pilot indicated that there was no sign of an external oil leak from the engine and there was no oil on the windscreen (Figure 2).

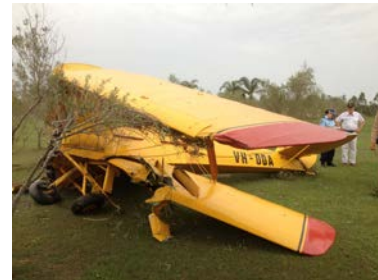
Aircraft damage

A small fire caused by a fractured fuel line was quickly extinguished by ground crew and the aircraft sustained substantial damage.

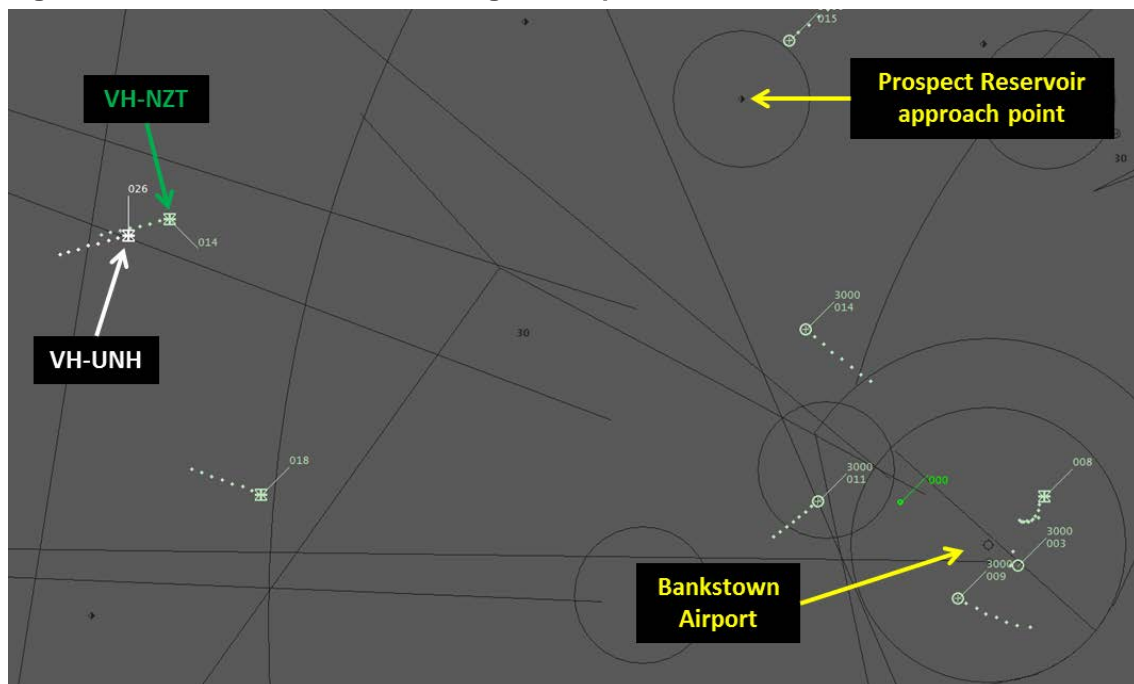
Figure 1: VH-NZT and VH-UNH tracking to Prospect Reservoir

Airservices Australia surveillance data showed UNH following NZT on a similar track (Figure 1).

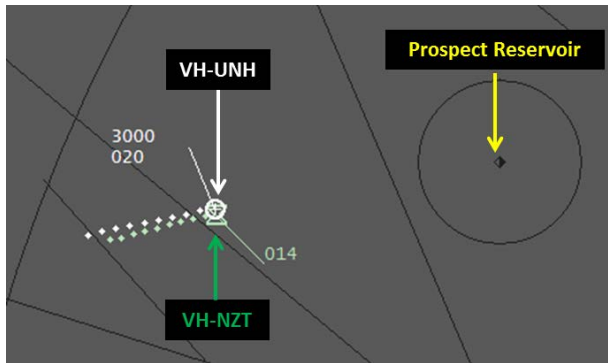
Figure 2: Aircraft positions at 1550:47

Both UNH and NZT continued tracking for Prospect and when at 4-5 NM, the instructor of NZT changed radio frequency to Bankstown Tower. Shortly after, at 3.5 NM (1550:47 Eastern Daylight-saving Time²), UNH was observed on the Airservices Australia surveillance data descending overhead NZT with 600 ft recorded vertical separation, which was actually 500 ft, accounting for

NZT's transponder discrepancy (Figure 2). The pilot of NZT reported maintaining 1,500 ft while UNH continued to descend.

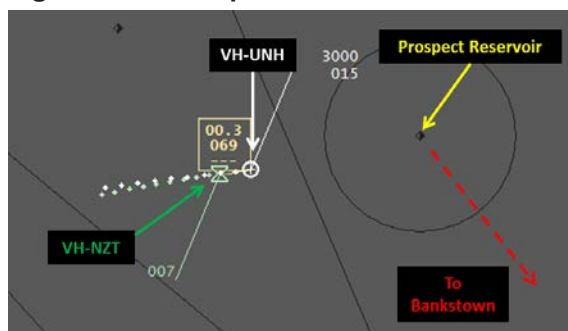
Figure 4: Aircraft positions at 1551:37

At 1551:37, when 2 NM from Prospect, the instructor of UNH changed to the Bankstown Tower frequency and heard a broadcast from NZT advising they were inbound from Prospect at 1,500 ft (Figure 4). At that time, UNH was also maintaining 1,500 ft. As the instructor and student were not aware of NZT, they immediately commenced looking for the aircraft.

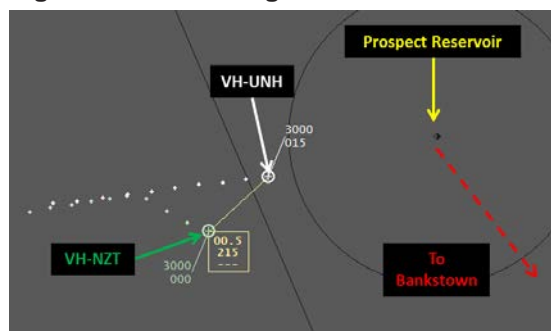
Figure 5: NZT turning inbound

NZT commenced the turn inbound to Bankstown (Figure 5). At the time of the incident, both NZT and UNH were operating in Class G airspace⁶.

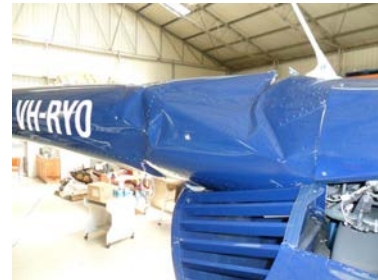
Helicopter damage

A witness reported hearing the rotor RPM behaving erratically and observing the helicopter pitching and rolling. The tail boom contacted the ground several times and the helicopter then rotated around the tail and came to rest on its right side.
