The Response of Aircraft Oxygen Generators Exposed to Elevated Temperatures

April 2003

DOT/FAA/AR-TN03/35

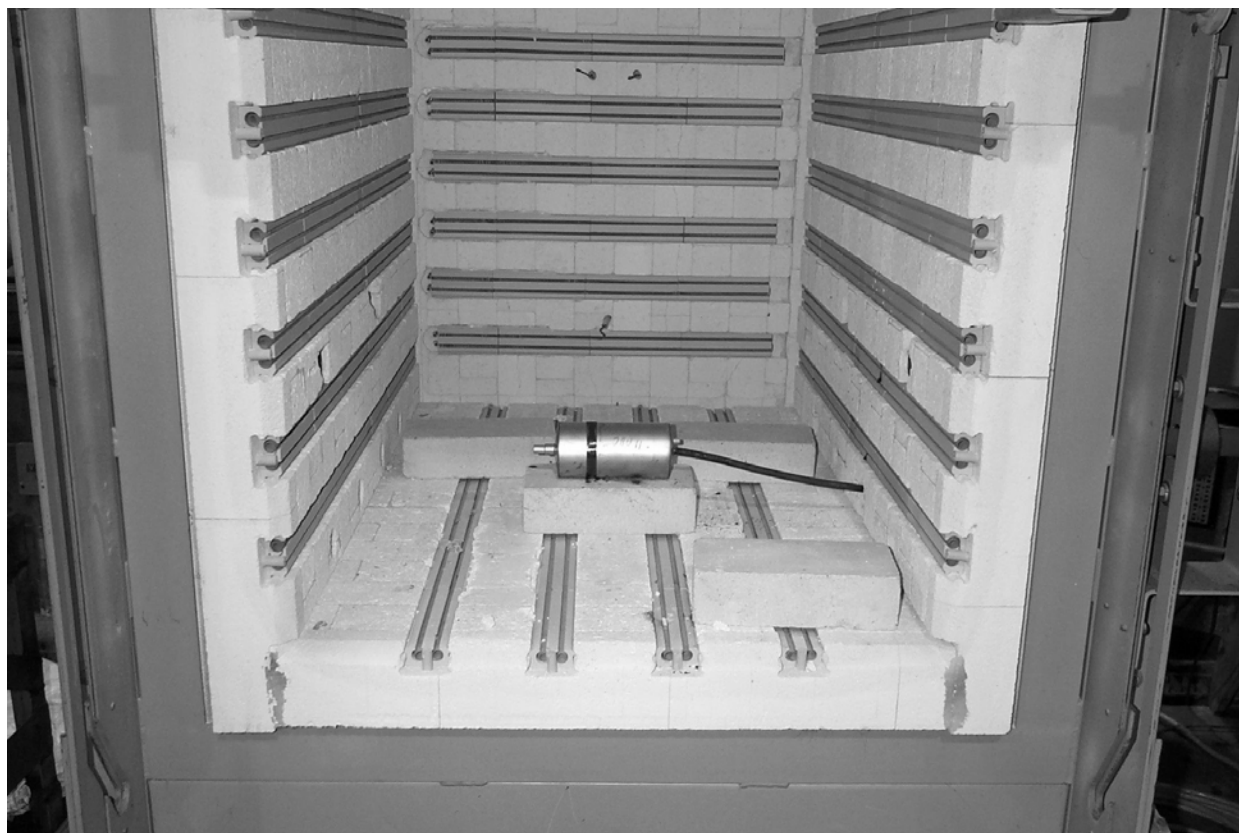
FIGURE 1. FURNACE AND OXYGEN GENERATOR

Twenty-three tests were conducted in an electric box furnace. The multiple outlet fittings that feed the individual passenger oxygen masks were removed from all generators prior to testing. The main outlet of the generator was then attached to a copper tube that was routed outside of the furnace. A small strip of paper was placed over the outlet of this copper tube and used as an indication of the flow of oxygen from a generator activation. Figure 1 shows the test configuration.
