**NASA Technical Memorandum 110204**

**Structural Test Documentation and Results for  
the McDonnell Douglas All-Composite Wing  
Stub Box**

**Dawn C. Jegley and Harold G. Bush**  
*Langley Research Center, Hampton, Virginia*

**April 1997**

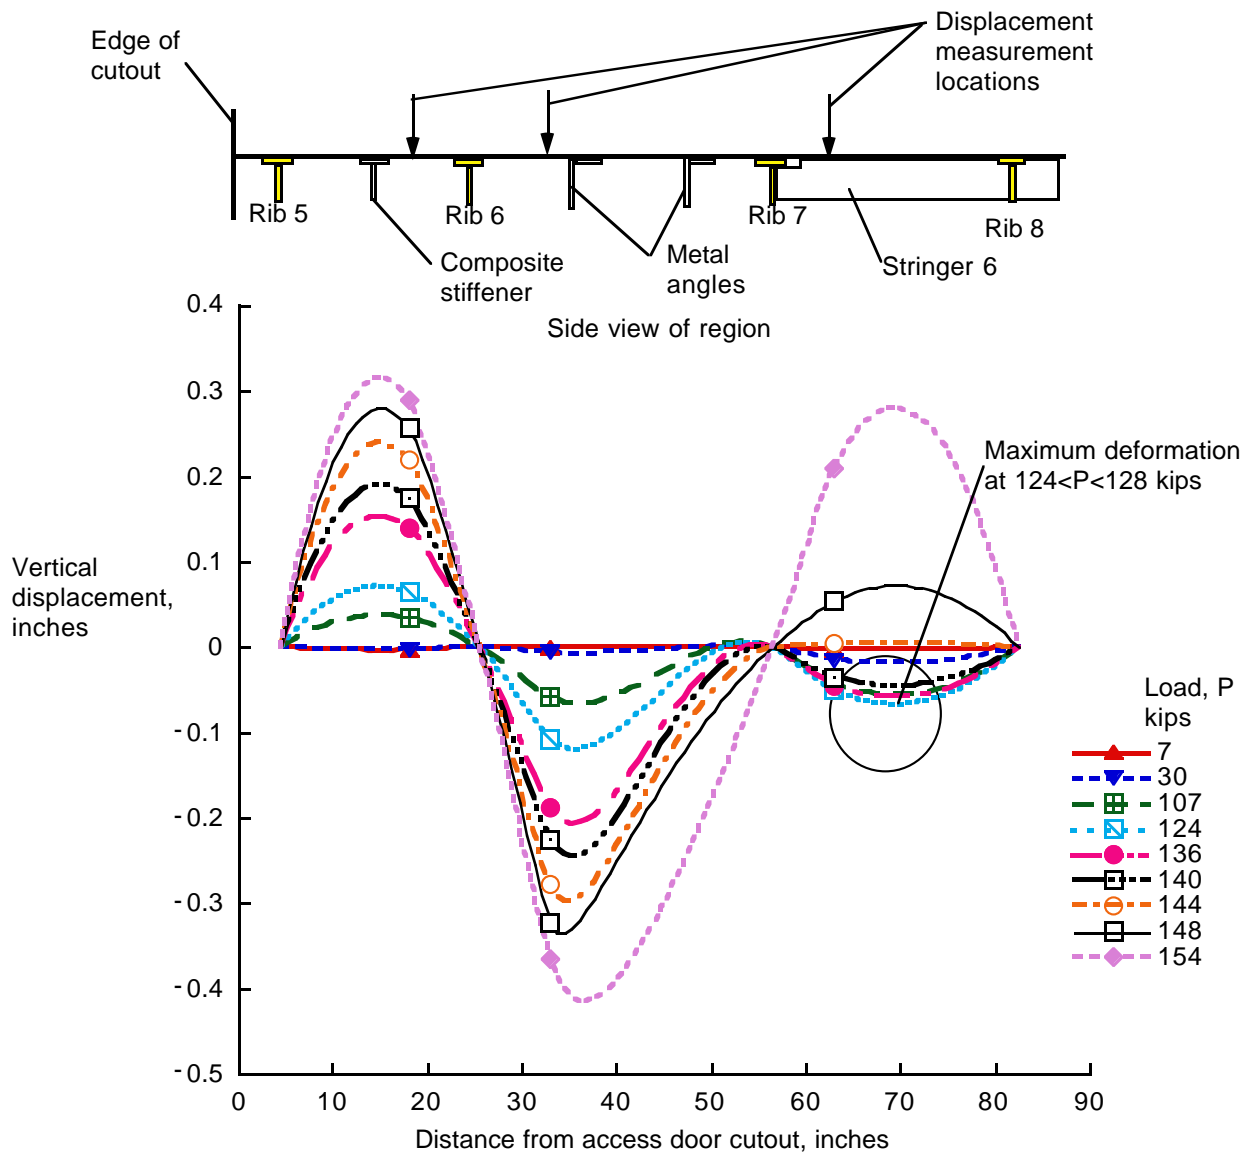
Ribs 5, 6, 7, and 8 support the cover panel outboard of the access-door cutout. By assuming that there is no difference between deformations in the unsupported region and the far field results at the locations of these ribs, and by considering the difference between displacement measurements in the unsupported region and the far field region, deformations caused by local behavior outboard of the access-door cutout edge to rib 8 can be determined. This deformation pattern is shown in figure 29 for a series of load levels. Measured differences are shown as symbols in figure. The curves shown in the figure are interpolations used to connect the assumed rib displacements and the measured data. Between ribs 5 and 6, the displacement increases monotonically as the load increases from zero to the maximum load. The location of the maximum displacement in this bay is half way between the ribs and the magnitude of the maximum displacement is approximately 0.33 inches. The skin deforms upward out of the wing stub box. Between ribs 6 and 7, the magnitude of the displacement also increases monotonically as the load increases from zero to the maximum load, however, the location of the maximum displacement is not half way between the ribs but is dependent upon the load level. The maximum displacement is 0.42 inches downward into the wing stub box between ribs 6 and 7. Between ribs 7 and 8, the magnitude of the displacement increases monotonically as the load increases from zero to 120 kips. However, the displacement reaches a maximum value of 0.07 inches downward into the wing stub box at a load of approximately 126 kips, then decreases in magnitude and changes sign at a load of approximately 144 kips. This reversal of direction of the displacement indicates that a change in the behavior of the upper cover panel skin has occurred. Nevertheless, the location of the maximum displacement in this bay is half way between the ribs for each load level whether the displacement is up or down. The maximum displacement between ribs 7 and 8 when the structure failed was 0.28 inches.

Figure 29. Relative vertical displacements outboard of access door cutout.

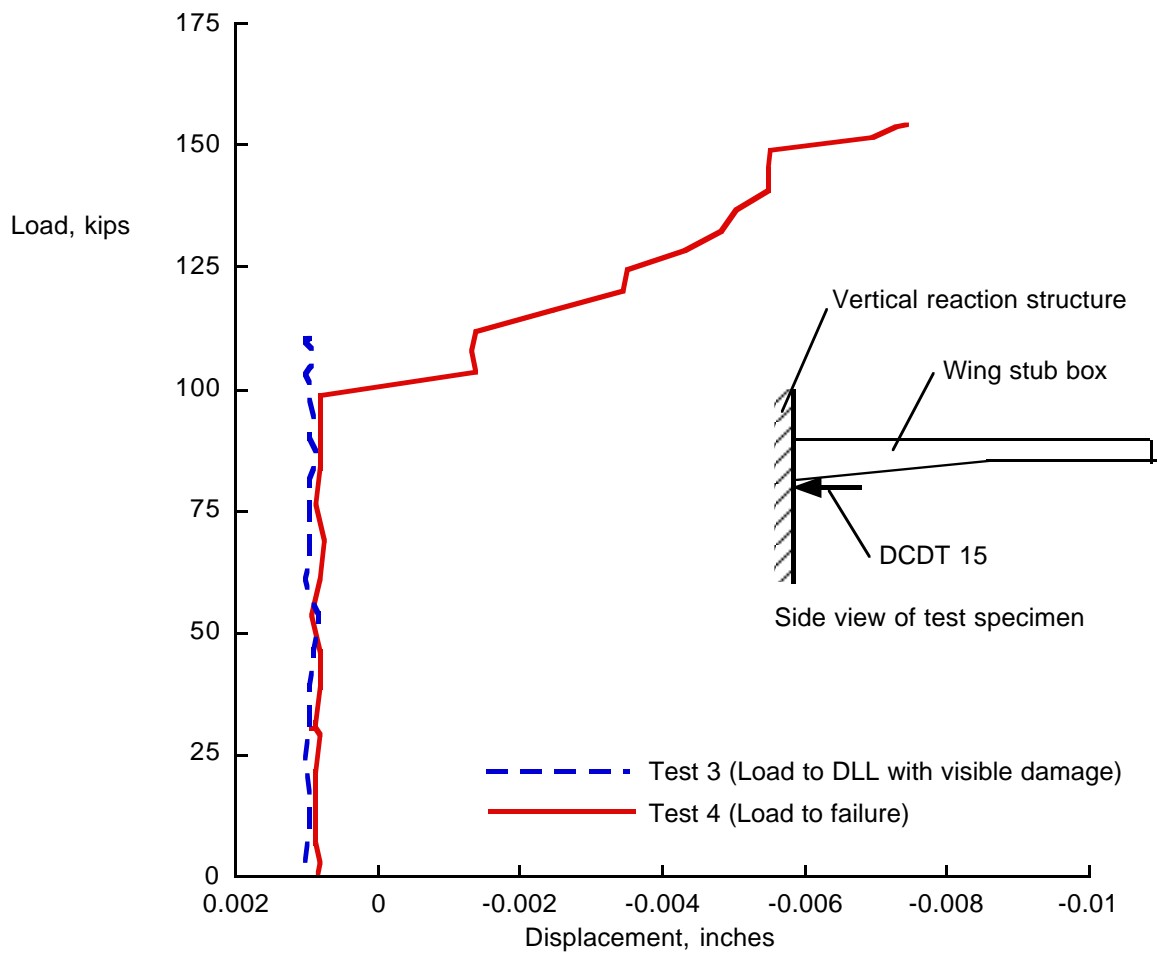
The displacement of the vertical reaction structure is shown for the last two tests in figure 30. The displacement of the vertical reaction structure never varied by more than 0.00015 inches during test 3, which had a maximum load of 110 kips. The displacement of the vertical reaction structure never varied by more than 0.00011 inches during the final test for loads less than 100 kips. However, for load levels greater than 100 kips in the last test, the displacement appeared to increase to almost 0.008 inches. Prior to each test, each DCDT was examined to verify that it would slide easily as the probe tip was moved. After the last test, examination of this DCDT revealed that the probe was jammed into its base and was not movable. No explanation for this damage could be found. Therefore, the data recorded from this DCDT during the last test must be considered suspect. There was no reason to believe that data recorded during the third test for this DCDT are in error.

Figure 30. Displacement of vertical reaction structure slotted plate near the rear spar.

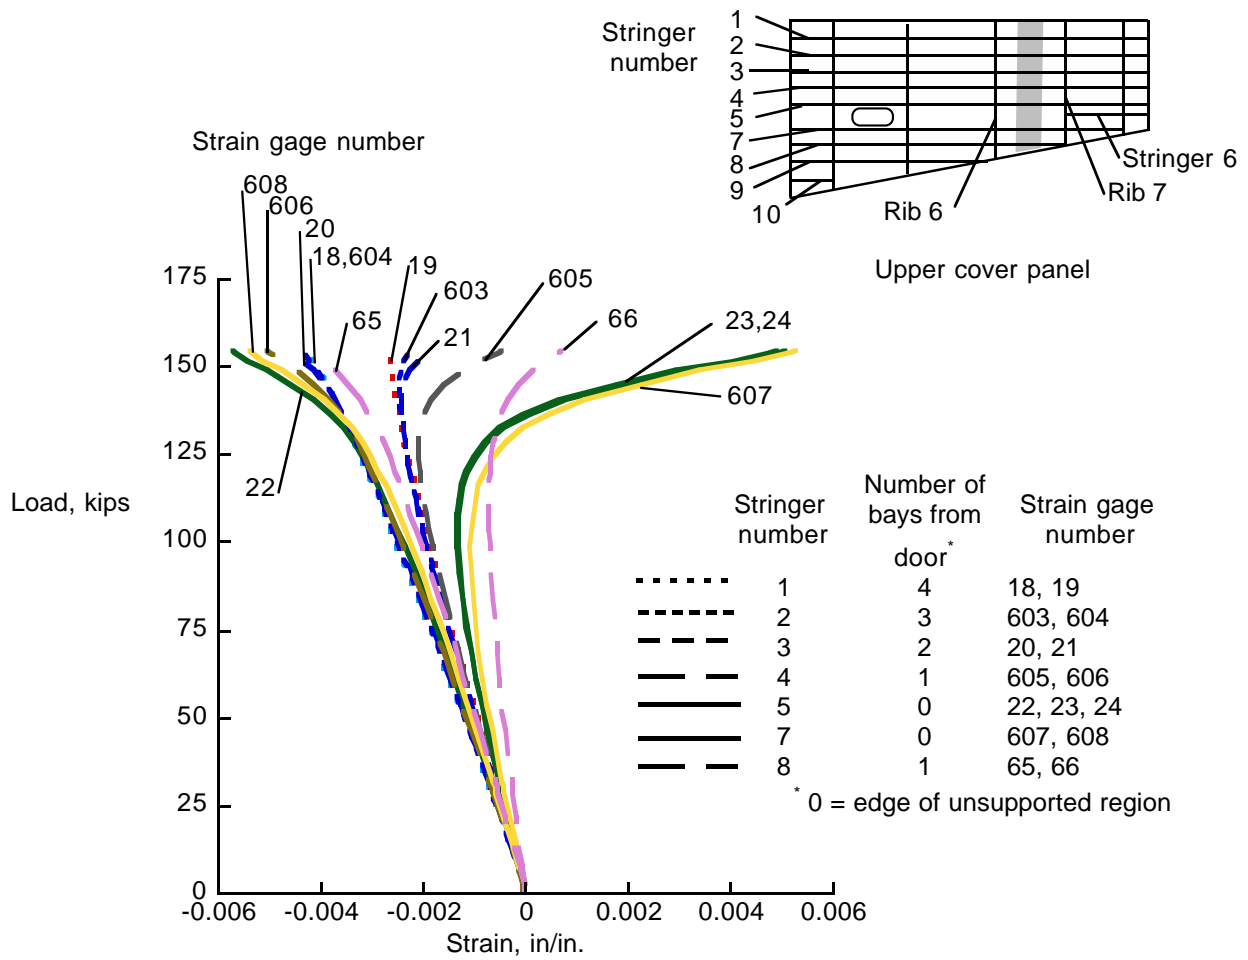
The strains measured between ribs 6 and 7 are shown in figure 31. The solid lines represent strains from strain gages 22, 23, 24, 607 and 608, which are on the stringer blades and skin at the edge of the unsupported region. The dashed lines represent strains from strain gages which are farther away from the unsupported region. Results from strain gages 23, 24 and 607, which are on the blades on the edge of the unsupported region, indicate the onset of nonlinear behavior at a load of approximately 100 kips and indicate pronounced nonlinear behavior starting at approximately 125 kips. Results from strain gages 18 and 19, which are the farthest from the unsupported region in this row, indicate nonlinear behavior away from the unsupported regions begins at a load of approximately 130 kips.

Figure 31. Strains for stringers in upper cover panel between ribs 6 and 7.

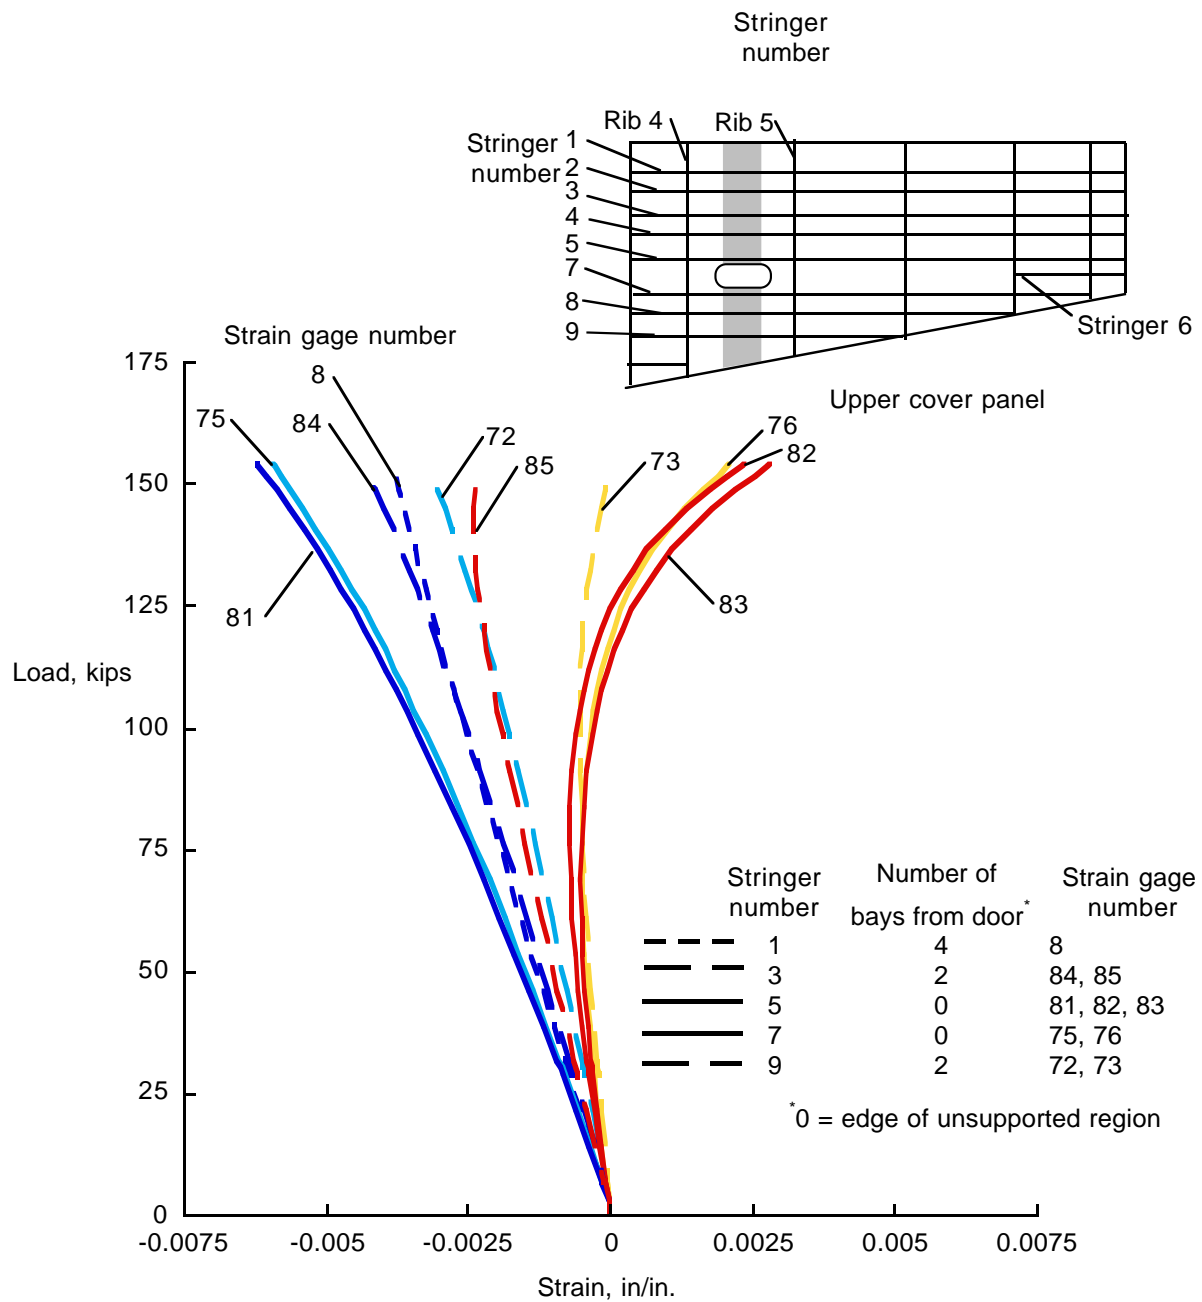
The strains measured between ribs 4 and 5 are shown in figure 32. The solid lines represent strain gages 75, 76, 81, 82 and 83 which are on the stringer blades and skin at the edge of the bay containing the access door. The dashed

Figure 32. Strains at stringers for upper cover panel between ribs 4 and 5.

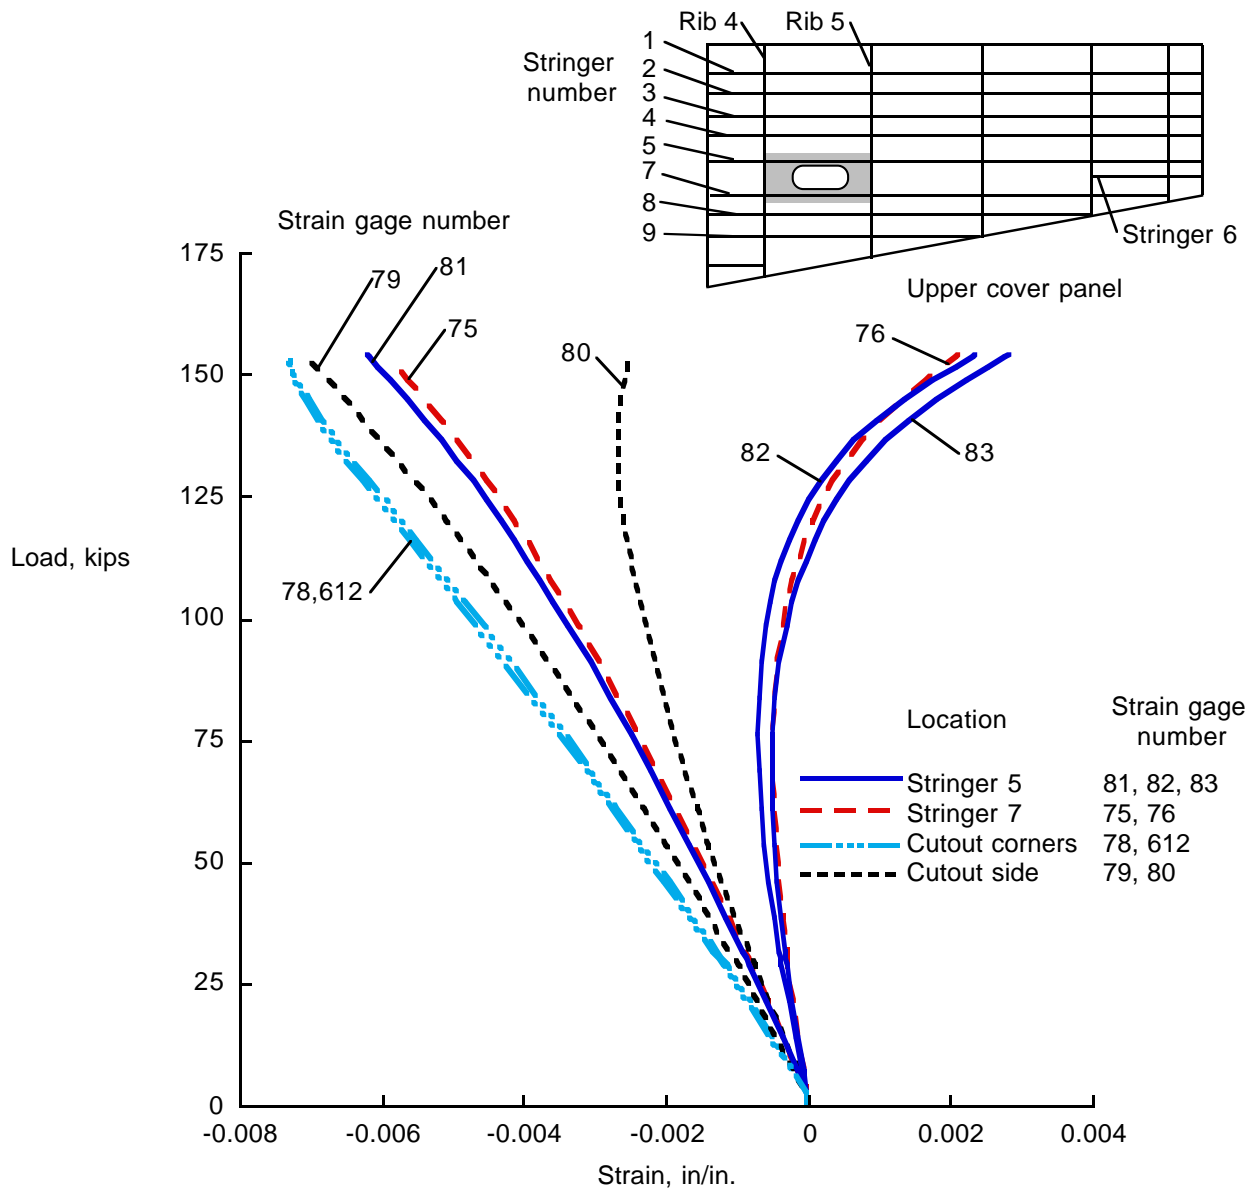
The strains measured in the region immediately around the access door are shown in figure 33. The strains in stringer 5 are shown as solid lines. The strains in stringer 7 and at the cutout edges are shown as dashed lines. Strain gages 78 and 612 are located at the corners of the access-door cutout on the external surface and record approximately linear strain for loads lower than 150 kips. The magnitude of the maximum strain recorded by these strain gages is approximately 0.007 in/in. Strain gages 79 and 80 are on the internal and external surfaces, respectively, at the side of the cutout. Strains at the side of the cutout are less than strains at the corners, and nonlinear behavior is evident at the sides but not at the corners. The nonlinearity in the behavior of the strain gages on the stringers is more dramatic than in the skin, although higher strains occur in the skin. The interaction between the access-door cutout edge and the bolt holes around the access door leads to high strains around the access-door cutout. The nonlinearity is caused by the large unstiffened region, i.e., the large cutout in the skin. The access-door carries little load and contributes little to the stiffness of the cover panel.

Figure 33. Strains for the region around the access door.

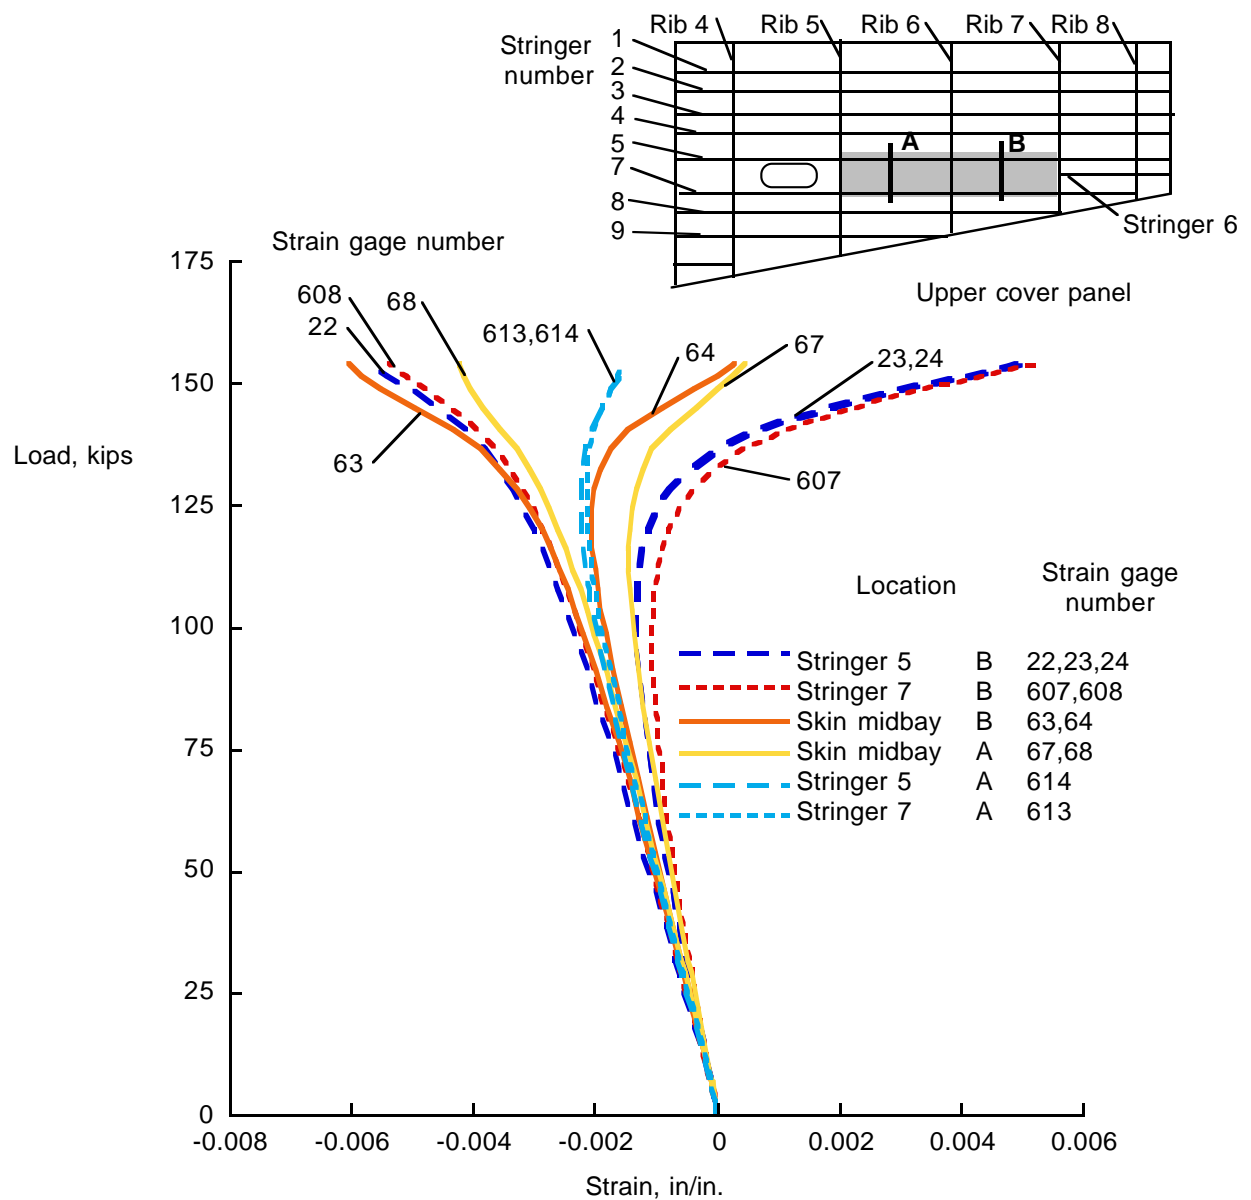
The strains measured in the unsupported skin between ribs 5 and 7 and in adjacent stringers 5 and 7 are shown in figure 34. Location "A" in the figure is half way between ribs 5 and 6. Location "B" in the figure is half way between ribs 6 and 7. The results from strain gages on the skin are shown as solid lines while the results from strain gage at the stringers are shown as dashed lines. All strain results in this region indicate nonlinear behavior. The most pronounced nonlinearity can be seen in the results from interior strain gages 23, 24 and 607, which are on the stringers surrounding the unsupported skin between ribs 6 and 7. Comparison of results from back-to-back strain gages 63 and 64, which are on the skin between ribs 6 and 7, suggest that an instability initiates at approximately 135 kips. Nonlinear behavior initiates prior to that load level. Similarly, results from strain gages 67 and 68, which are between

Figure 34. Strains in and around unsupported skin region between ribs 5 and 7.

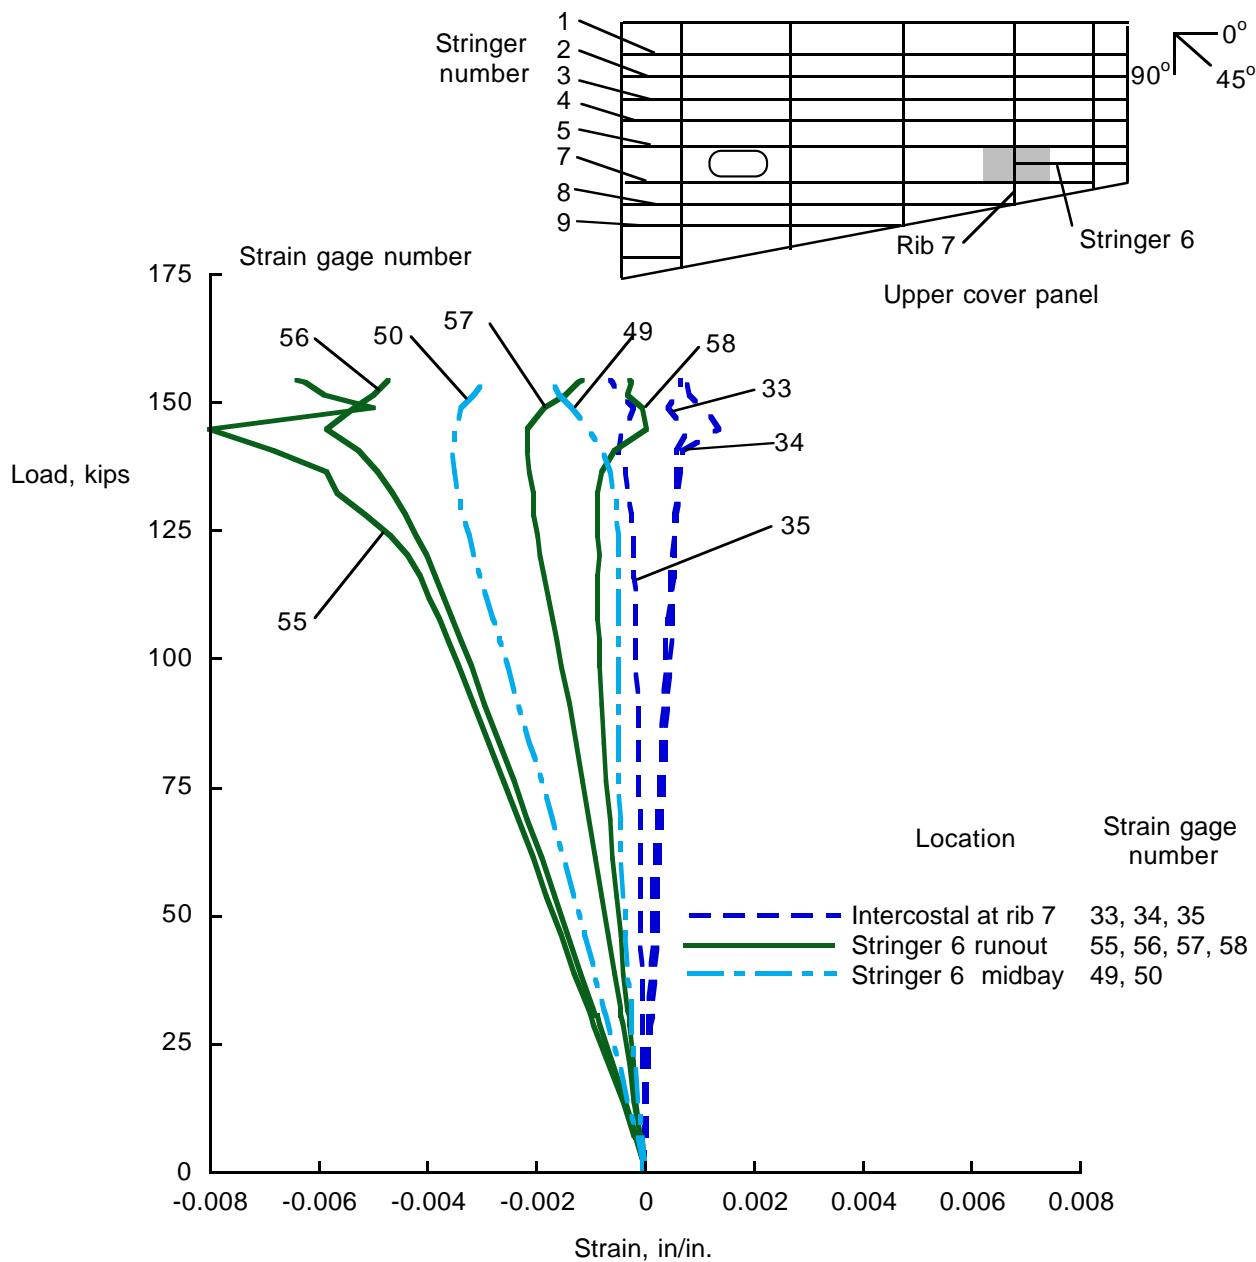
The strains measured on the runout of stringer 6 and at the intercostal at the intersection of rib 7 and stringer 6 are shown in figure 35. All strain gages are oriented axially except for strain gage 34, which is oriented 45 degrees to the stringers, and for strain gage 35, which is oriented 90 degrees to the stringers. All strain gage results indicate linear behavior with no pronounced discontinuities in slope for loads less than 120 kips. Nonlinearity in the load-strain behavior in the runout at stringer 6, indicated by strain gages 55, 56 and 58, begins at a load of approximately 120 kips. Nonlinear behavior initiates between 130 and 140 kips for strain gages 57, 35, 49 and 50. A strain reversal occurs at a load of 140 to 145 kips at strain gages 33, 34, and 35 on the intercostal at rib 7 and at strain gages 55, 56, 57, and 58 on the stringer at the runout. This reversal also occurs on stringer 6 away from the runout at strain gages 49 and 50, though no pronounced discontinuities in slope occur at strain gages 49 and 50. Discontinuities in slope occur in strain gages 55, 56, 57, and 58 at 145 kips. Discontinuities in slope occur at strain gages 33 and 34 at 140 kips, 145 kips and at 150 kips. A series of local failures would explain this behavior.

Figure 35. Strains for stringer 6 runout and intercostal at rib 7.

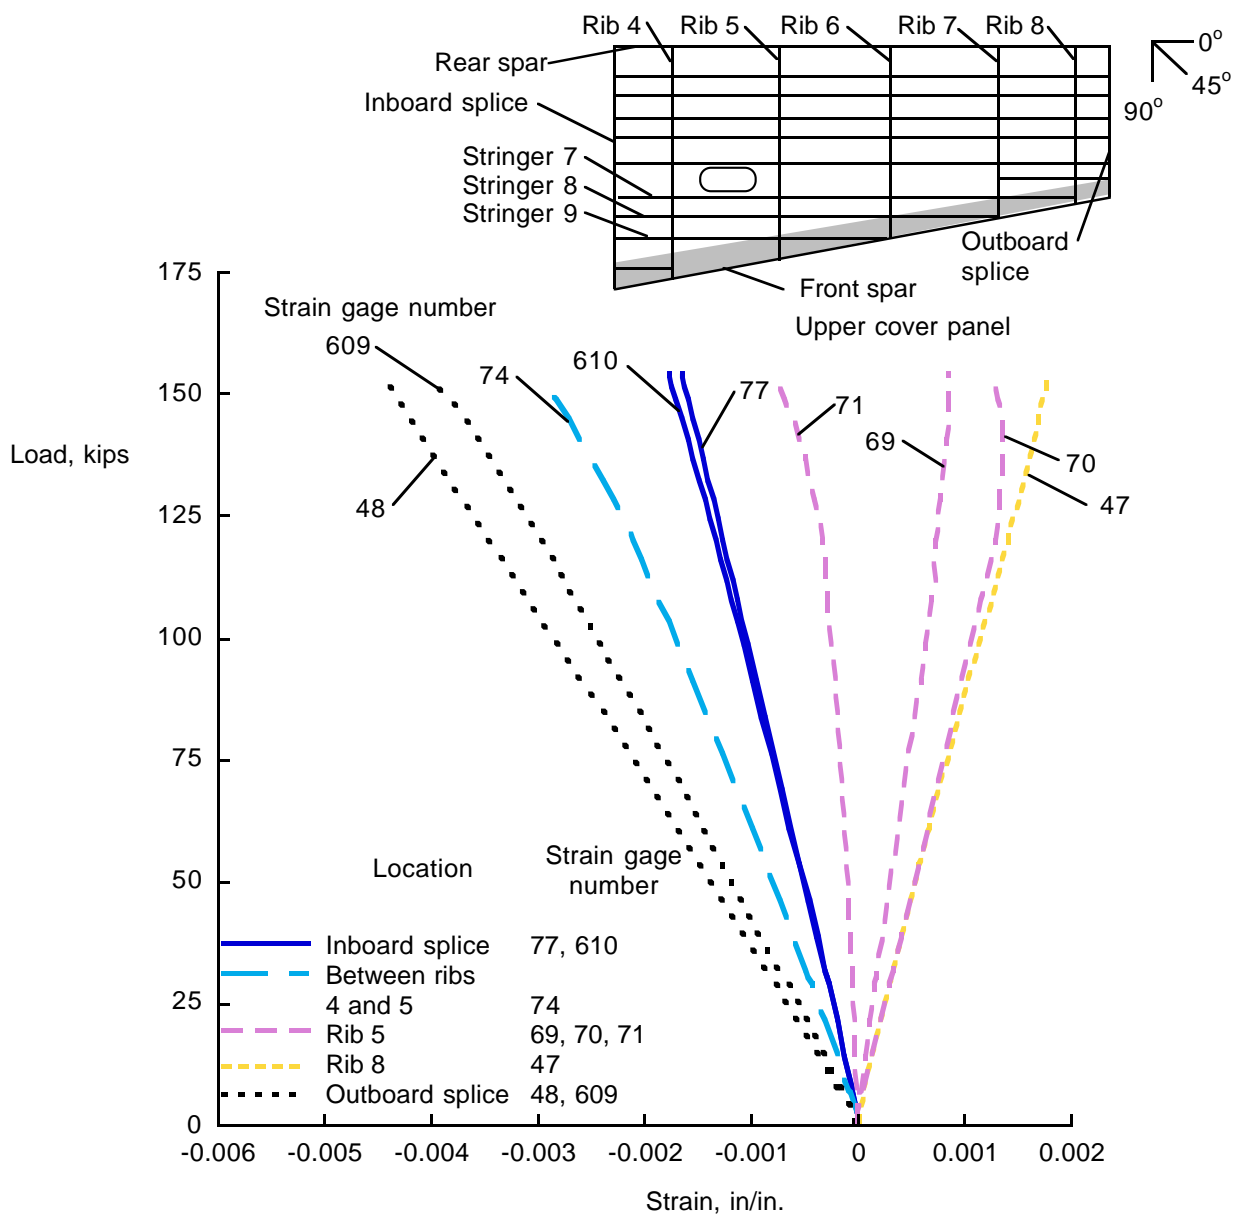
The strains measured in the upper cover panel at the front spar are shown in figure 36. The solid lines in the figure represent strains at the inboard splice between the load-transition structure and the composite stub box. The dashed lines represent strains further outboard on the stub box. Strain gages 48, 74, 77, 609, 610 are parallel to the front spar (-13 degrees to the stringers). Strain gage 47 is perpendicular to the front spar (-103 degrees to the stringers). Strain gages 69, 70, and 71 form a rosette measuring strain in the 0, 45, and 90 degree directions, respectively. The magnitude of the strain measured by these strain gages were less than 0.005 in/in. All strain gages along the front spar indicate linear behavior for load less than approximately 110 kips. Strains at the inboard splice and at rib 8 remain linear throughout the entire load range. However, nonlinear behavior initiates and a discontinuity in the slope of the load-strain relationship occurs in the 45 and 90 degree components of the rosette at rib 5 at a load of 100 kips. Nonlinear behavior

Figure 36. Strains for upper cover panel at the front spar.

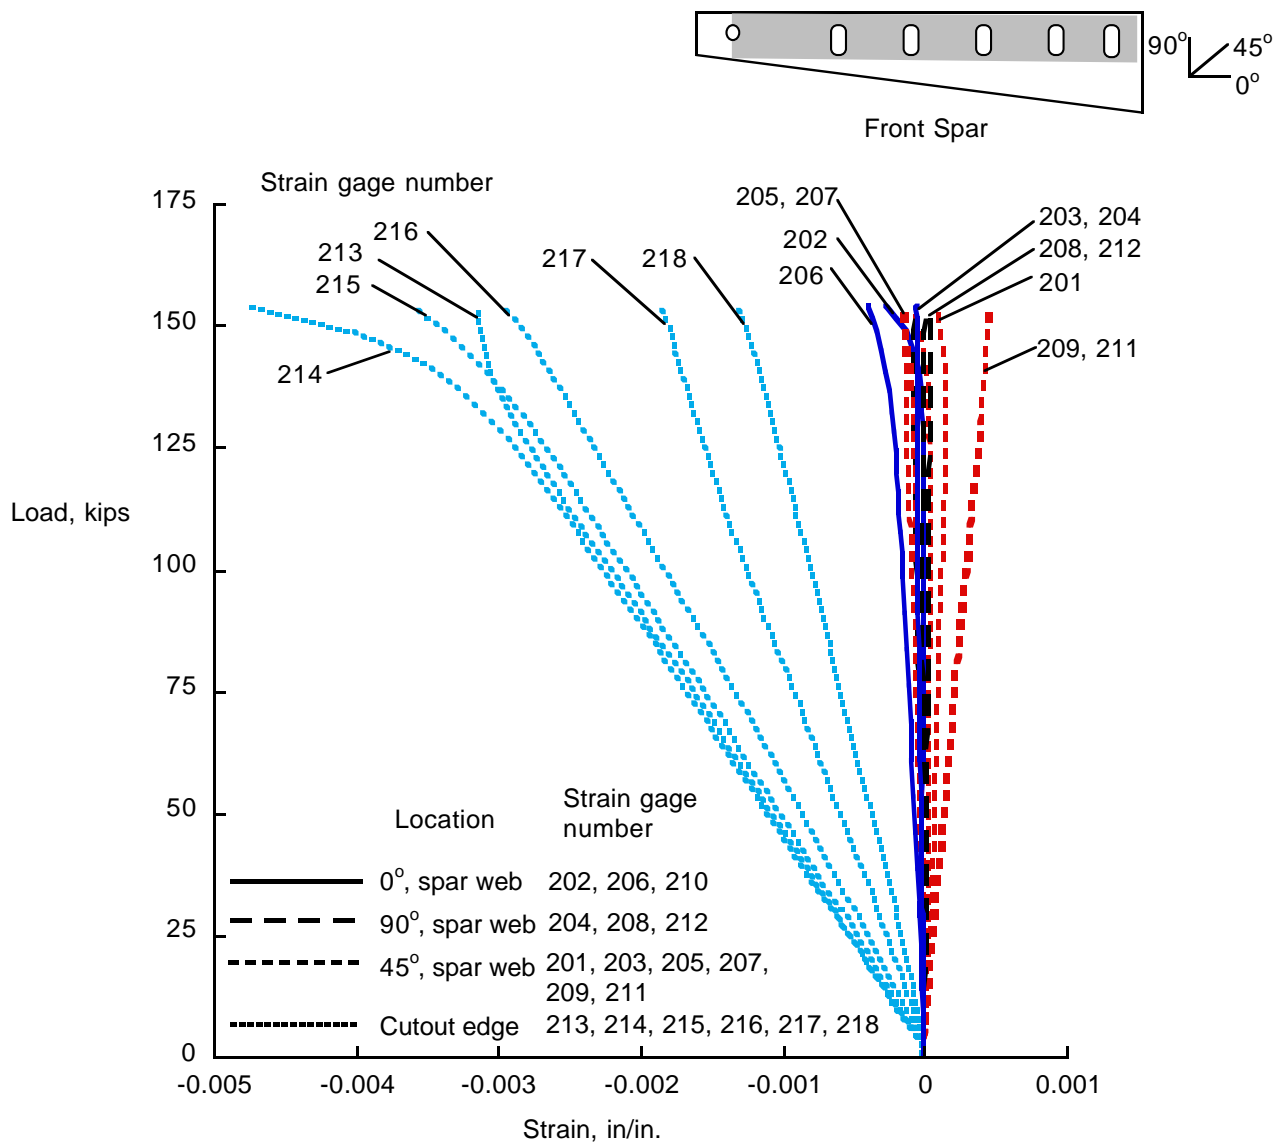
Figure 48. Strains for front spar.

Strain gage results for the front and rear spars are shown in figures 48 and 49, respectively, for strain gages positioned in midbay locations and on the cutout edges. Results for axial midbay strain gages are shown in the figure as solid curves. Results for strain gages oriented 90 degrees to the upper cover panel (out-of-plane to the cover panels), oriented at a 45 degree angle to the upper cover panel, and at the cutout edges are shown as dashed curves. The plots of strains in the front and rear spars are shown to the same scale. Strains measured on the front spar are linear for the entire load range except for strain gages 213, 214, 215 and 216. These four strain gages have a linear behavior for loads less than approximately 120 kips, then have a nonlinear behavior. They are located on the upper edges of cutouts in the front spar, with the more outboard strain gages recording the higher strains. The

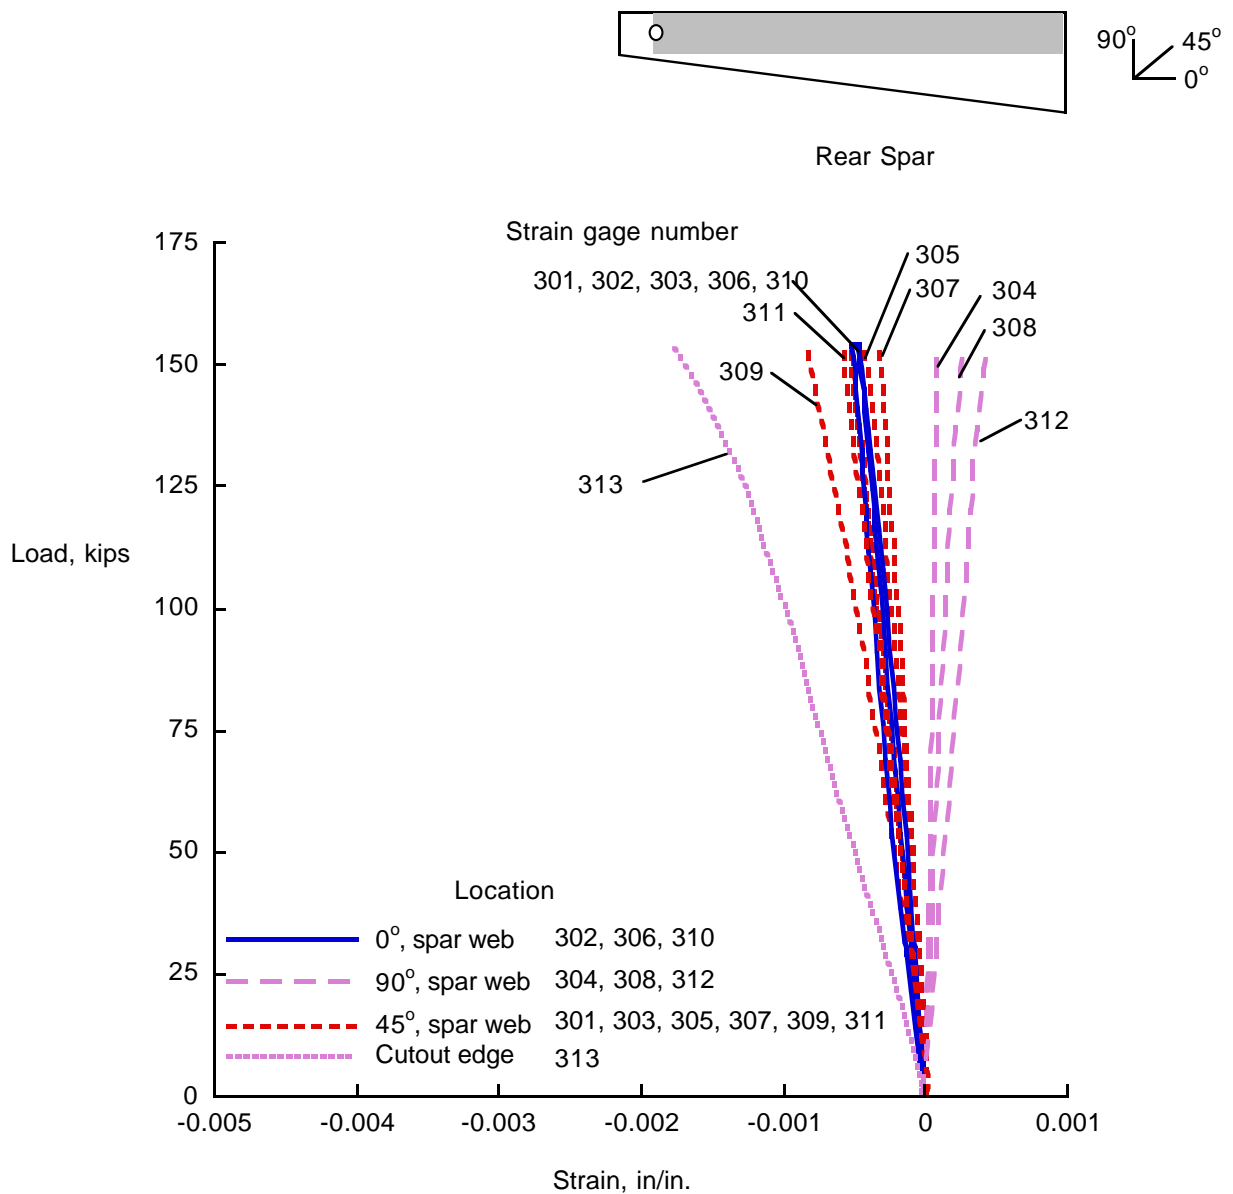
Figure 49. Strain in rear spar.

Only strain gage 313 on the rear spar recorded nonlinear strains, as shown in figure 49. There was one cutout in the rear spar and strain gage 313 was located on the upper edge of that cutout. No strains with magnitudes greater than 0.002 in/in. were recorded on the rear spar.

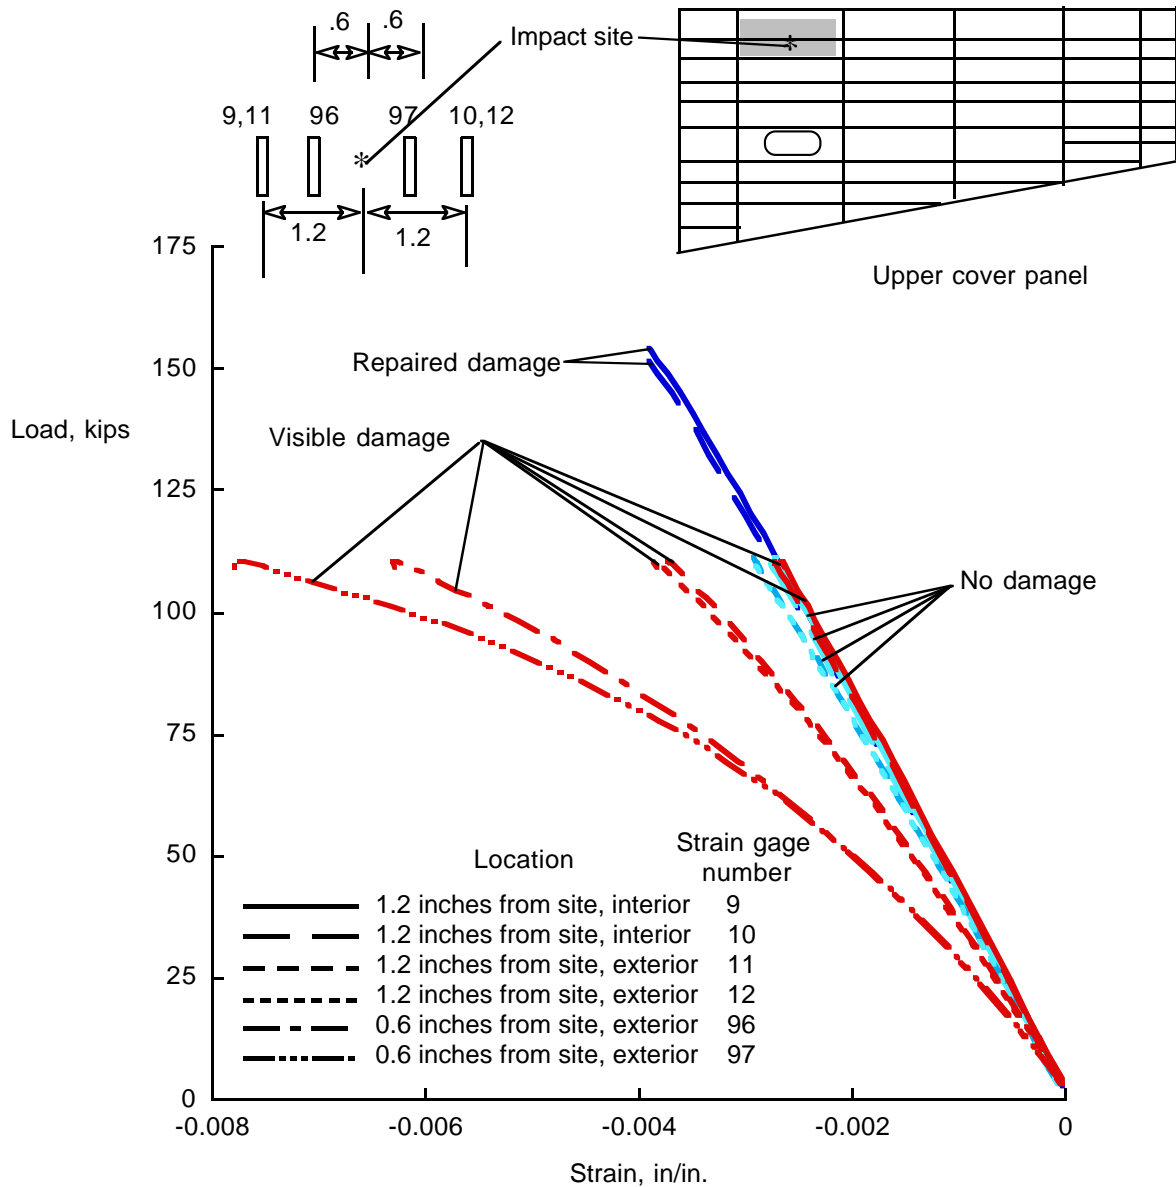
Figure 57. Strains in detectable-damage and repair region during last three tests. All dimensions are in inches.

The strains in the impact-damaged regions are presented in figures 57-61. The strains recorded for the upper cover panel skin in the region of detectable impact damage during three tests of the structure are shown in figure 57. Results are shown for the structure loaded to DLL prior to inflicting damage, the structure loaded to DLL after inflicting damage and the structure loaded to failure after the repair was installed. The strains for the skin and the repair for the final test only are shown in figure 58.

During the loading prior to inflicting damage, the strains in the skin are linear and reach a maximum magnitude of approximately 0.003 in/in. All strain gages in the region to be repaired recorded approximately the same strain. In the loading after visible damage was inflicted, the strains in the skin closest to the damage site were nonlinear in behavior for the entire load range. The maximum strain recorded in the region of visible impact damage is approximately 0.0073 in/in. in a strain gage which is 0.6 inches away from the impact site (strain gage 97). Interior strain gages 1.2 inches away from the impact site (strain gages 9 and 10) recorded the same strains with and without impact damage and with repair. The repair of the structure required the removal of the exterior strain gages closest to the impact site (strain gages 11, 12, 96 and 97). Axial strains measured during the final loading in the repaired bay and the bay adjacent to the repaired bay are shown in figure 58. Strain gages 5, 8, 9 and 10 on the skin recorded approximately the same strain. Strains recorded in the metallic repair are less than half the strains recorded

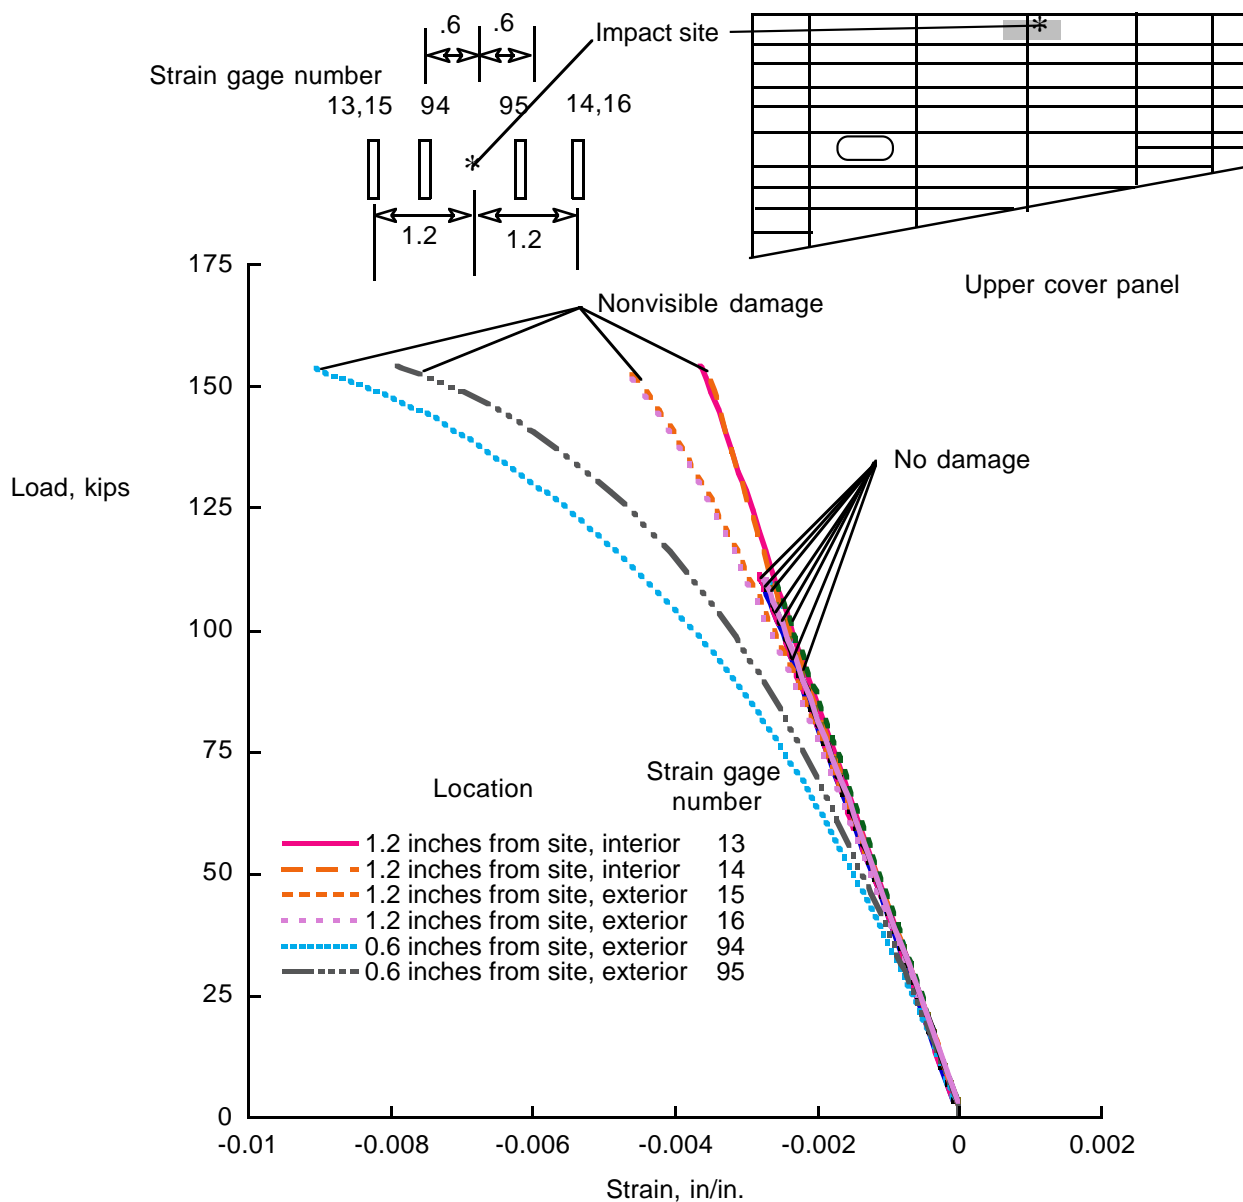
Figure 59. Strains at nonvisible damage site 1 for last three tests. All dimensions are in inches.

Two locations on the upper cover panel were subjected to nonvisible impact damage prior to the final test. The strains recorded during the last three tests near the location labeled NDT1 in figure 5 are shown in figure 59 and the strains around the location labeled NDT2 in figure 5 are shown in figures 60 and 61. Impact site NDT1 is located at the edge of an intercostal flange half way between the rear spar and stringer 1. Strain gages 13, 14, 15 and 16 are located 1.2 inches from impact site NDT1 and strain gages 94 and 95 are located 0.6 inches from site NDT1. Prior to impact, the strains 1.2 inches from NDT1 are linear and all strain gages recorded approximately the same values. The strain 1.2 inches from NDT1 at DLL is -0.003 in/in. After impact, the strains on the interior surface of the skin 1.2 inches from the NDT1 show the same linear behavior as they did prior to impact and remain linear to failure. A small amount of nonlinearity can be seen in the exterior strain gages 1.2 inches from the impact site and significant nonlinearity can be seen 0.6 inches from the impact site. At the maximum load of 154 kips, the largest compressive strain recorded in this region is -0.009 in/in. There were no failures detected in this region, and post-test evaluation of the site indicated no growth in the size of the damaged skin region.

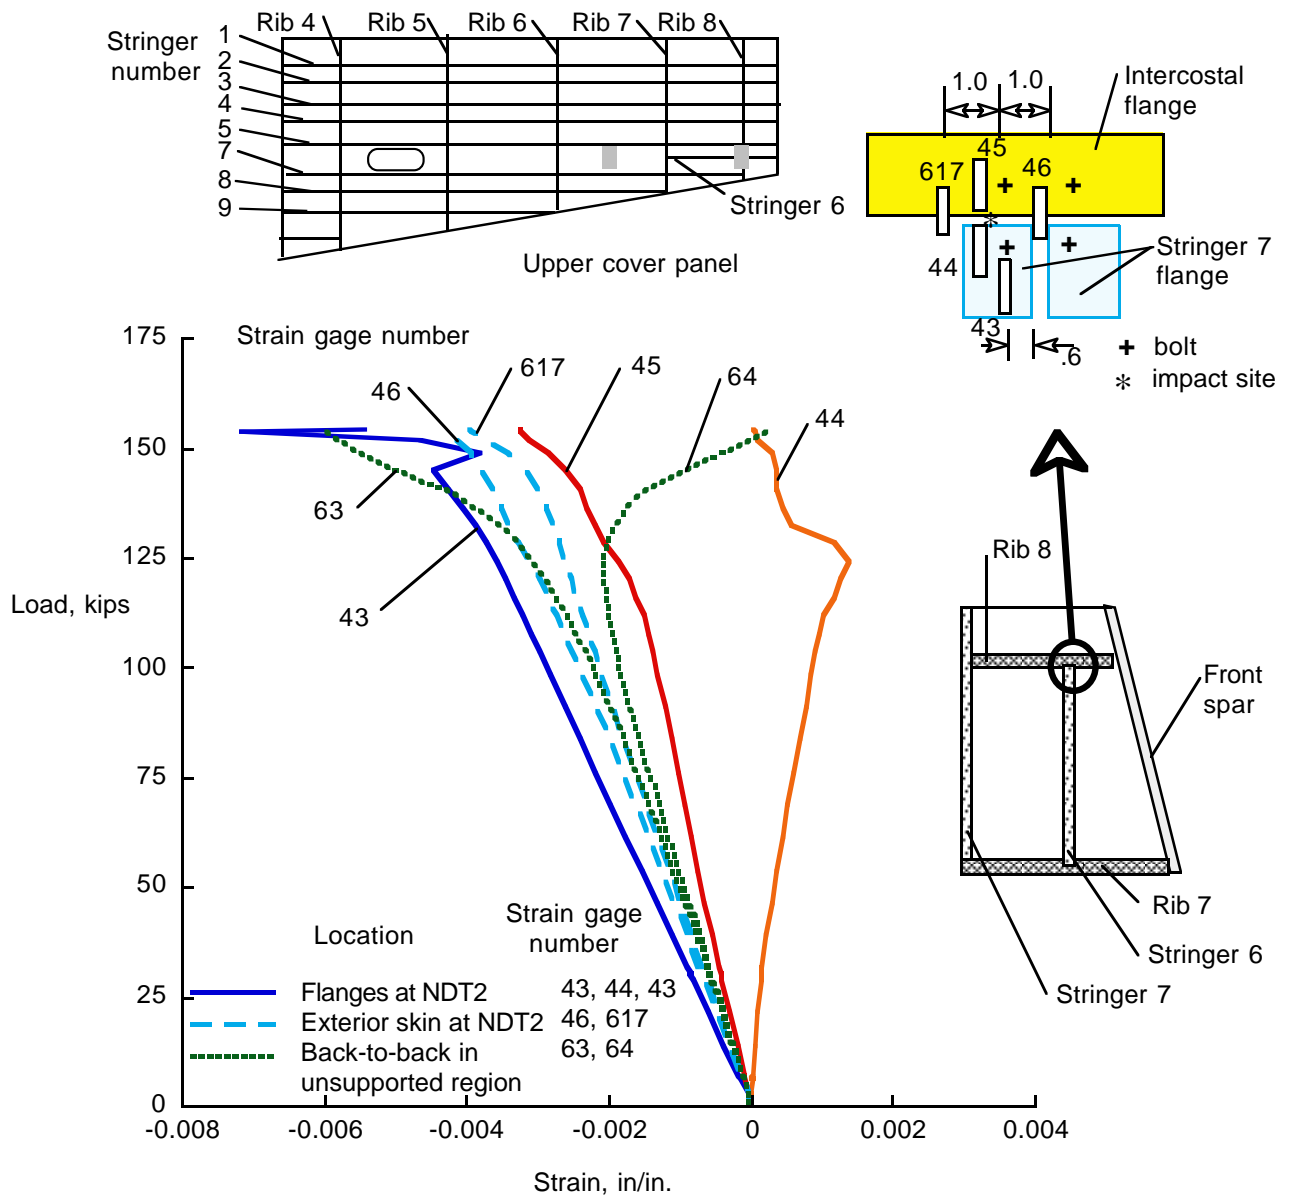
Results from strain gages closest to the impact damage site NDT2, (strain gages 43, 44, 45, 46 and 617), and back-to-back strain gages in the unsupported skin region, (strain gages 63 and 64), are shown in figure 62. C-scans of the damaged region made immediately after impact indicate the presence of damage at strain gages 44 and 45, so the structure may not perform as an undamaged structure at these locations. Nonlinear material behavior caused by the impact damage would explain the behavior of gage 45. Strain gages 43 and 46 at the impact damage site show linear behavior at higher loads than strain gages in the unsupported skin region which show linear behavior. The fact that the strain in the unsupported skin region becomes nonlinear before the strain at the impact damage site become nonlinear indicates that the behavior at the impact damage site was not influenced significantly by the buckling of the unsupported skin region.

Figure 62. Strains in region of nondetectable impact damage site 2 and in unsupported skin region. All dimensions are in inches.
