NASA/TM-2013-217993

# Evaluation of Acoustic Emission SHM of PRSEUS Composite Pressure Cube Tests

*Michael R. Horne*  
*National Institute of Aerospace, Hampton, Virginia*

*Eric I. Madaras*  
*Langley Research Center, Hampton, Virginia*

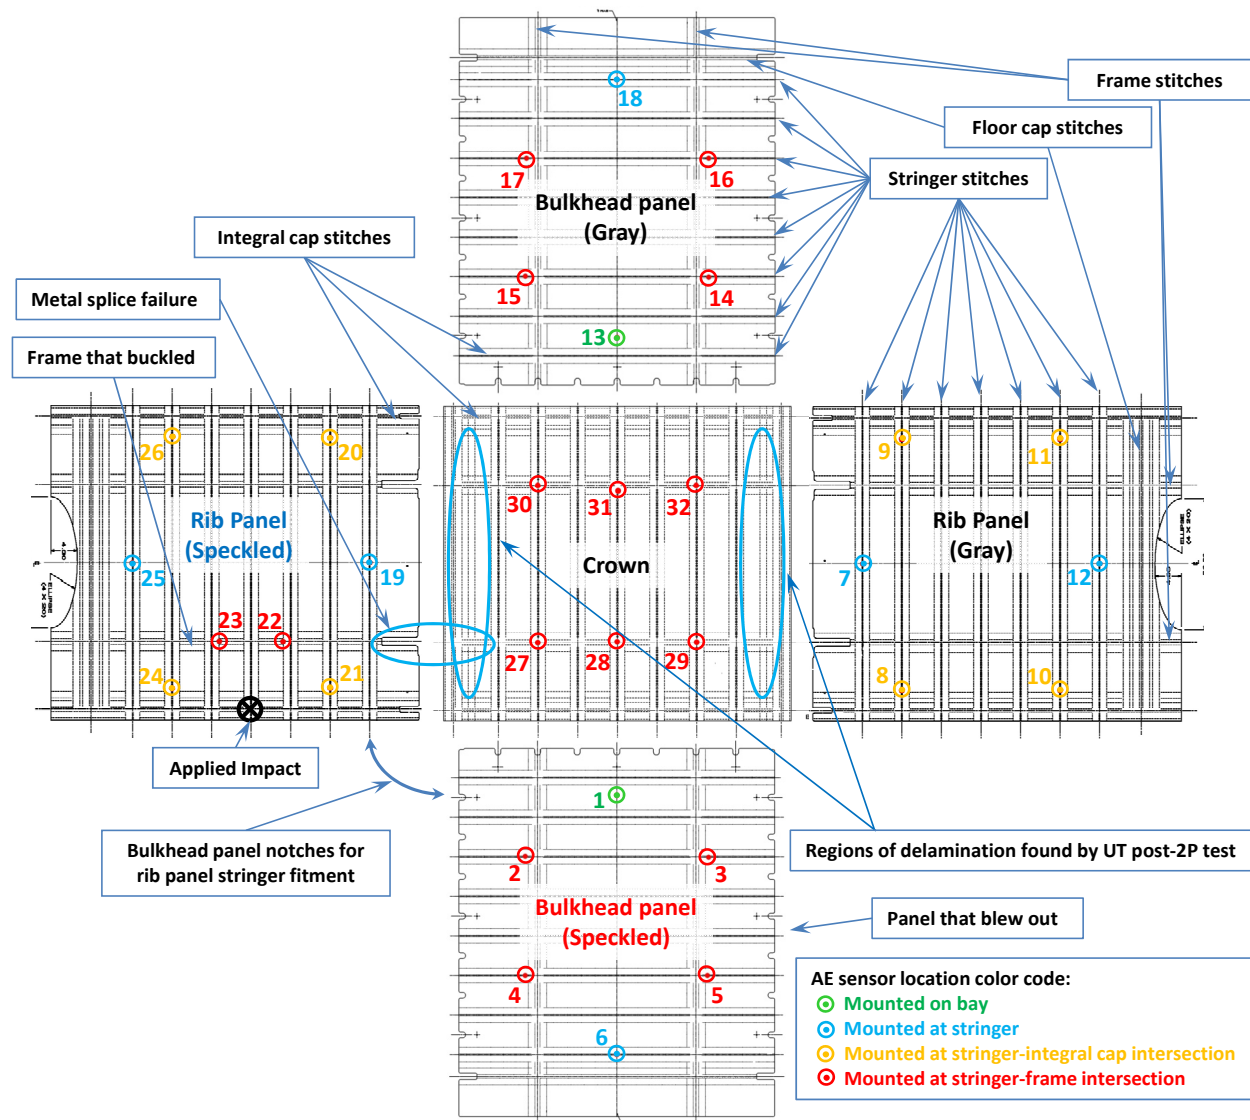
**Figure 3.** Locations of AE sensors on the panels of the pressure cube

Thirty-two acoustic emission sensors (Digital Wave B225.5) were mounted on the outside of the pressure cube as shown in figures 2 and 3. For easy removal all sensors were bonded with Lord 202 acrylic adhesive onto aluminum metal tape that was attached to the test article as seen in figure 4. The diameter of the sensor is approximately 0.75 inches.

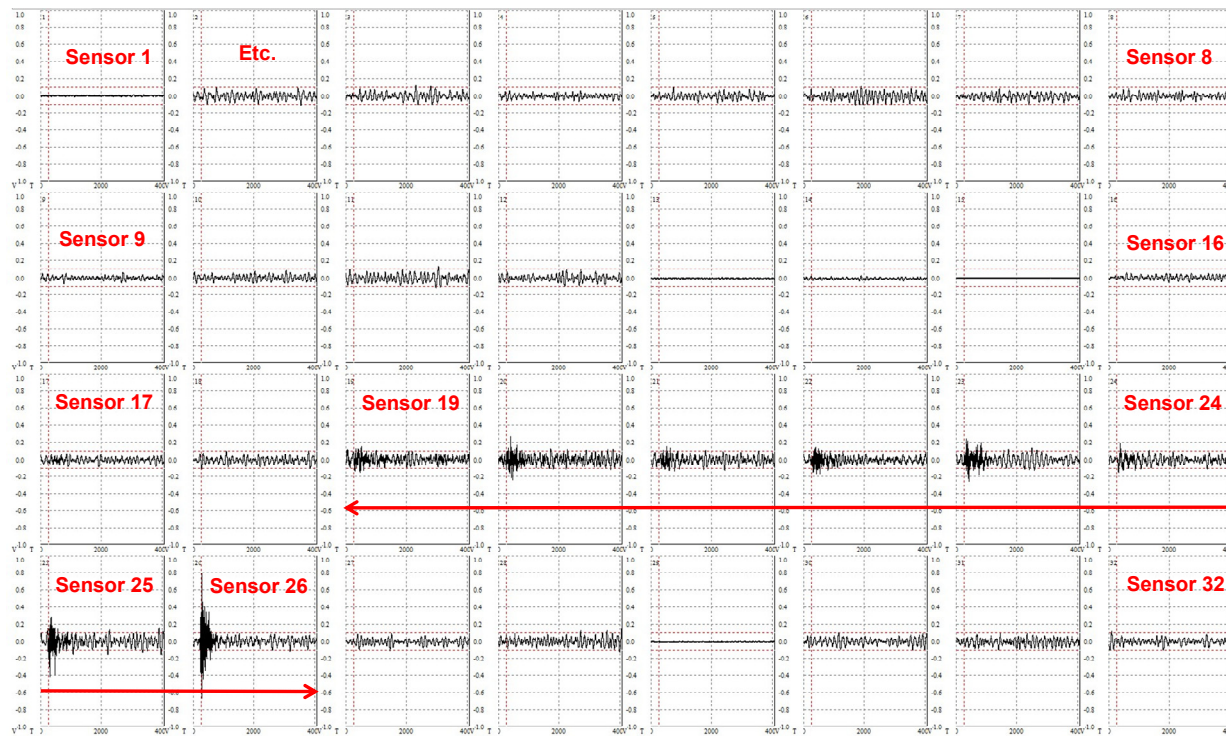
**Figure 9.** Checkout test 2 waveforms from AE event #1 captured at all the sensors

During checkout test 2, only two AE events occurred, near the peak pressure, as seen in the “Load profile and AE events” plot in figure 8. These events show less localized (geographically) and longer (in time) activity, indicated by the number of sensors with significant waveform, as illustrated in figure 9 of event 1. The event registered significantly on sensors 19 to 26, as indicated by the red arrowhead line. These signals look more like typical damage-induced AE signals. Also, these sensors are on the speckle-pattern rib panel which suffered a metal splice fracture and frame buckling during later tests. Compared to the signals from checkout test 1, these signals are more likely to be from a distributed structural “damage” source. The response of event 2 is similar and has indications on sensors 1-6, 8, and 10. Note that sensors 1-6 are on

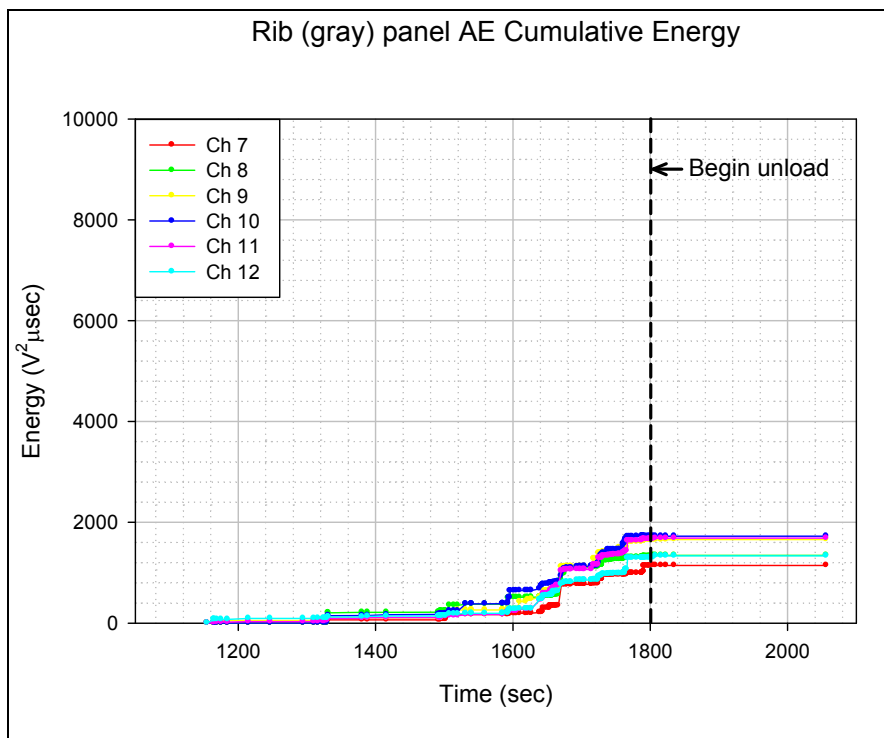
**Figure 12.** Pressure 1P Test: Gray rib panel AE energy

panel) at sensors 20 and 9 on the rib panels (adjacent to 30 and 32 respectively). In figure 14, sensor 20 obviously leads the others on the speckled rib panel. In figure 12 it is harder to see, but 9 is at the top with 10 and 11 by the end of the test.

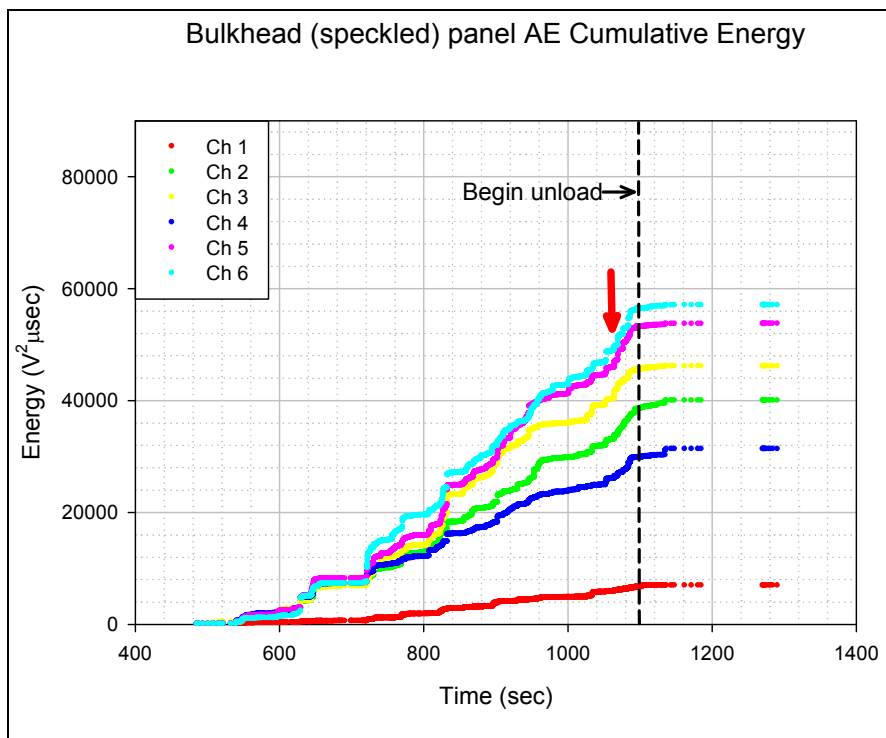
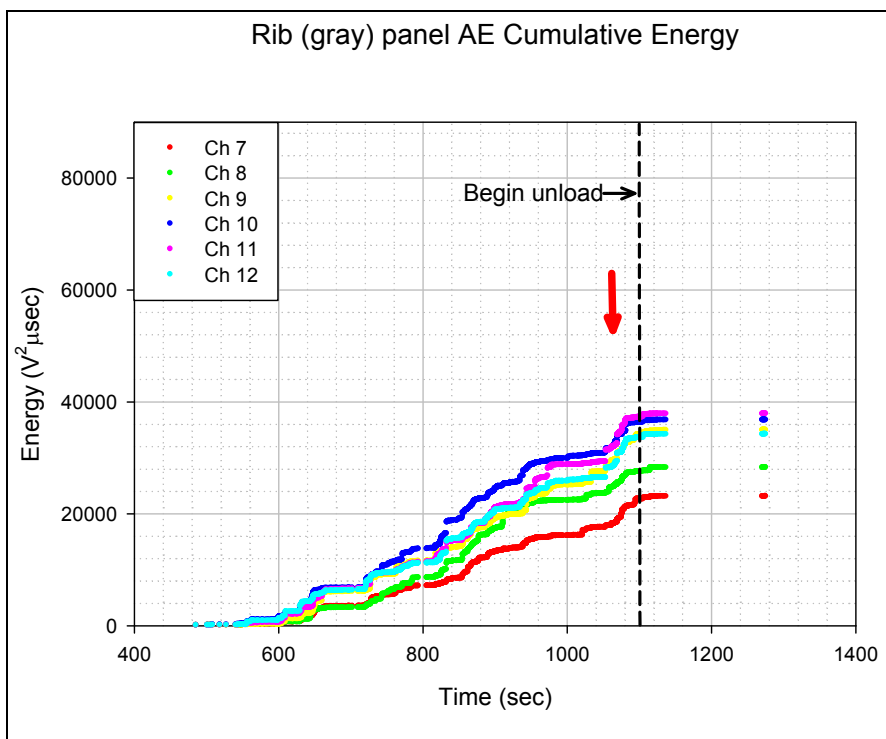
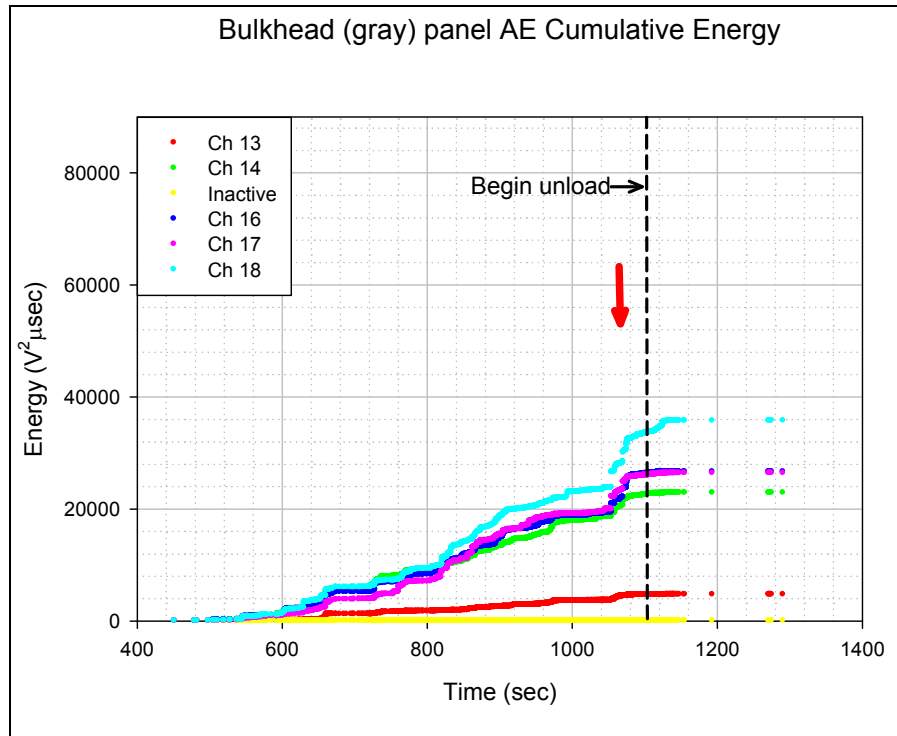
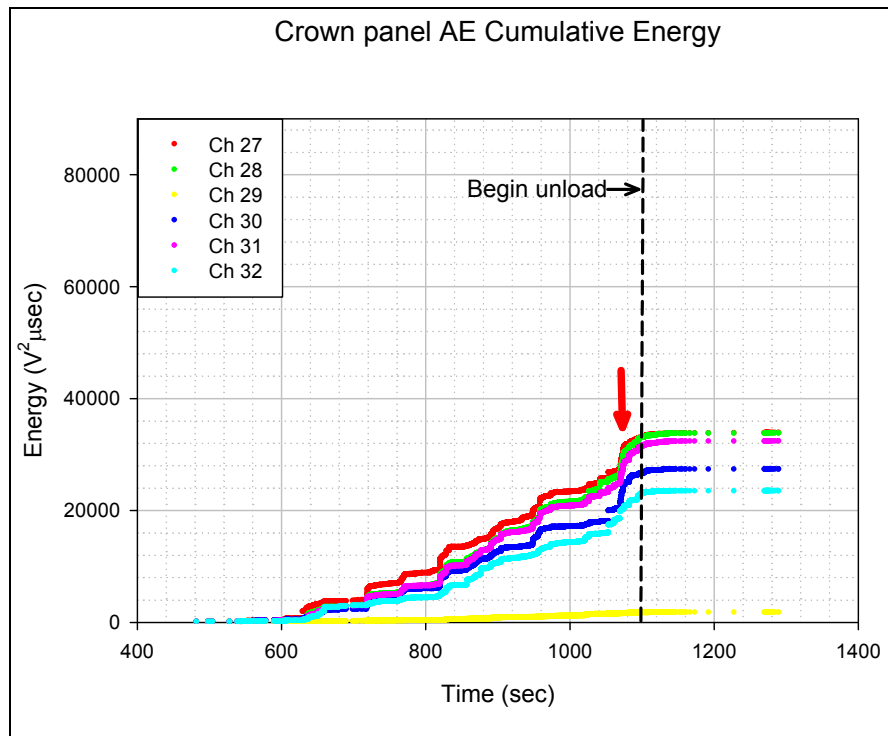
As indicated by the red arrow on the cumulative energy plots for all the panels (figures 18-22), all sensors show significant rate increase in cumulative energy around 1060 seconds (~ 19 psi). The vertical black lines indicate the beginning of unloading. In figure 21 of the speckled rib panel that initiated failure during the failure test, a significant increase occurred during unloading; suggesting that the metallic frame splice failure began during the 2P test. Figures 23-27 are close-ups of the cumulative energy plots with the yellow shaded region of strain gage activity-increase between 16 and 18 psi. The red ovals highlight significant increases in cumulative energy, most of them occurring well before the strain gages indicated damage.
