NASA/TP—2001–211302

Polymer Matrix Composite Lines and Ducts

(National Research Announcement 8–21 Final Report)

Marshall Space Flight Center, Marshall Space Flight Center, Alabama

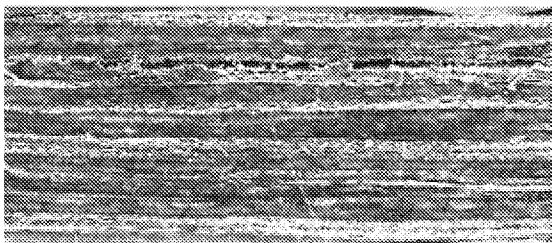
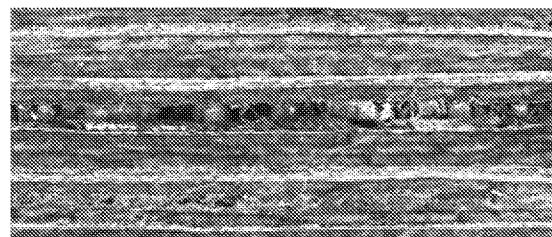
Figure 10 shows a completed feedline manufactured by TTL. A closer view of the flange area is given in figure 11. This area is particularly rough with obvious areas of nonconsolidation visible from the surface. This was of great concern since it could facilitate leaks and compromise the structural integrity of the feedline. A view of the microstructure in the acreage of the feedline is given in figure 12. Poor consolidation with large areas of delamination can be seen. The thermoplastic tape apparently was difficult to compact by the robotic head.

Figure 12. Microstructure of feedline manufactured via TTL:
(a) Longitudinal view and (b) radial view.

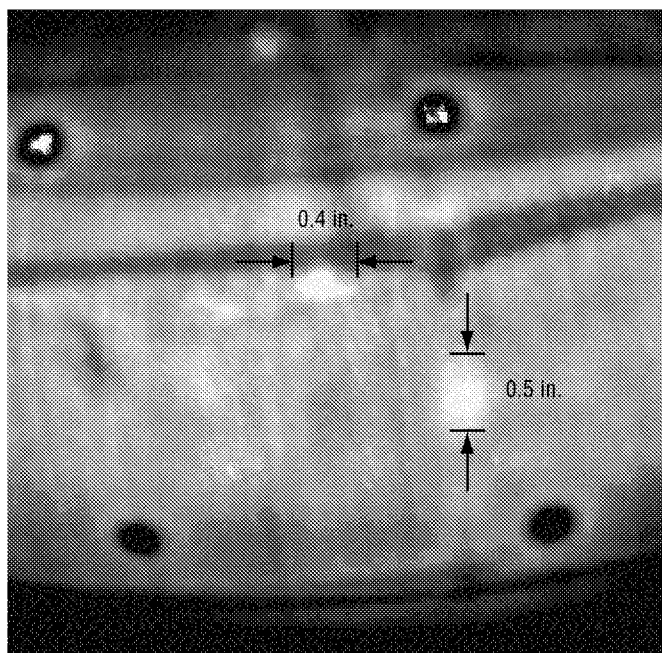
Figure 22b. No surface features. Unknown source.

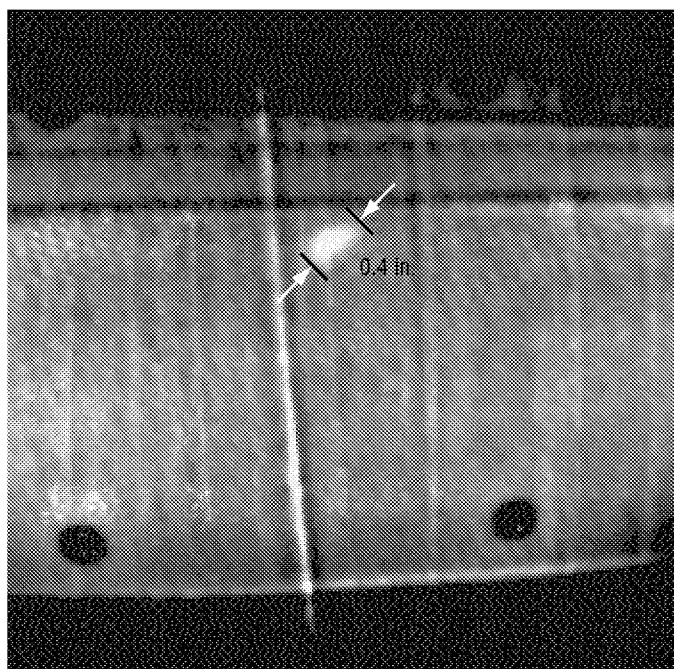
Figure 22c. No surface features but strong thermal indication.
The blurred edges may indicate that this is a delamination from impact.

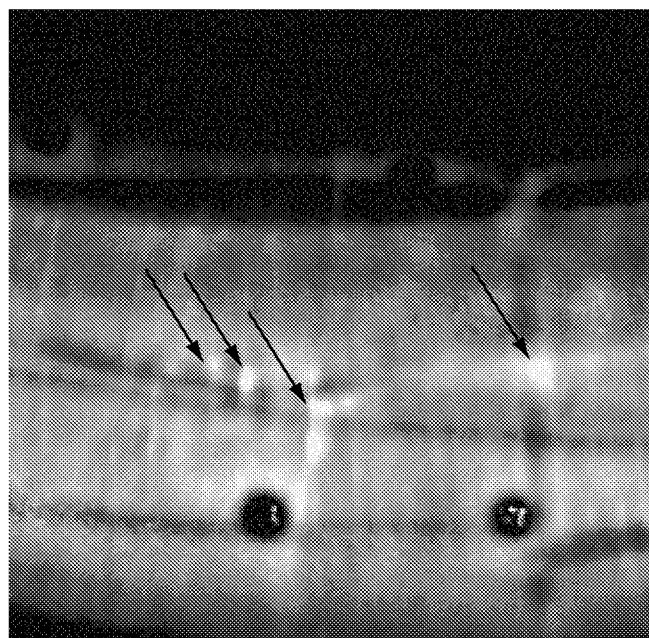
Figure 22e. The surface of the tube shows signs of overworking during fabrication. These regions may be thin, resin-starved zones (indicated by the arrows).

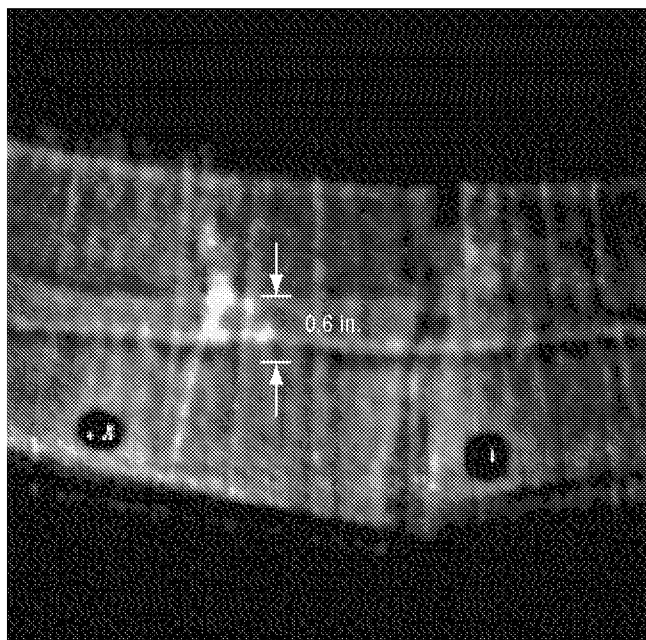
Figure 22f. The surface of the tube has a small bump, which would indicate an inclusion.

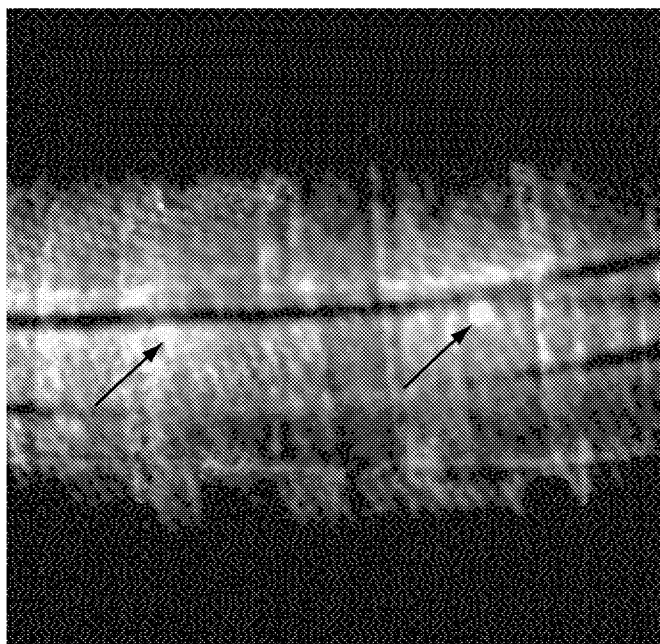
Figure 22g. Possible voids along a seam.

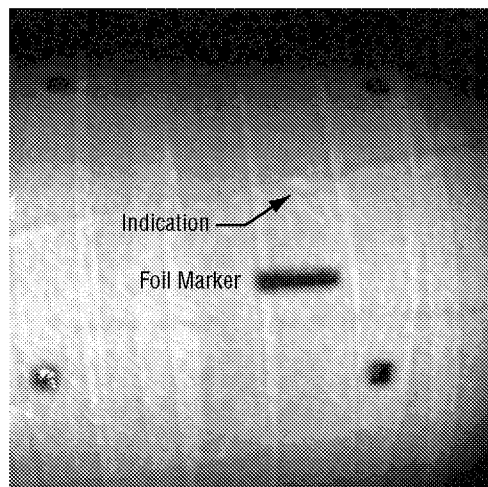
F3

On feedline HLU-8, three small thermal abnormalities were detected as shown in figure 26. The size of each indication was <0.25 by 0.5 in. At region A3, the indication correlates with a surface crack. At position F3, the indication appears to be within the laminate. At position B12, the indication is visible on the surface as a scratch.

Figure 26. Anomalies in feedline HLU-8 (continued).

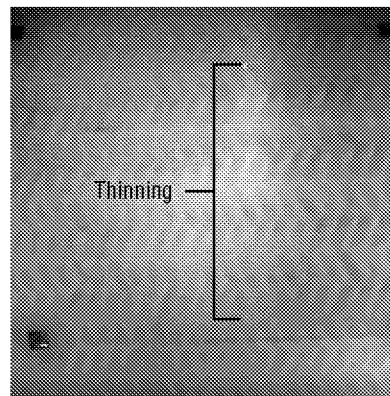
Four feedlines, manufactured using SARTM, were inspected using flash thermography. Feedline SARTM-1 showed no anomalies. Feedline SARTM-2 showed a ring of thinning that was detected on the inside of the tube ≈ 12 in. in from the flange. This is shown in figure 27.

Figure 27. Thermograph showing thinning in feedline SARTM-2.

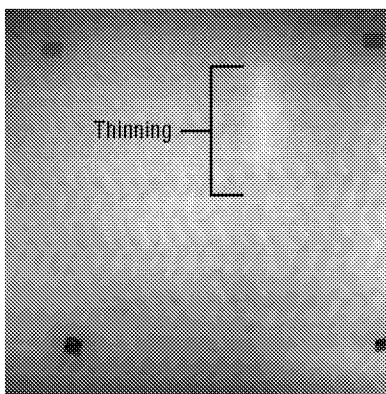
Feedline SARTM-3 showed the same type of thinning at the same location as feedline SARTM-2. A thermograph is presented in figure 28.

Figure 28. Thermograph of thinning in feedline SARTM-3.

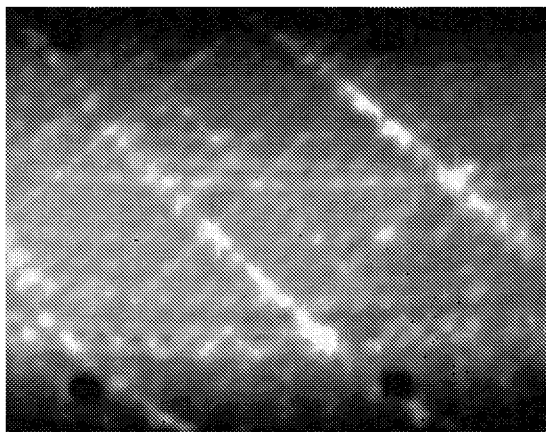
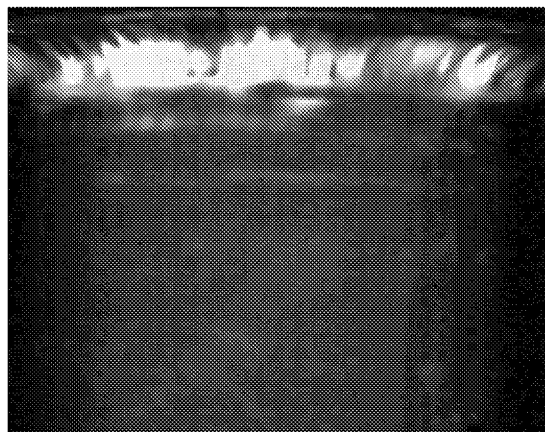
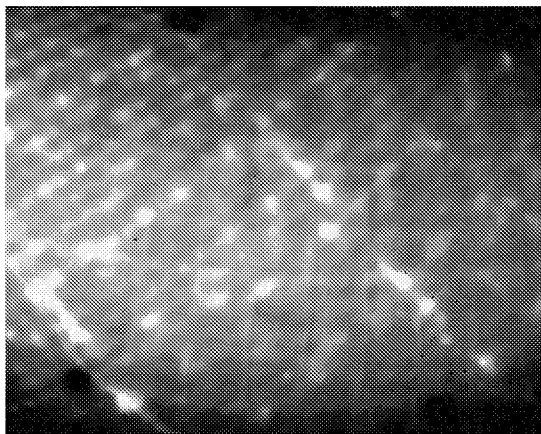
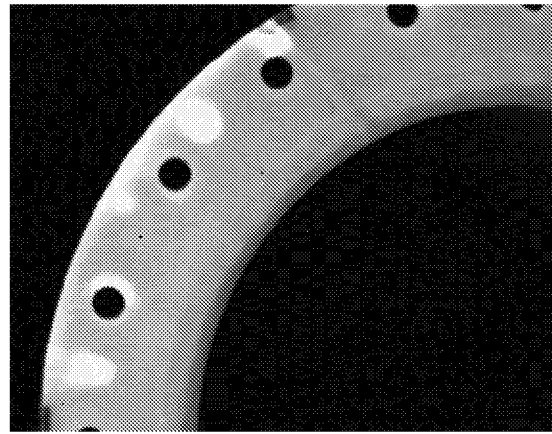
Four feedlines manufactured via TTL were inspected using flash thermography. For feedline TTL-1, the acreage of the tube appears to have many highly porous/low consolidation regions as indicated by the many bright patches in the images. The bright regions in the flange thermograms coincide with missing plies on its back surface. The fillet also shows many low consolidation/highly porous regions. Sample thermograms showing these voids are given in figure 29.

Figure 29. Sample thermograms from feedline TTL-1 showing regions where the tape was not well consolidated in acreage and voids in flanges.

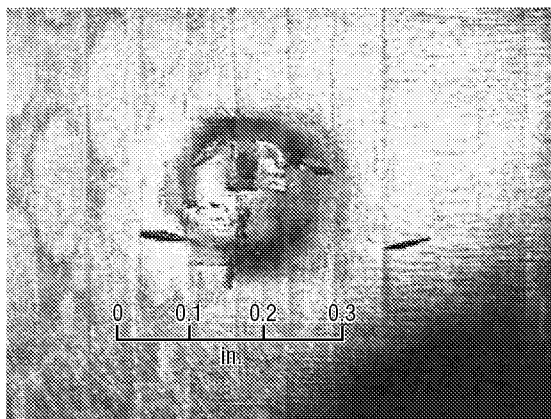
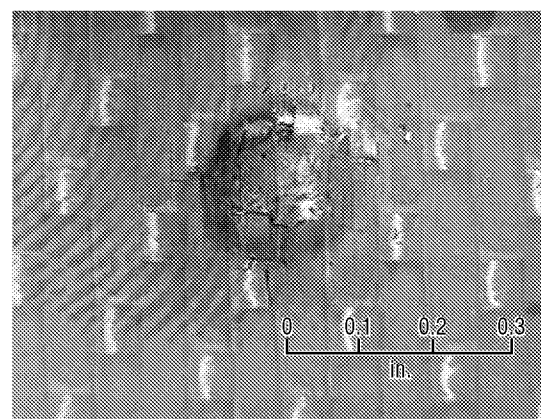
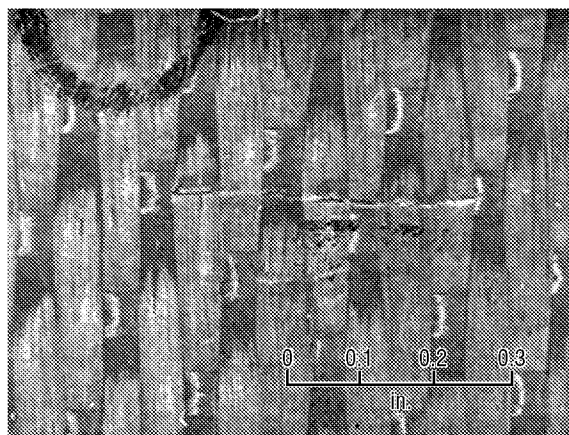
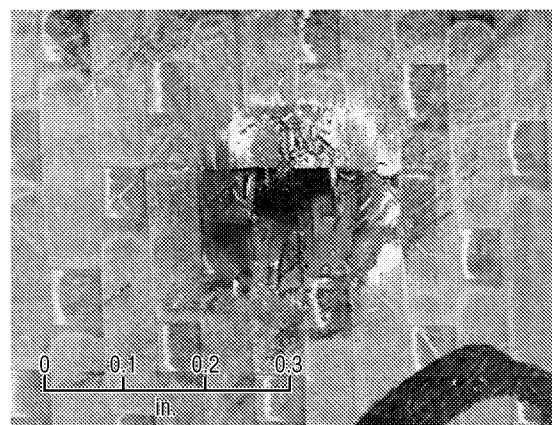
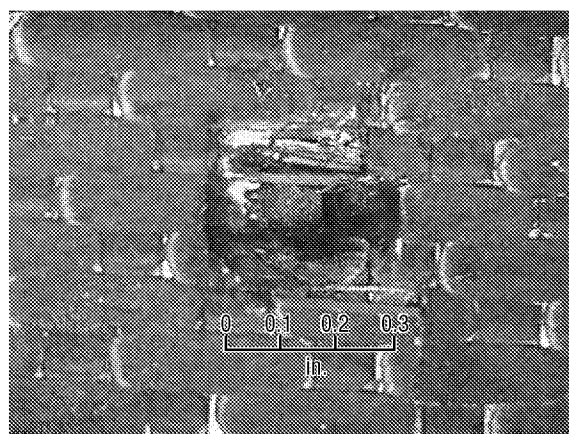
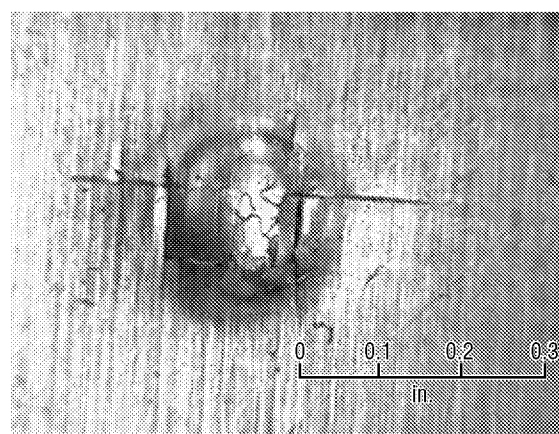
Figure 44 shows the impacted side of each specimen tested at the high (2.5 ft-lb) energy level. In all cases, except the 977-6 resin, a distinct dent is seen in each of the specimens. Fiber breakage is observed in all of the specimens. The 977-6 resin possesses a relatively long crack across the outer warp fibers that span the distance of the impacted zone. The PR 520 has short cracks at or near the indentation formed, as does the PEEK. The remaining three have fiber breakage within the indentation.

Figure 44. Typical damage to impacted side of specimens at 2.5 ft-lb.

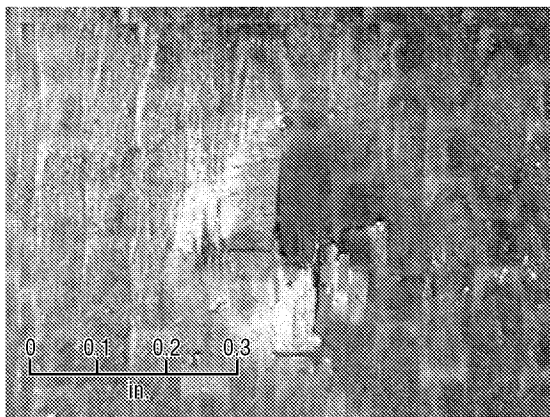
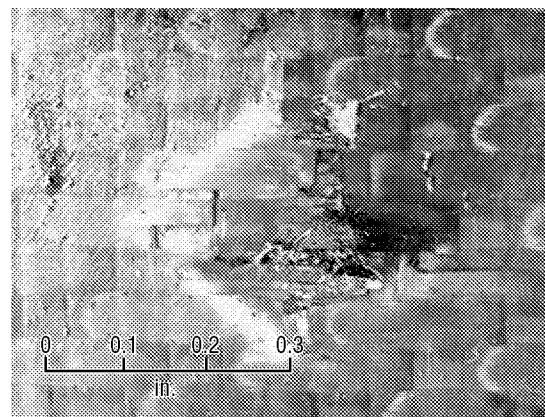
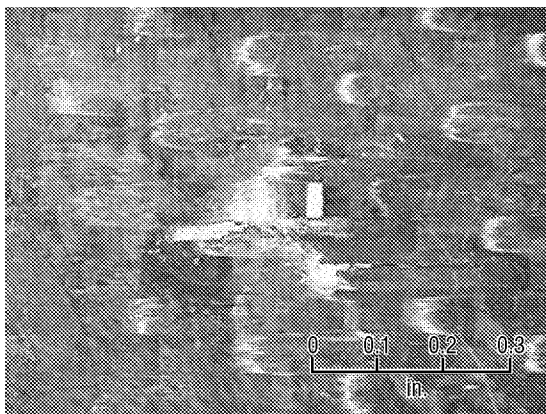
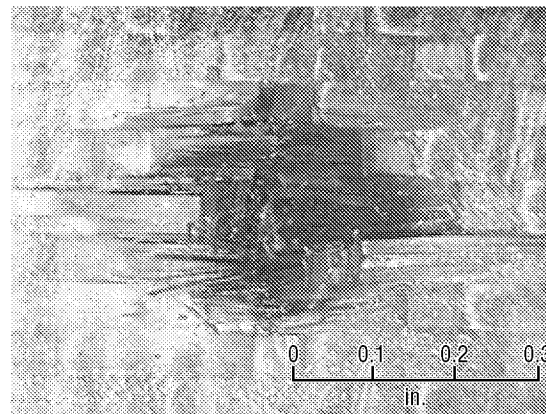
Figure 45 shows the back (nonimpacted) side of each type of specimen tested at the high (2.5 ft-lb) energy level. All samples show backface fiber breakage of varying magnitudes. The 977-2 is the least severe while the RS-E3 and Cycom 823 are the most severe where it appears near penetration occurred.

Figure 45. Typical damage to nonimpacted side of specimens at 2.5 ft-lb.

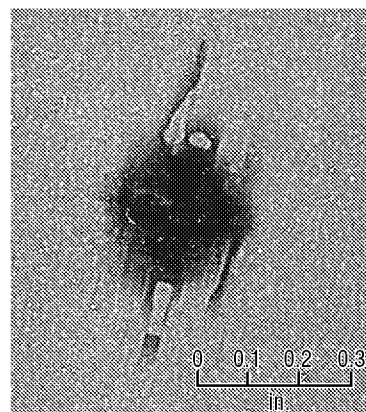
Figure 46 shows x rays of each type of resin system tested at the high-impact energy level. These x rays correspond to the visual observations of figures 44 and 45. The 977-6-resin system has noticeably less damage than the others. The Cycom 823 and RS-E3 systems appear as dark circles indicating massive damage directly under the impact zone. Delaminations emanating from the impact can be seen in the Cycom 823, RS-E3, and PEEK resin systems.

Figure 46. X rays of specimens impacted at 2.5 ft-lb.

Figure 46. X rays of specimens impacted at 2.5 ft-lb (continued).

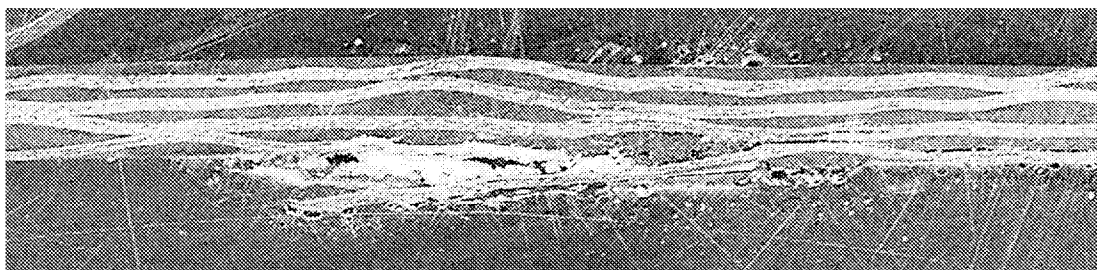
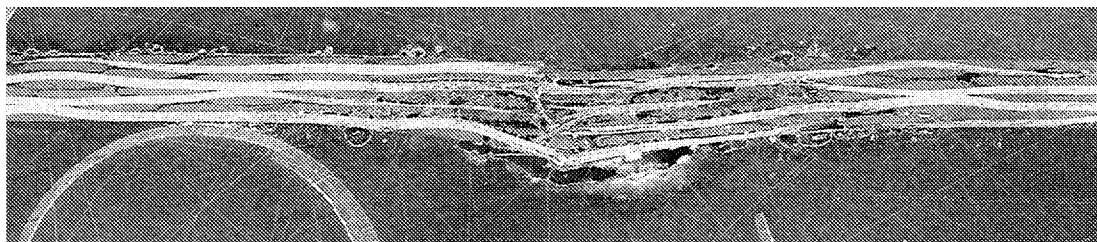
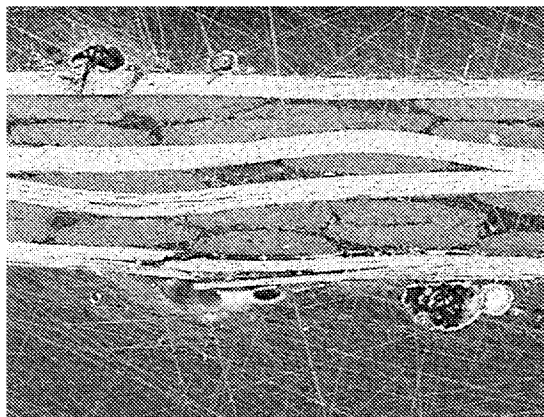
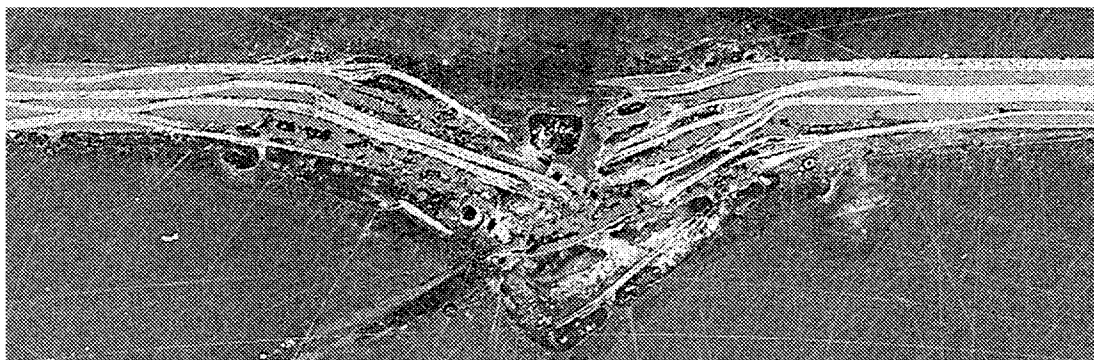
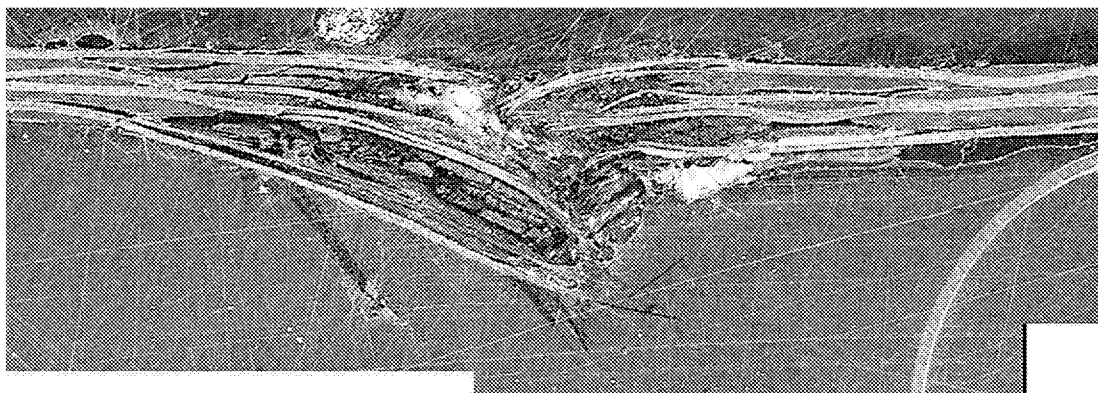
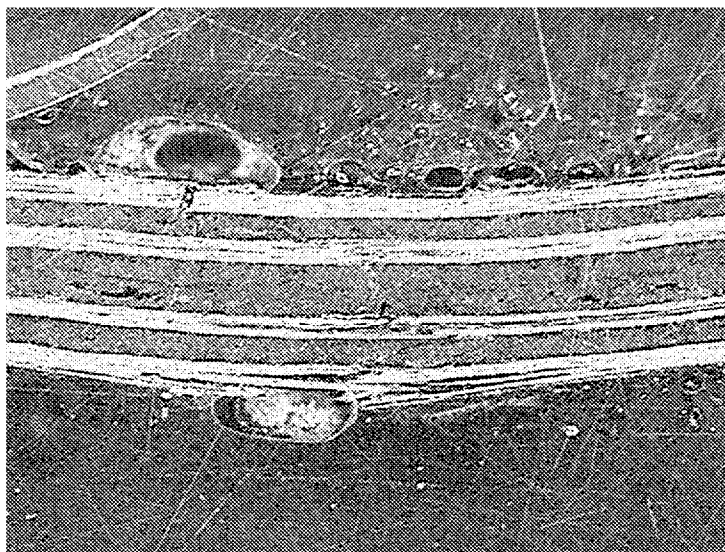
Figures 47 show photomicrographs of the cross section of each type of resin system tested at the high-impact energy level. The 977-6 and PEEK resins appear to have far less damage than the others tested. The Cycom 823 and RS-E3 resins show near penetration.

Figure 47. Cross-sectional photomicrographs of specimens impacted at 2.5 ft-lb.

Figure 47. Cross-sectional photomicrographs of specimens impacted at 2.5 ft-lb (continued).

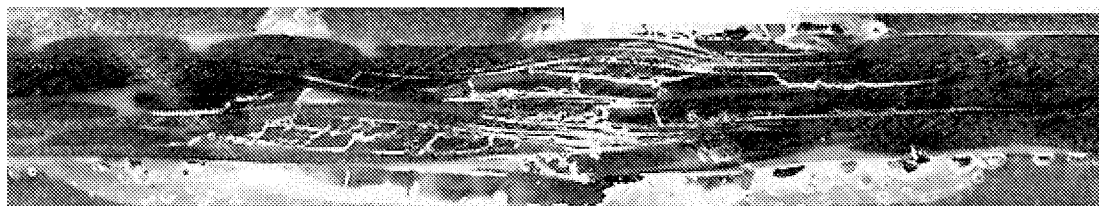
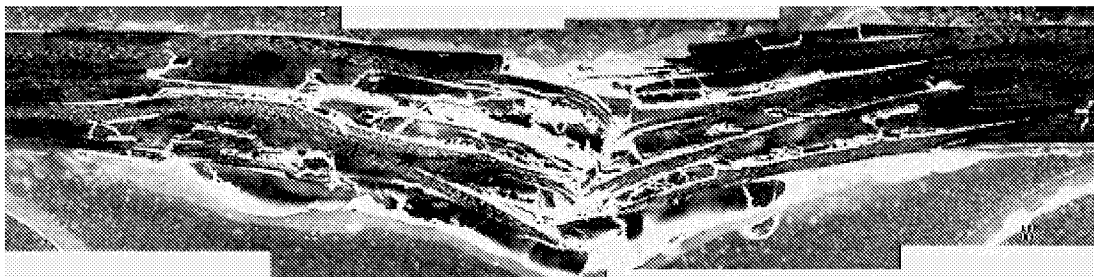
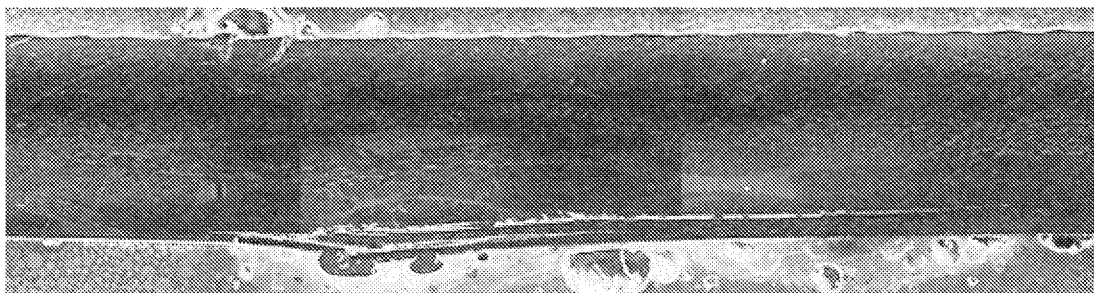
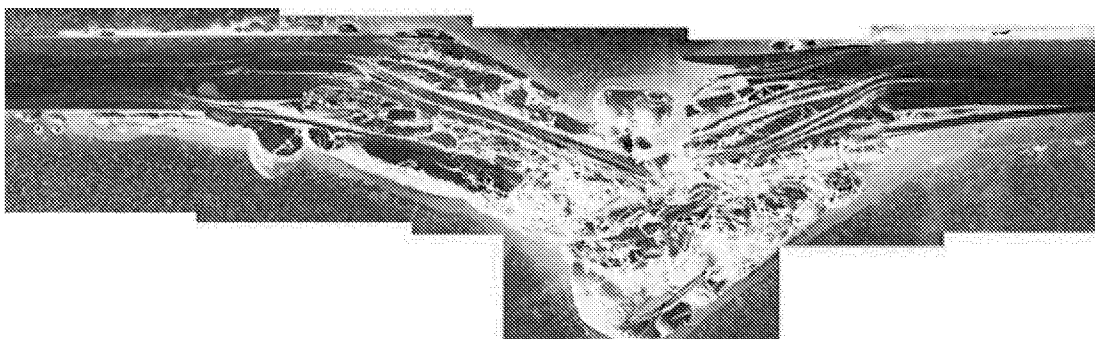
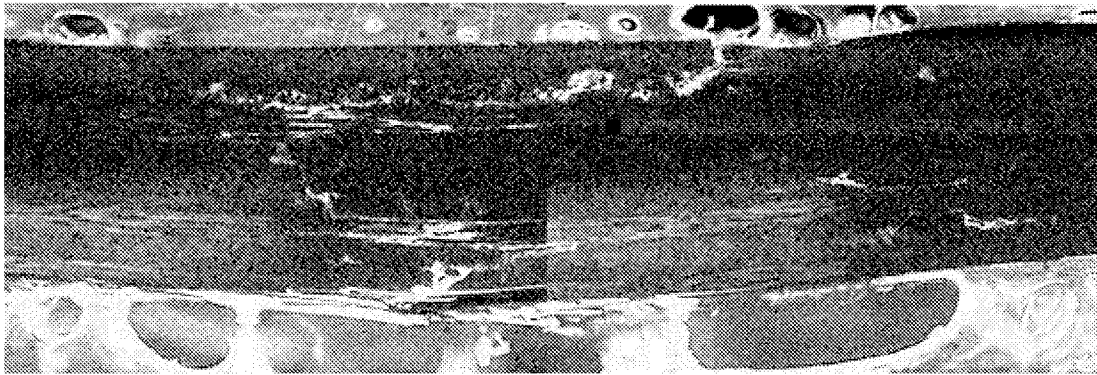
Figures 48 show fluorescent dye-enhanced photographs of these cross sections. This technique better shows the extent of damage present in the specimens. The 977-6 specimen only has two short delaminations near the outer plies and minor fiber breakage on the top ply. The plies in the center of the specimen appear to be completely damage free. The PEEK specimen shows good damage resistance; however, damage does exist throughout the thickness of the specimen. The severity of damage to the Cycom 823 and RS-E3 resin systems are even further highlighted by the fluorescent dye. The PR 520 resin system is seen to have delamination and matrix cracking within all plies although the photograph in figure 47 does not clearly show this and is a good argument for using a fluorescent dye penetrant even on samples where damage is readily visible.

Figure 48. Cross-sectional photomicrographs of specimens impacted at 2.5 ft-lb, fluorescent dye enhanced.

Figure 48. Cross-sectional photomicrographs of specimens impacted at 2.5 ft-lb, fluorescent dye enhanced (continued).

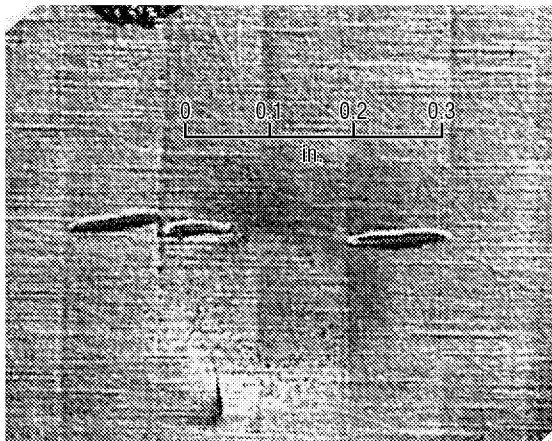
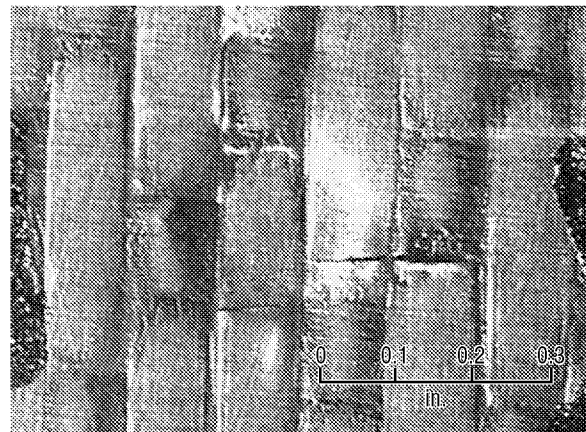
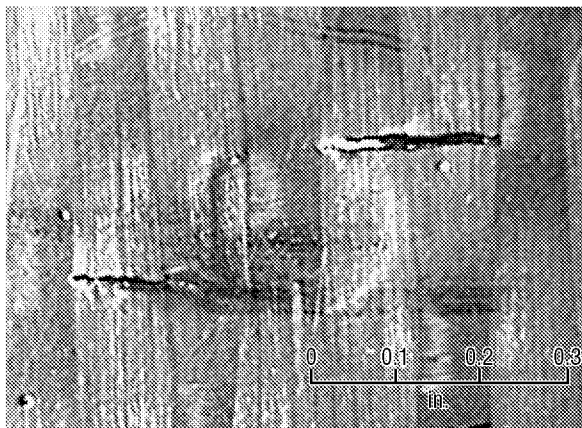
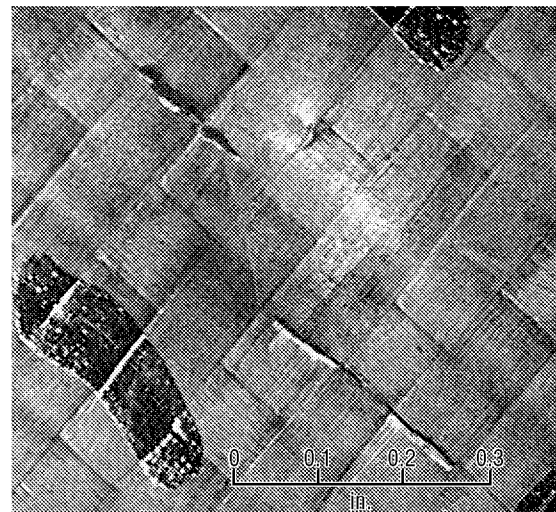
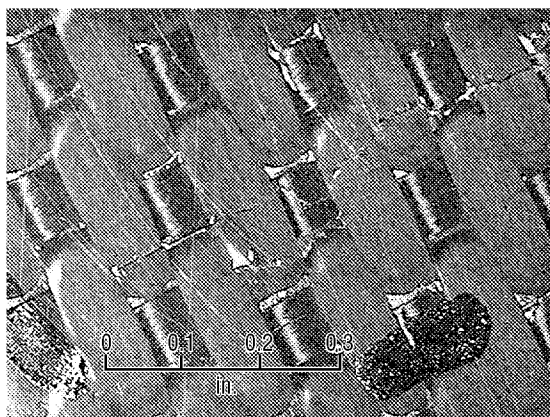
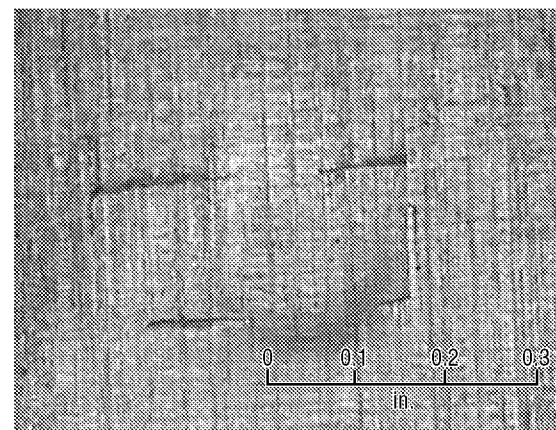
Figure 49 shows the impacted side of each specimen tested at the low (1.8 ft-lb) energy level. Fiber breakage is observed in most of the specimens in the form of short cracks emanating from the indentation on the surface. The RS-E3 resin has a long, fine crack that runs from the lower left to the upper right of the figure and very little indentation is observed. The mechanics behind these small cracks is unknown, but they have been noted in a previous study.⁷

Figure 49. Typical damage to impacted side of specimens at 1.8 ft-lb.

Figure 49. Typical damage to impacted side of specimens at 1.8 ft-lb (continued).

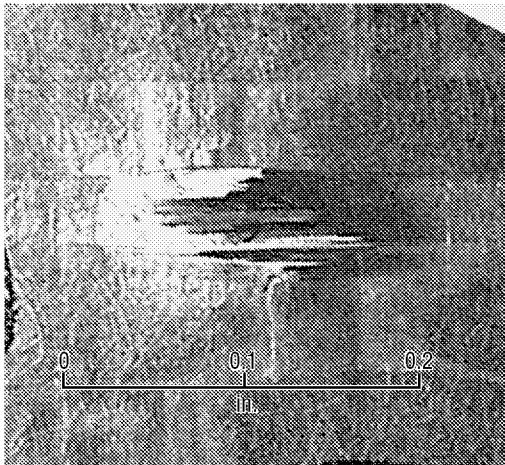
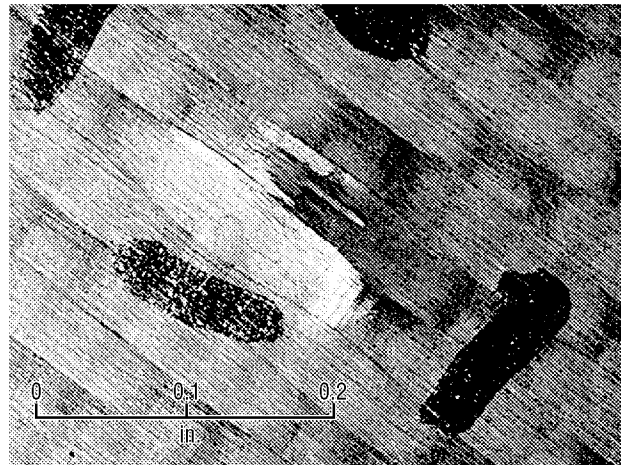
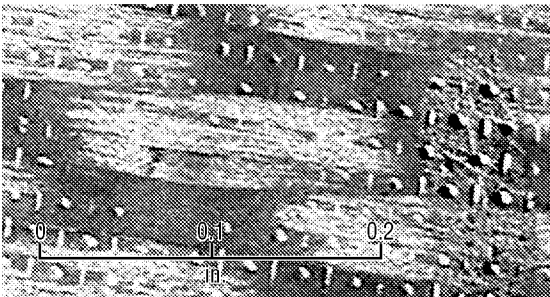
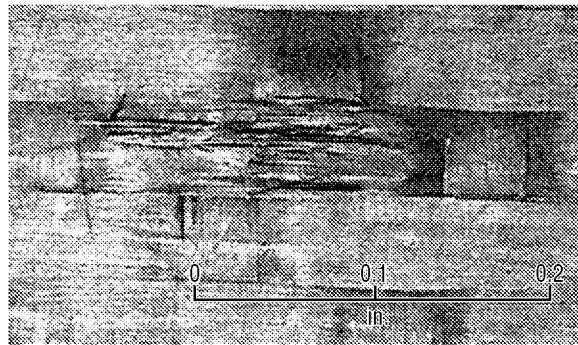
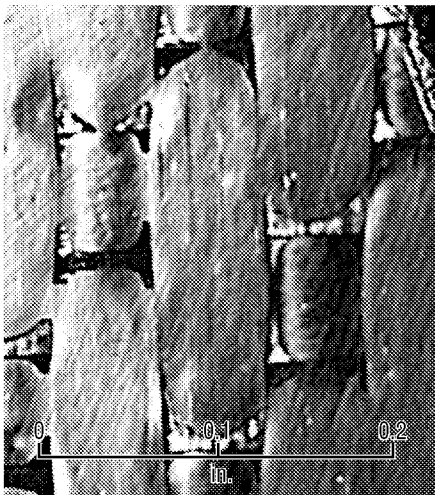
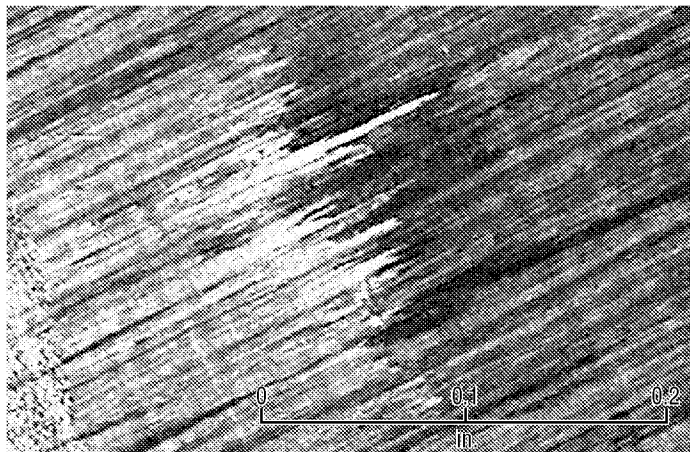
Figure 50 shows the back (nonimpacted) side of each type of specimen tested at the low (1.8 ft-lb) energy level. All samples show backface fiber breakage of varying magnitudes. The 977-6 and RS-E3 resin systems have barely noticeable backface damage. What little damage is present in these two systems is limited to less than two stitches, but never three or more. This type of damage could easily be overlooked during a routine inspection of a part.

Figure 50. Typical damage to nonimpacted side of specimens at 1.8 ft-lb.

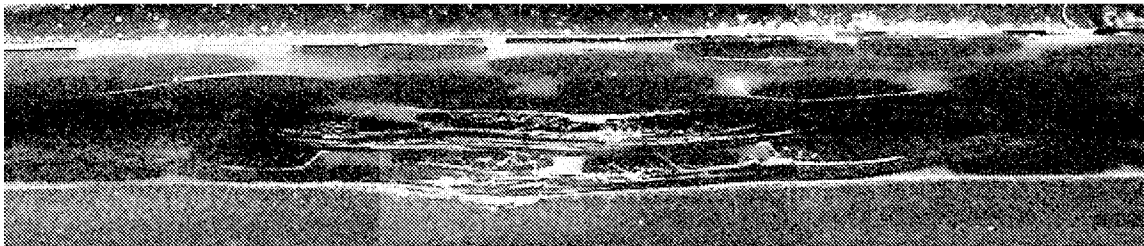
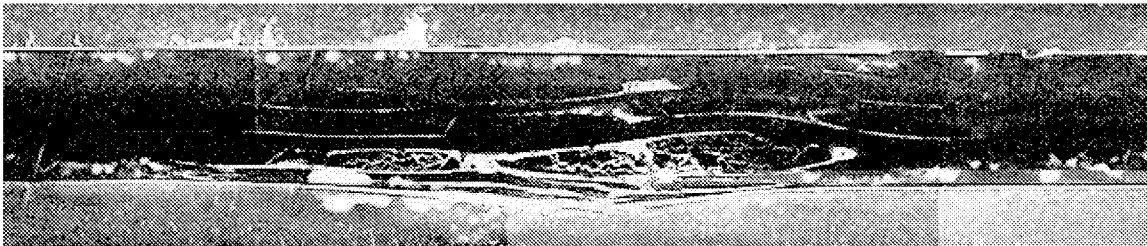
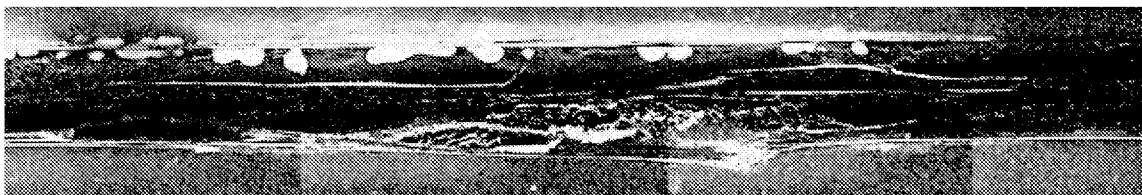
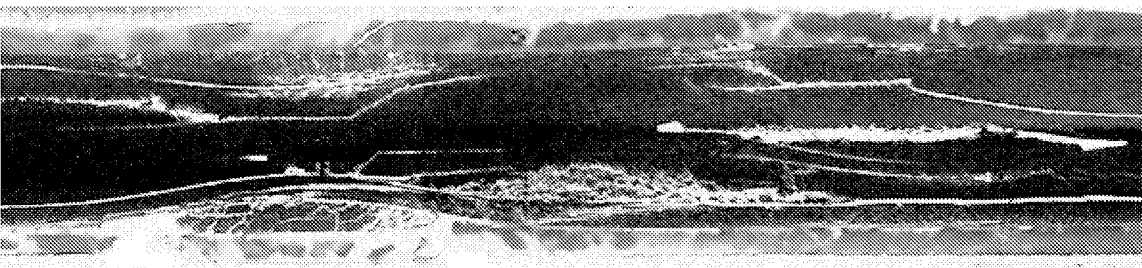
Figure 51 shows photomicrographs of the cross section of each type of resin system tested at the low-impact energy level. The fluorescent dye technique was employed on all of these specimens since visible light did not readily detect all of the damage present. The 977-6 and the PEEK resins showed the least amount of damage, as they did for the high-impact energy level. The 977-6 resin showed a short delamination at the bottom plies and some matrix cracking within the bottom ply, but the majority of the cross section is undamaged. The PEEK resin showed similar damage with some small delaminations and matrix cracking in or near the bottom ply.

Figure 51. Cross-sectional photomicrographs of specimens impacted at 1.8 ft-lb.

Figure 51. Cross-sectional photomicrographs of specimens impacted at 1.8 ft-lb (continued).

The RS-E3 resin system had extremely long delaminations emanating from the impact damage, so two pictures are presented to include the entire range of damage.
