**U.S. ARMY**  
**H-25 HELICOPTER DROP TEST**  
**22 October 1960**

James W. Turnbow, Ph.D.

Technical Report 60-76

SUBJECT: U. S. Army H-25 Helicopter Drop Test Report

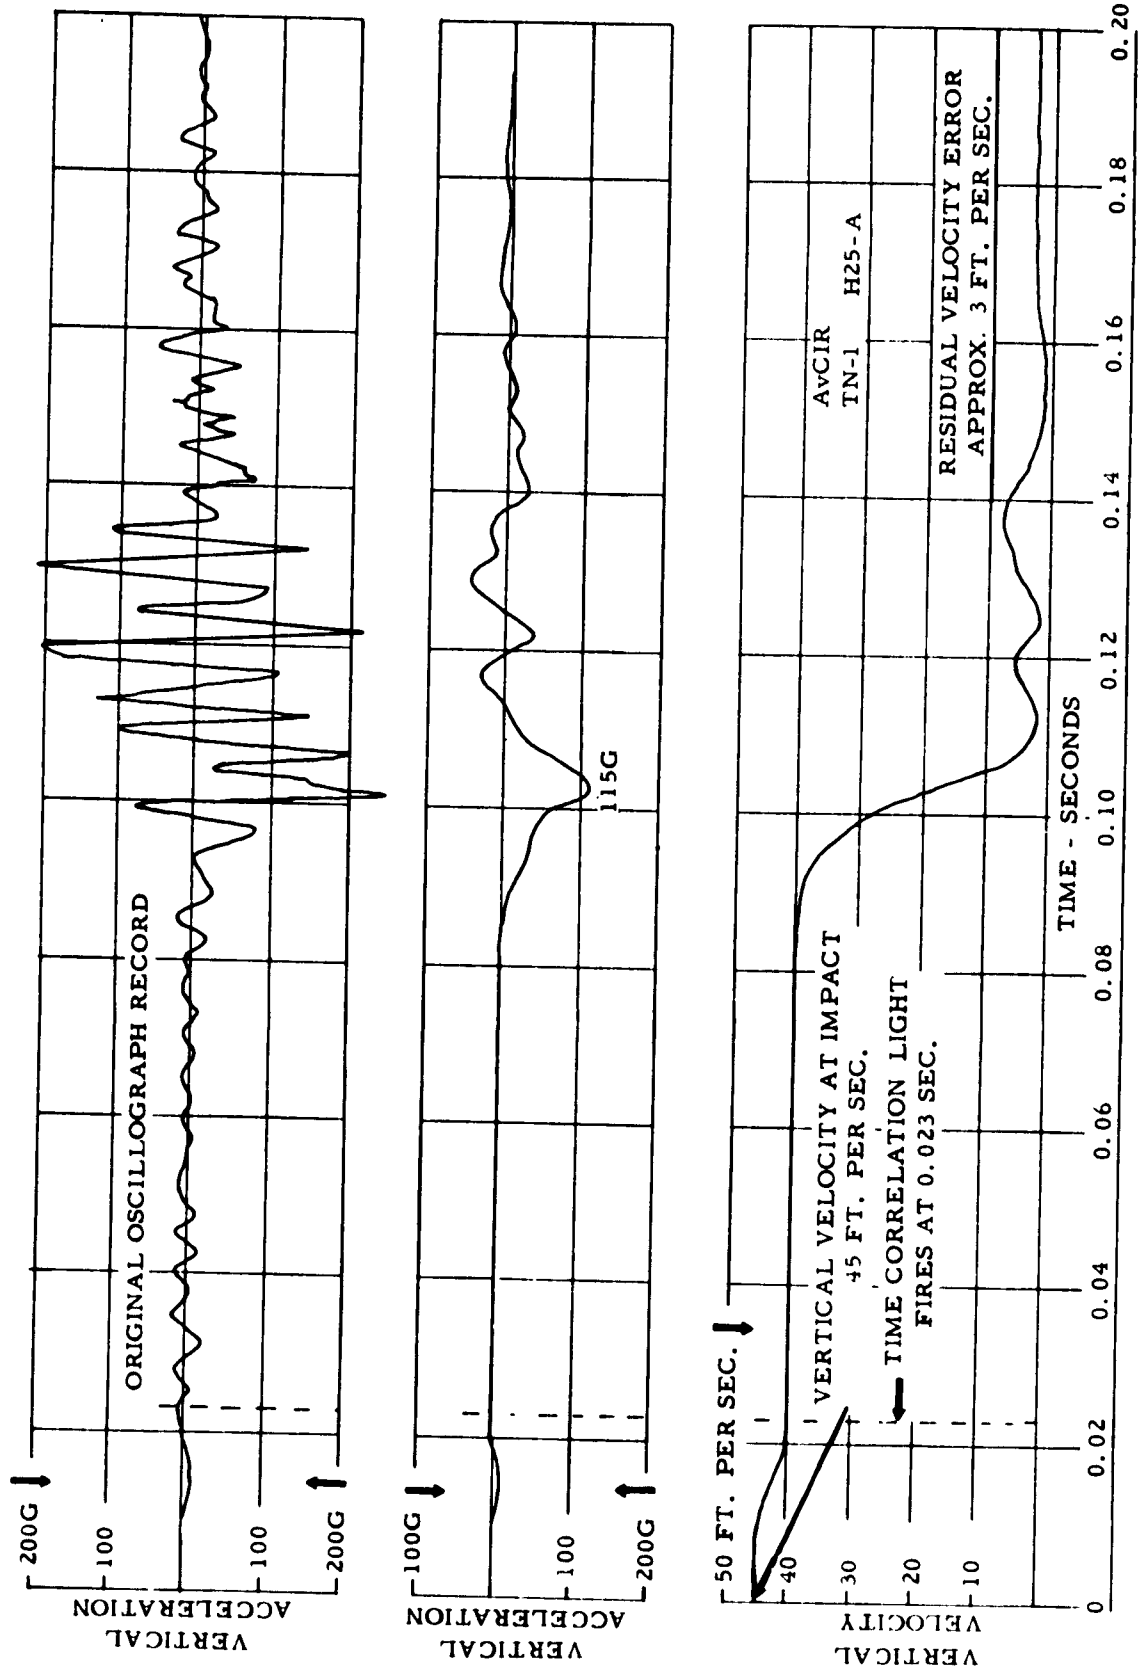
Figure 27. Acceleration and Velocity of Cockpit Floor

Referring to Figure 32 and to the sequence photographs of Figure 40-2 and Figure 40-3, it is clear that the landing gear did not appreciably decelerate the aircraft during the impact. The 4 f. p. s. reduction in vertical velocity of the cockpit-floor, as indicated in Figure 27 for the first 0.04 second of the impact, is not borne out by a similar value for the passenger cabin floor. This value of 4 f. p. s. is within the range of experimental error for tests of this nature, and can thus be disregarded. The primary acceleration pulse began at 0.085 second, at which time the forward portion of the fuselage began to contact the ground.

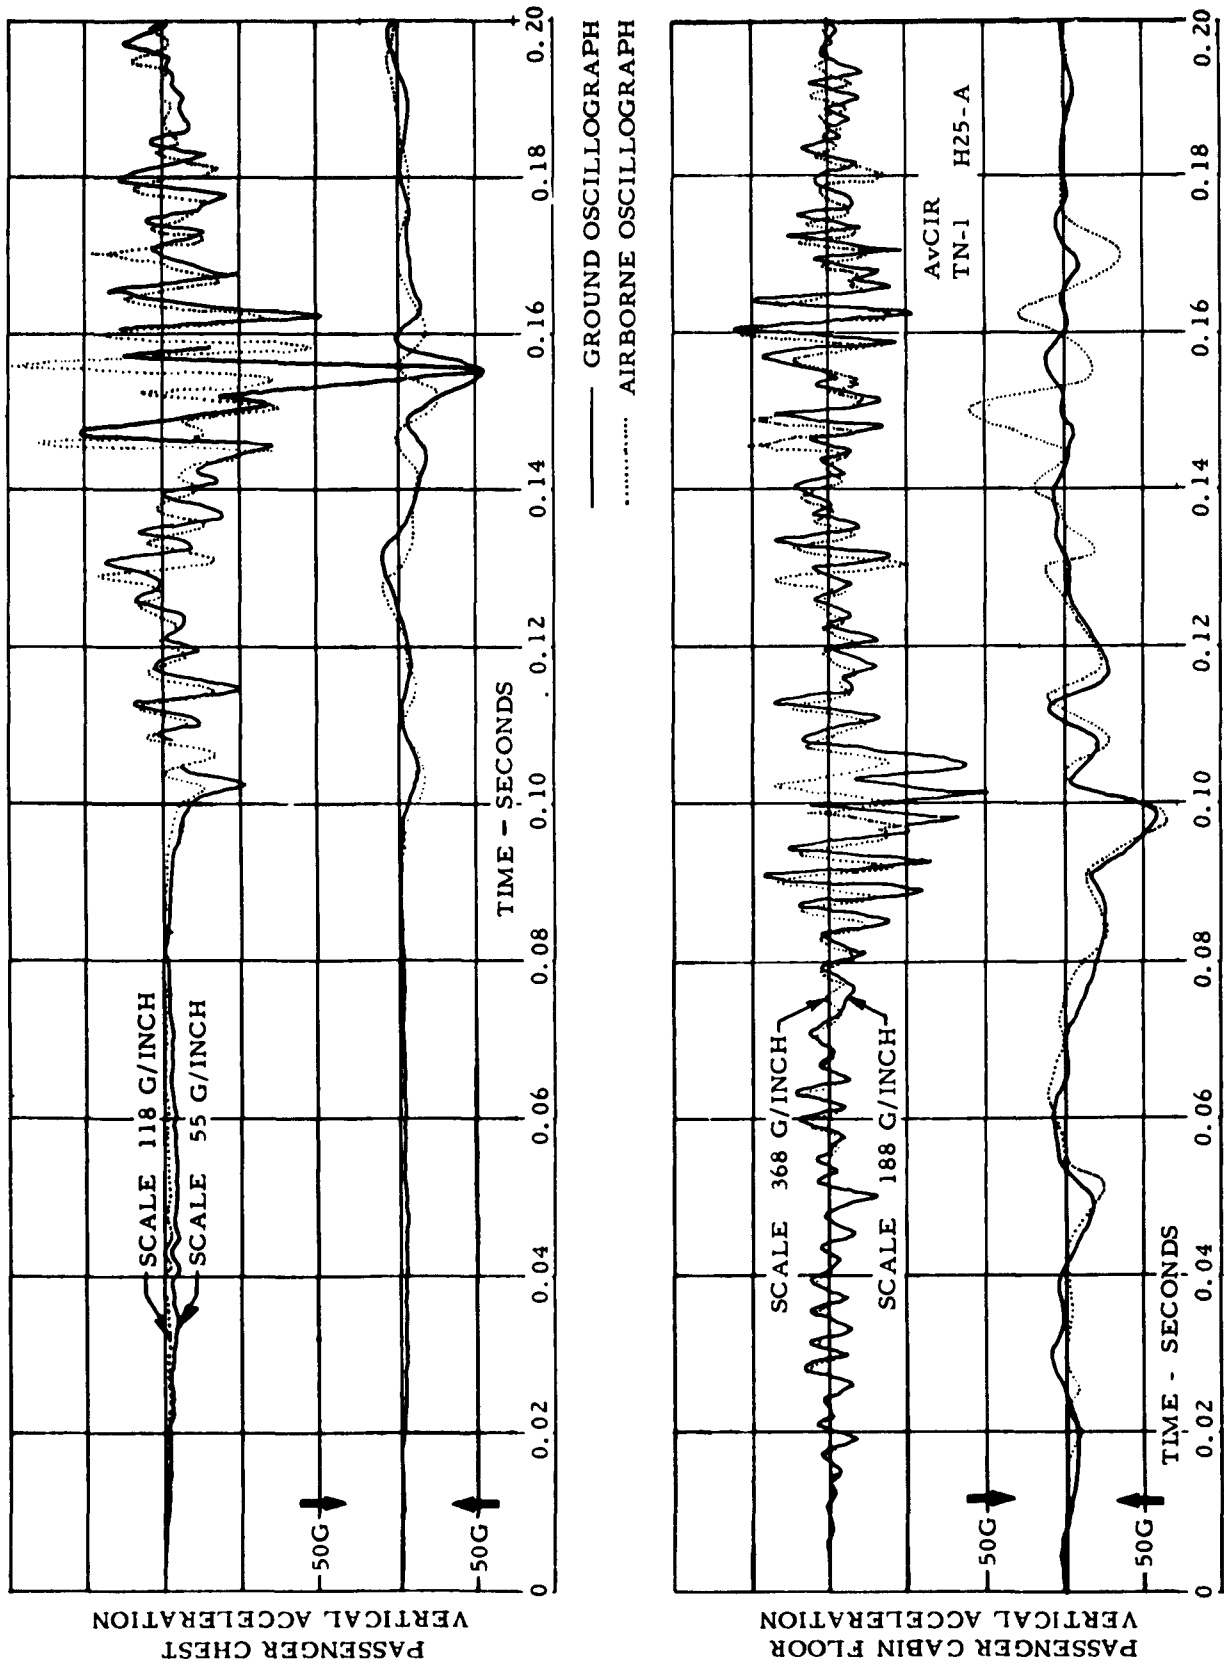
Figure 30. Comparison of Ground and Airborne Recording

Examination of the airborne instrumentation recording system following the crash found this equipment to be operable. The shock absorption devices had apparently functioned to properly protect the equipment and allow its operation during the test. A study of the ground and airborne oscillograph records later showed certain discrepancies in the airborne records. (See Figure 30.)

after impact to necessitate the temporary withholding of publication of eight channels of data recorded only on the airborne recorder. These channels are indicated in Table I and Figure 10. In Figure 30, both the original and smoothed acceleration-time curves (for ground and airborne recording) are shown for the passenger cabin floor and passenger chest accelerations. The first serious discrepancy in both cases is seen to occur at about 0.13 second. A plot of the lateral, longitudinal, and vertical accelerations of the airborne instrument package, given in Figure 31, shows that, at 0.128 second, a severe disturbance in the longitudinal acceleration record occurred. This disturbance was not a true acceleration, however, and was probably due to a poor connection at the emergency-disconnect in the umbilical cord at the crane. This disturbance at 0.128 second was clearly evident in eleven of the airborne recorder channels, although to a much lesser degree in all cases except for the fuel tank pressure record. Only minute evidence of this disturbance was observed in the other ground-recorded data.

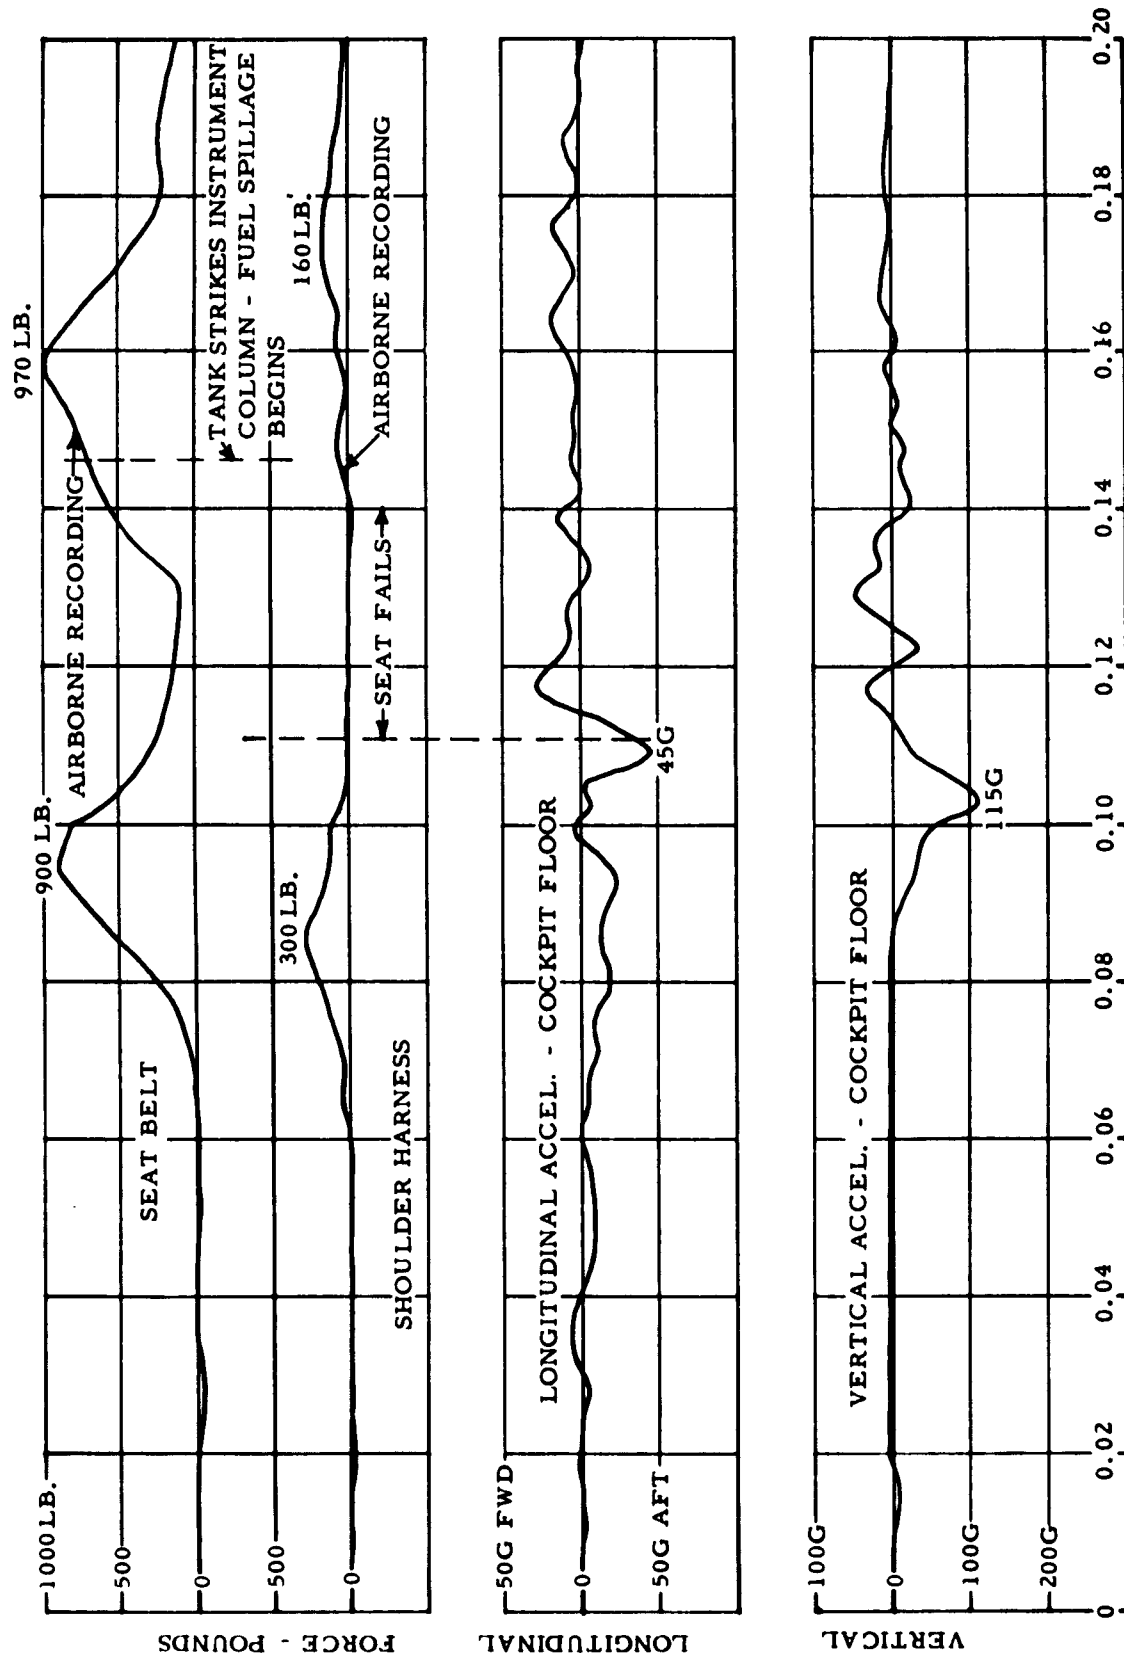
Figure 38. Range Extender Tank Loads

Acceleration of the airborne package exceeded the design value of 14.5G at 0.19 second as may be observed in Figure 31. The results obtained from the airborne recorder are thus considered doubtful, pending further analysis of the data. The two channels of airborne data presented in Figure 38 (range extender tank seat belt and shoulder harness) are accurate to 0.13 second and are significant beyond this time in that the indicated loads in these belts are low.
