# Under reporting of aviation wirestrikes

**ATSB Transport Safety Report**  
Aviation Research Report  
AR-2011-004  
Final

AR-2011-004

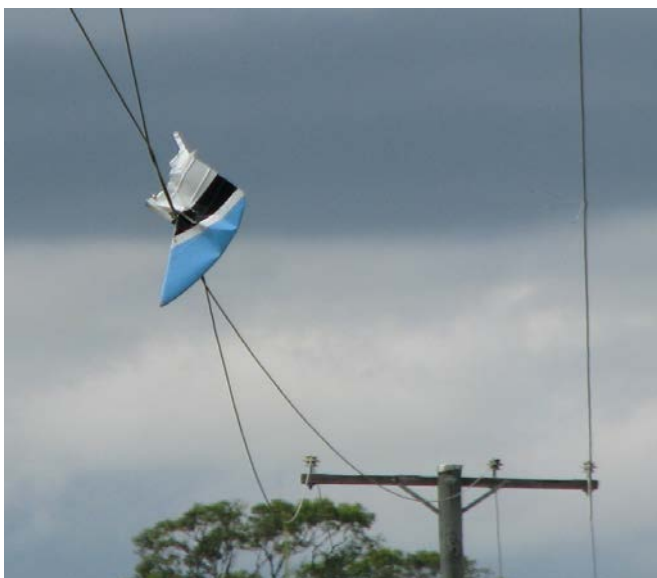
Electricity conductors and detached rudder horn (Investigation AO-2010-026)

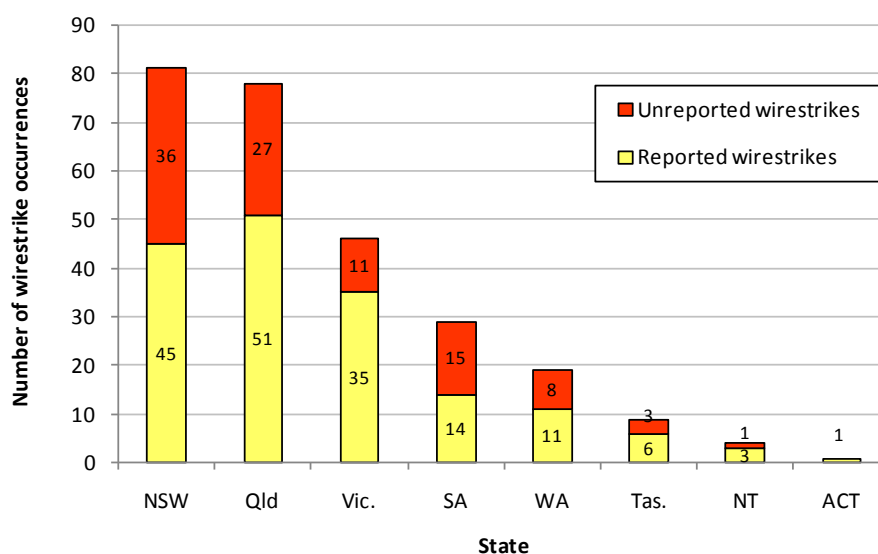
**Figure 3: Number of wirestrikes by state**

Figure 3 shows that New South Wales (NSW) had the greatest number of wirestrikes closely followed by Queensland (Qld). Victoria (Vic.) had the third highest number of wirestrikes. The majority of wirestrikes (77 per cent) were concentrated in these eastern states. This concentration was to be expected as there is more aerial agricultural activity, and thus low-level flying, in these states compared with other states (BITRE, 2012). Conversely, in the Northern Territory (NT), there were only four wirestrikes in the reporting period, making up only 1.5 per cent of national wirestrikes. This may be due to the relative lack of wires and/ or aerial agricultural activity in the NT.

New South Wales made up the greatest proportion of *unreported* wirestrikes in Australia, followed by Qld. Most states had at least one-third of wirestrikes not reported to the ATSB. However, for NSW, WA and SA, this figure increased to 40 to 50 per cent of all wirestrikes.

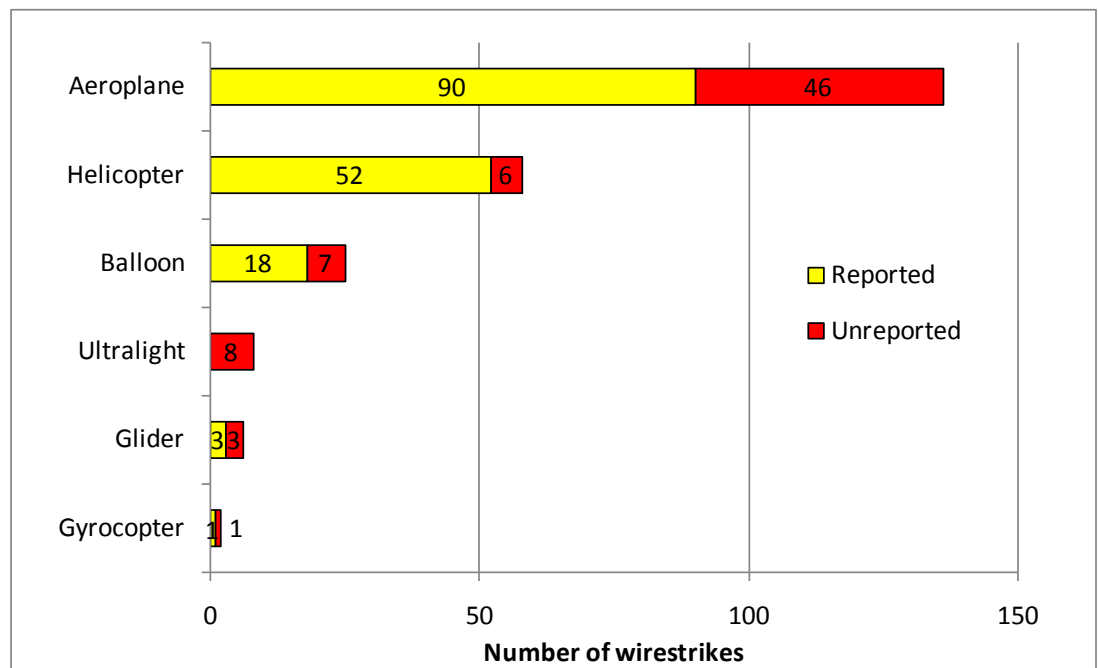
**Figure 5: Aircraft types involved in unreported and reported wirestrikes**

not previously reported (Figure 5). This may be due to helicopters being more prone to aircraft damage following a wirestrike than either aeroplanes or balloons.

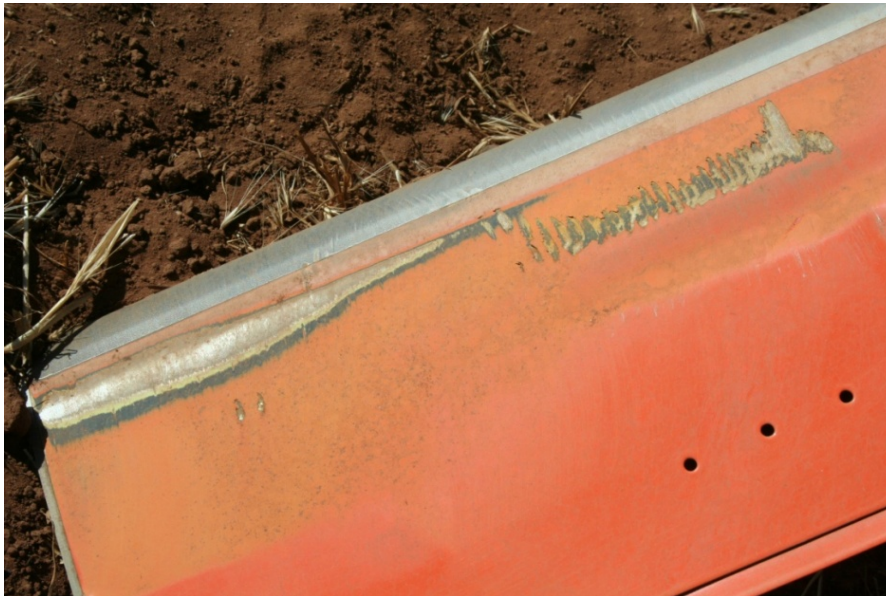
Main rotor blade witness mark tip damage (Investigation AO-2008-078)

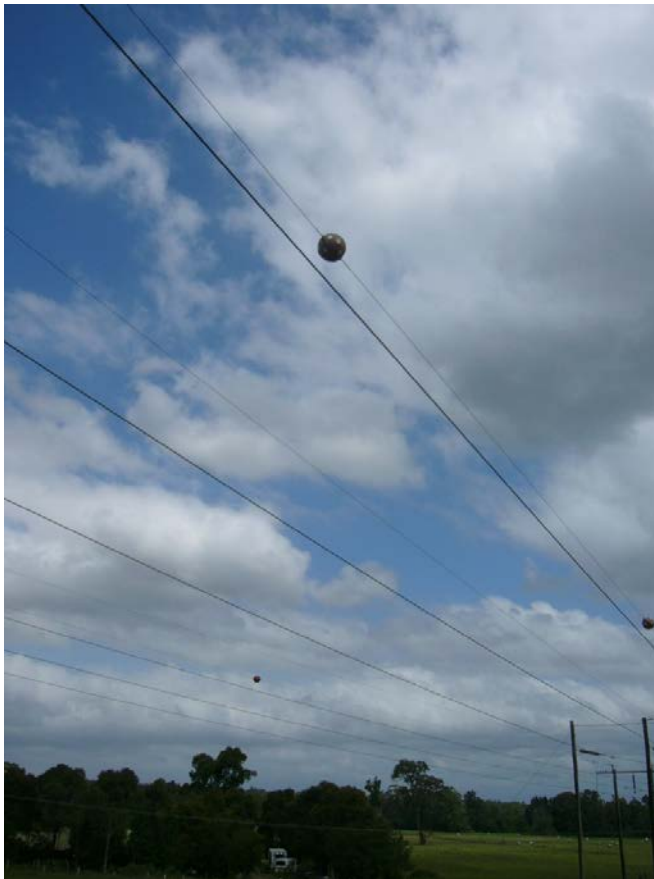
An example of cable marking

Electricity distribution and transmission companies install aerial markers on wires upon request. Land owners can request to have wires on their property marked and pilots who have a need to fly low-level near powerlines can also request wires to be fitted with markers.
