Aviation Occurrence Statistics 2002 to 2011

ATSB Transport Safety Report
Aviation Research Report
AR-2012-025
Final

Report No. AR-2012-025

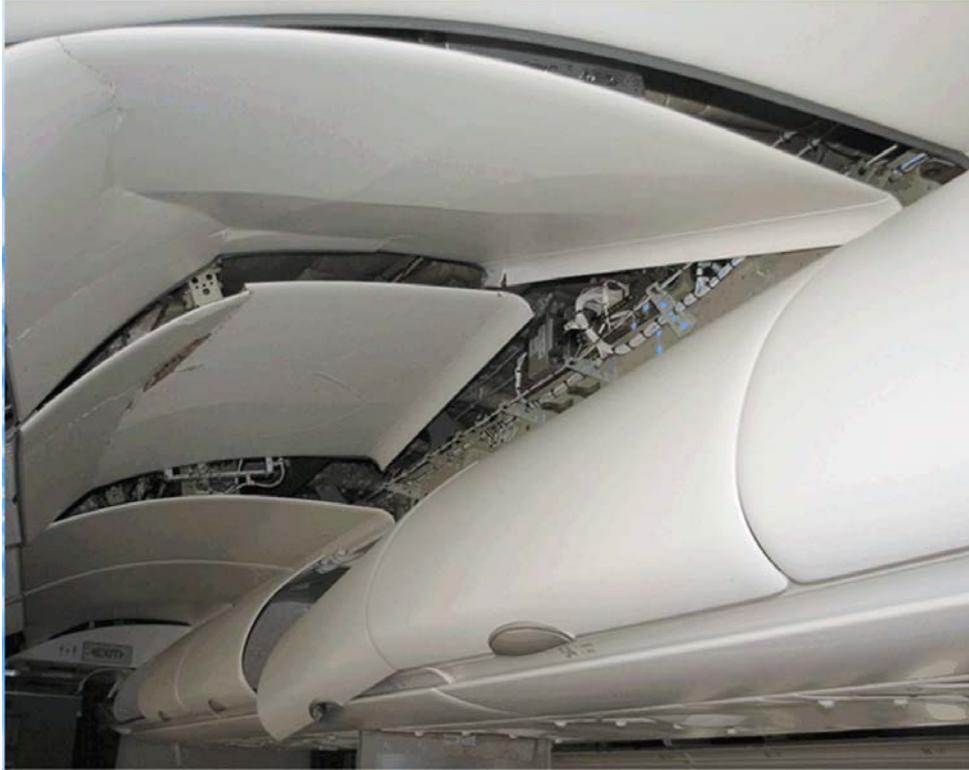
Damage to overhead cabin panels after an in-flight upset, Airbus A330 (VH-QPA) Western Australia (AO-2008-070)

- On 7 October 2008, an Airbus A330-303 aircraft, registered VH-QPA, was operating from Singapore to Perth and cruising at an altitude of 37,000 ft when the autopilot disconnected. Following this, the crew received various aircraft system failure indications. While the crew were evaluating the situation, the aircraft abruptly pitched nose-down and descended 650 ft. After returning the aircraft to 37,000 ft, the crew commenced actions to deal with multiple failure messages. Shortly thereafter, the aircraft commenced a second uncommanded pitch-down event and descended about 400 ft. One flight attendant and 11 passengers were seriously injured and many others experienced less serious injuries. Most of the injuries involved passengers who were standing, or who were seated without their seatbelts fastened (AO-2008-070).

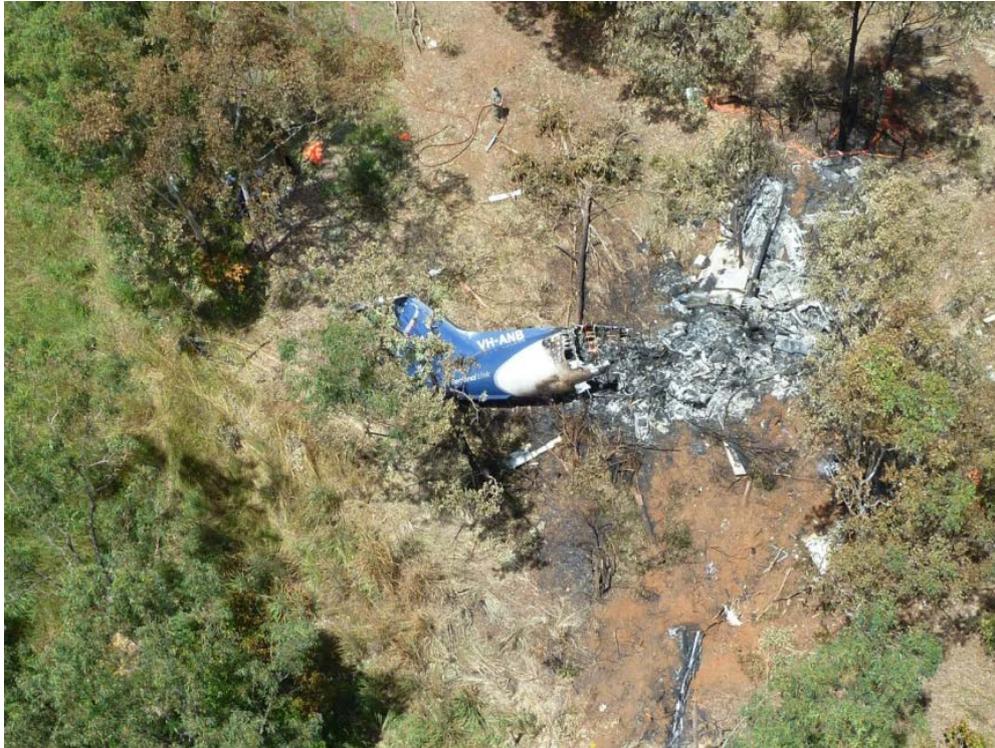
Loss of control, Embraer EMB-120ER (VH-ANB), near Darwin Airport, Northern Territory (AO-2010-019)

Darwin Airport on a training flight. Immediately after becoming airborne, the training captain carried out a simulated engine failure (asymmetric flight), but the aircraft rolled left and entered a steep nose-down attitude before impacting the ground. Both pilots were fatally injured (AO-2010-019).

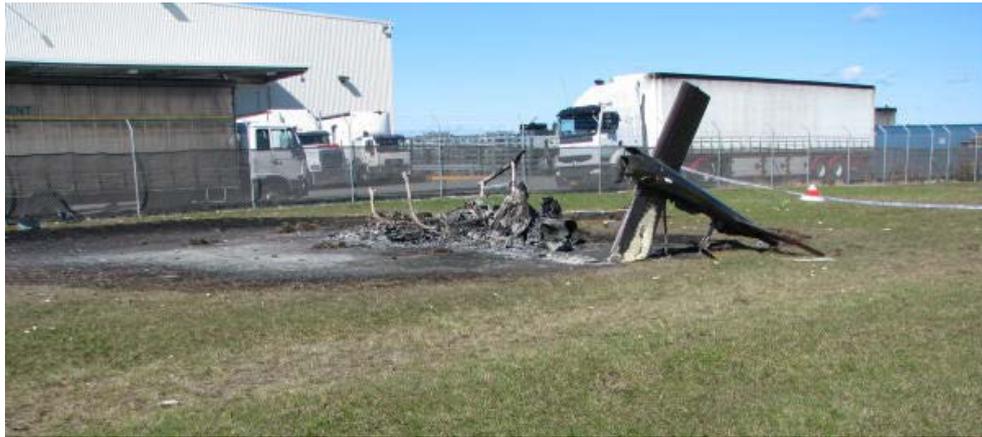
Loss of control, Aérospatiale AS350 B3 Squirrel helicopter (VH-XXW), Bankstown Airport, New South Wales (AO-2011-063)

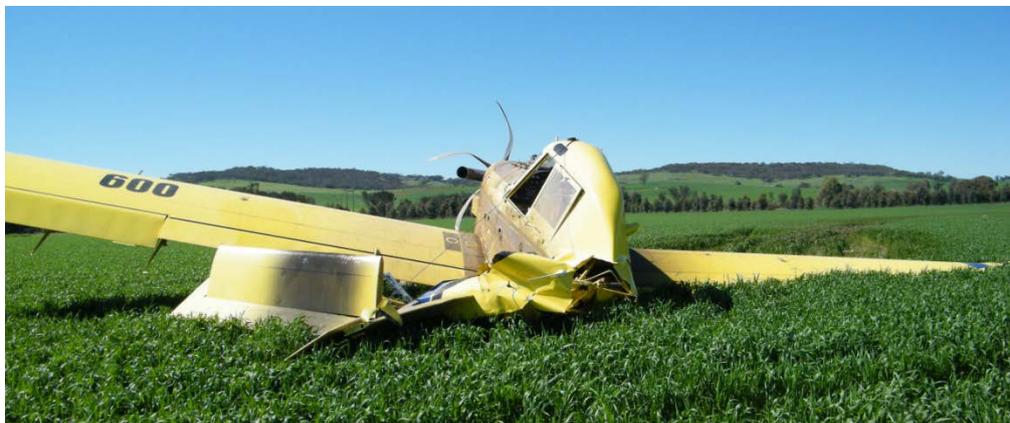
Wirestrike, Air Tractor AT-802 (VH-NIW), 5 km N of Mogumber, Western Australia (AO-2011-107)

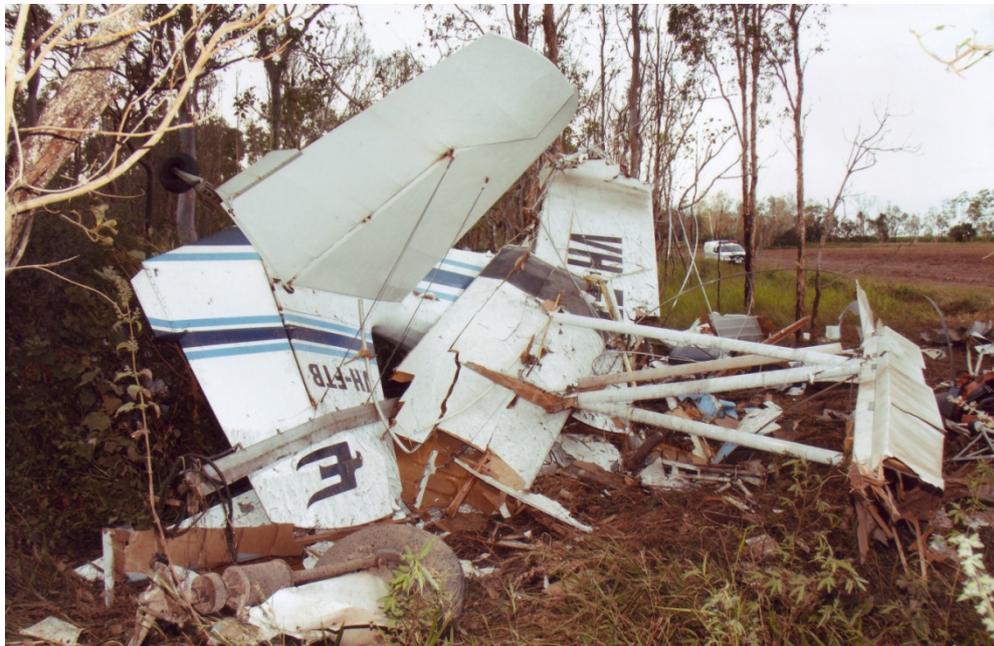
Collision with terrain, Eagle Aircraft Company DW-1 (VH-FTB), 28 km S of Ingham, Queensland (AO-2011-048)

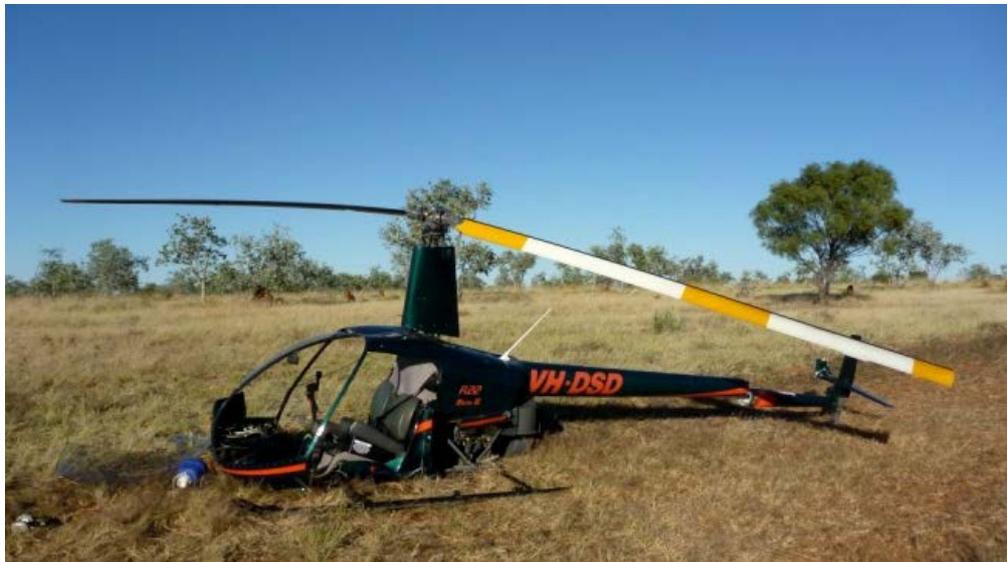
Collision with terrain, Robinson R22 Beta II helicopter (VH-DSD), 85 km NW of Julia Creek, Queensland (AO-2011-060)

Of the six aerial mustering accidents in 2011, one was fatal, and one resulted in a serious injury. One of these accidents, involving a Robinson R22 helicopter accident near Julia Creek, Queensland, is currently under investigation by the ATSB. Examination of the accident site found fragments of a broken drive belt 60 m from the main wreckage, which is consistent with a radio transmission by the pilot prior to the accident that a problem had occurred and he was unable to continue flying (AO-2011-060). The remaining accident was a helicopter that hooked a powerline with its skid as the pilot descended to move cattle away from a fence line, resulting in a loss of control and collision with the ground. The aircraft operator had previously looked into a wire alerting system utilising the onboard global position system (GPS) equipment. Following the accident, they are continuing to examine ways in which this technology could be incorporated into their operation.

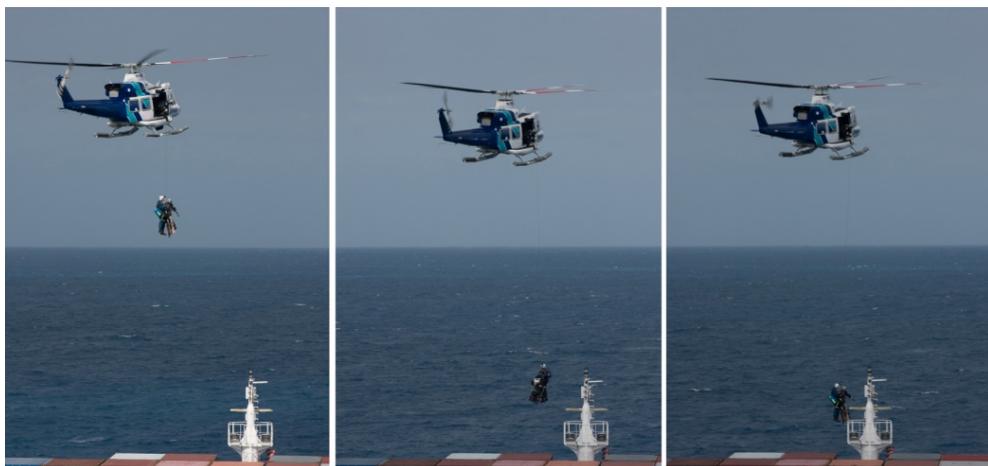
Approaching the winching area prior to winch cable failure, Bell 412 helicopter (VH-EMZ), 132 km W of Horn Island, Queensland (AO-2009-068)

- On 9 November 2009, a Bell 412 helicopter (registered VH-EMZ) departed Horn Island, Queensland, to rendezvous with a container ship located about 132 km to the west of the island. The purpose of the flight was to evacuate an ill crew member via rescue winch from the ship's forecandle deck, and transfer them to hospital. Approaching overhead the winching area, with the rescue crew officer and paramedic being lowered by the winch and about 6 m above the deck, the pilot lost sight of the ship. Shortly after, the helicopter began drifting back towards a mast that was located on the ship's forecandle. Despite assistance from the winch operator to re-establish the hover, the pilot was unable to arrest the helicopter's movement and the winch cable caught on the mast while the helicopter continued to drift rearwards. The winch cable separated and the paramedic and rescue officer fell about 10 m to the ship's deck, seriously injuring both personnel. The investigation found that there was no guidance to assist pilots to confirm that an adequate hover reference existed overhead an intended winch area, before deploying personnel on the winch (AO-2009-068).

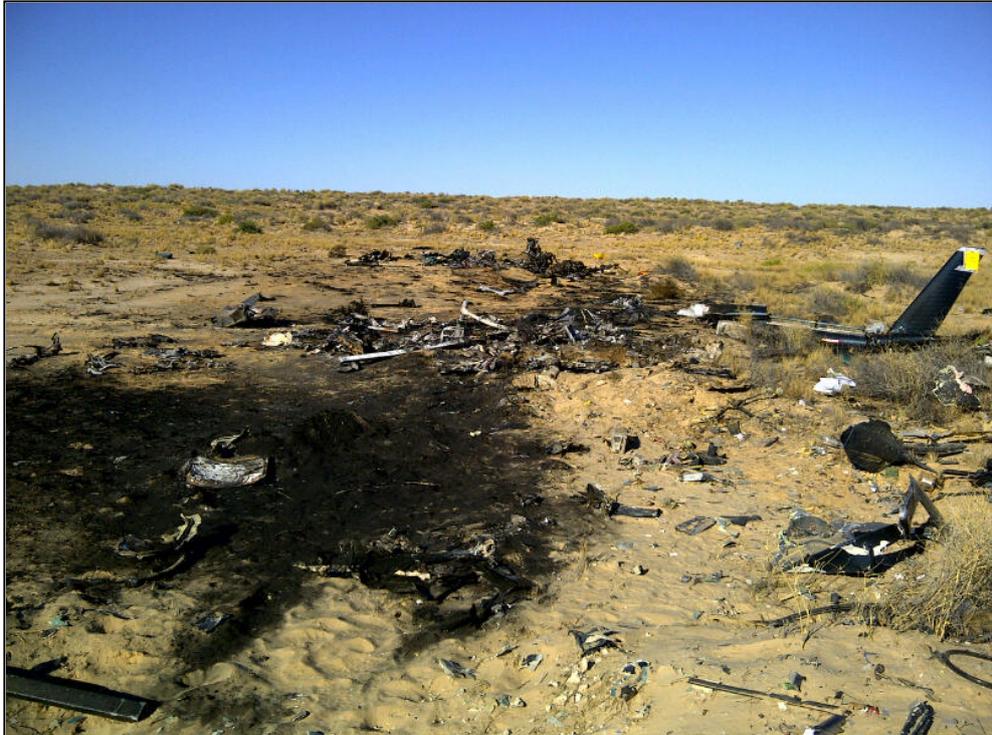
Collision with terrain, Aérospatiale AS355 F2 Twin Squirrel helicopter (VH-NTV), 145 km N of Marree, South Australia (AO-2011-102)

- On 18 August 2011, an Aérospatiale AS355 Twin Squirrel helicopter (registered VH-NTV) was operating in an area east of Lake Eyre, South Australia. The helicopter was being used to film footage for an Australian Broadcasting Corporation (ABC) documentary. On board were the pilot and two passengers. The helicopter landed on an island in the Cooper Creek inlet, about 145 km north of Marree, South Australia, at about 1715 Central Standard Time, so that the occupants could meet and interview a tour group. At about 1900 (after the end of civil twilight), the helicopter departed the island to return to a property 48 km north of Marree where the pilot and passengers were staying for the night. Soon after takeoff, the helicopter collided with terrain. All of the occupants were fatally injured, and the helicopter was destroyed by the impact forces and a fuel-fed fire. At the time of writing, this accident was still under investigation by the ATSB (AO-2011-102).

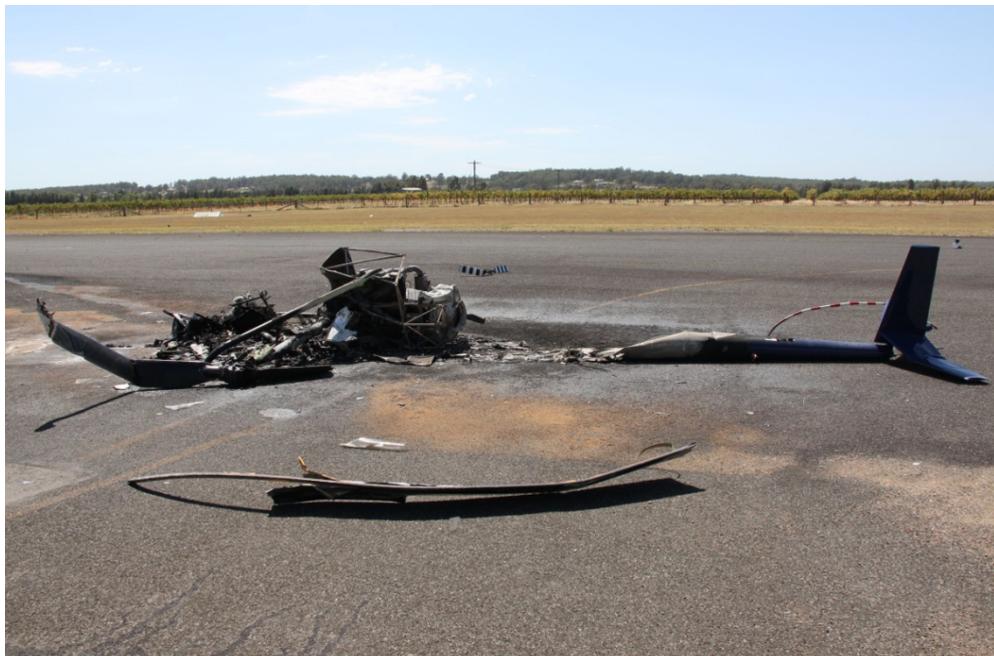
Collision with terrain - Robinson R44 helicopter, VH-HFH, Cessnock Aerodrome, New South Wales, 4 February 2011 (AO-2011-016)

- On 4 February 2011, a Robinson R44 helicopter (registered VH-HFH) was conducting circuit training at Cessnock Aerodrome, New South Wales. Following a simulated failure of the helicopter's hydraulic-boost system, the instructor assessed that the hydraulic system had actually failed. He decided to reposition the helicopter on the aerodrome to facilitate further examination. Upon becoming airborne, control of the helicopter was lost, it collided with the runway and, shortly after, there was a fire. The pilot, who received serious injuries, managed to exit the helicopter; however, the instructor and passenger were fatally injured. Examination of the wreckage found that a bolt securing part of the flight control system had detached. At the time of writing, this accident was still under investigation by the ATSB (AO-2011-016).

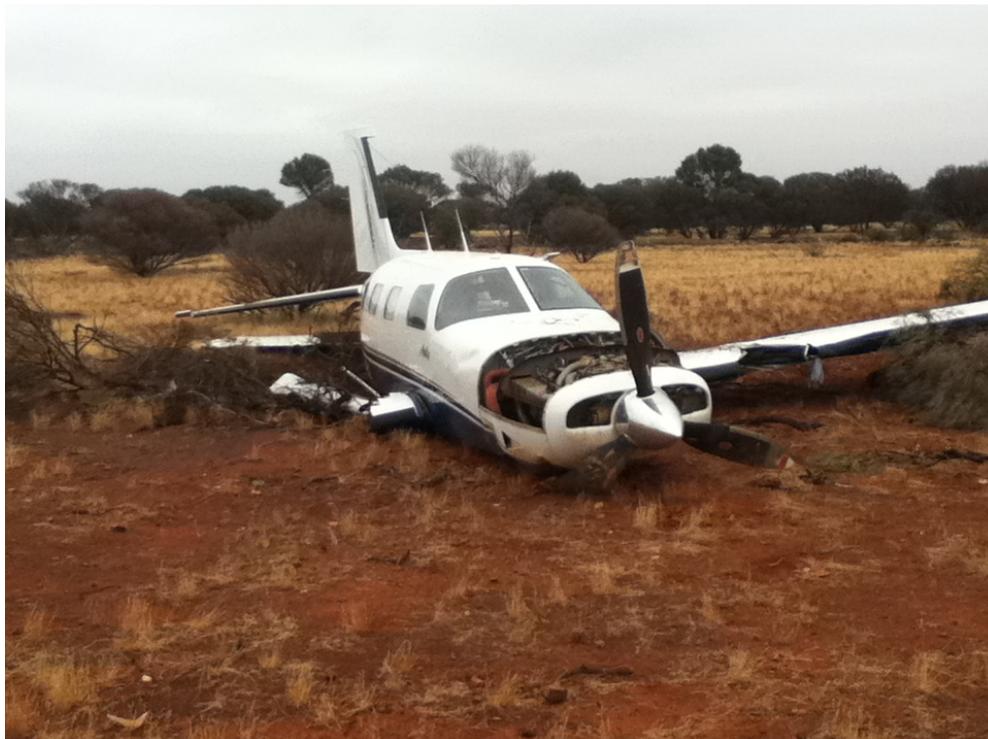
Total power loss and runway undershoot, Piper PA-46-310P Malibu (VH-FAL), Meekatharra Aerodrome, Western Australia (AO-2011-072)

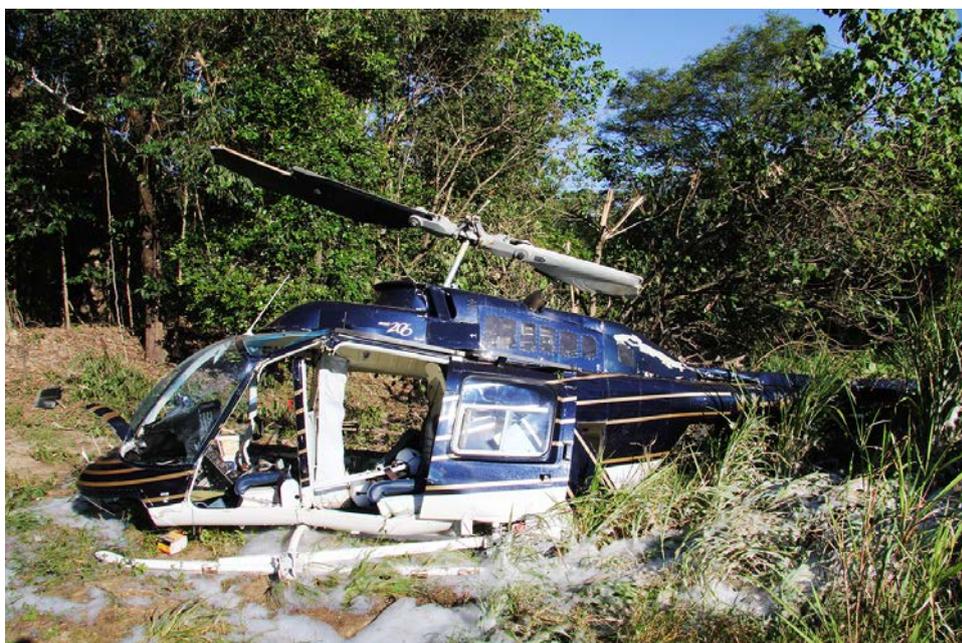
Wirestrike, Bell 206B III JetRanger helicopter (VH-BHU), near Mossman Hospital, Queensland (AO-2011-067) (image courtesy of Queensland Police)

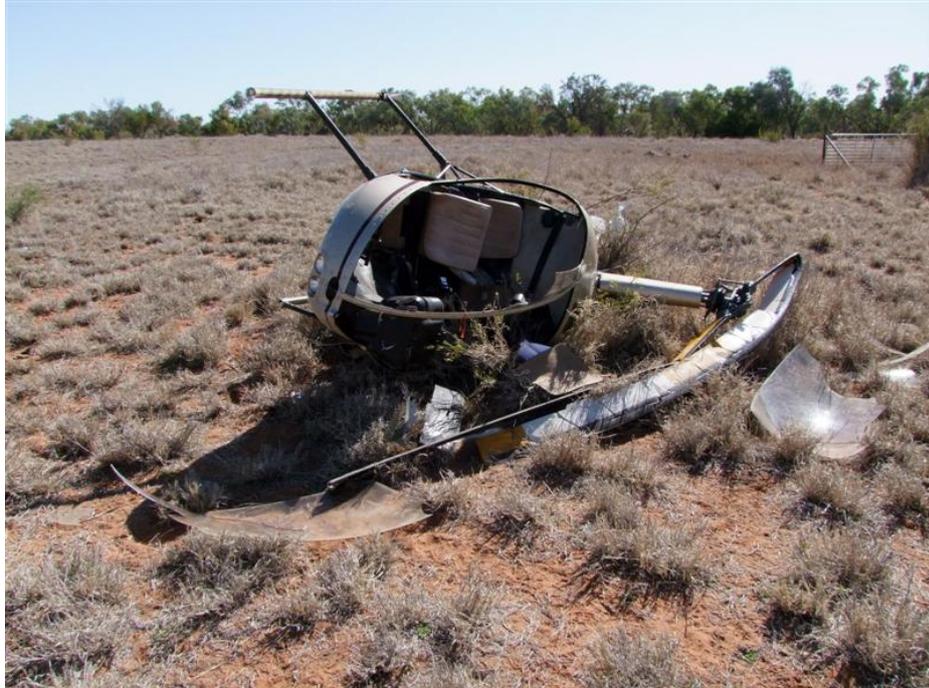
Wirestrike, Robinson R22 Beta II helicopter (VH-HSW), 90 km SW of Cunnamulla, Queensland (AO-2011-080) (image courtesy of Queensland Police)

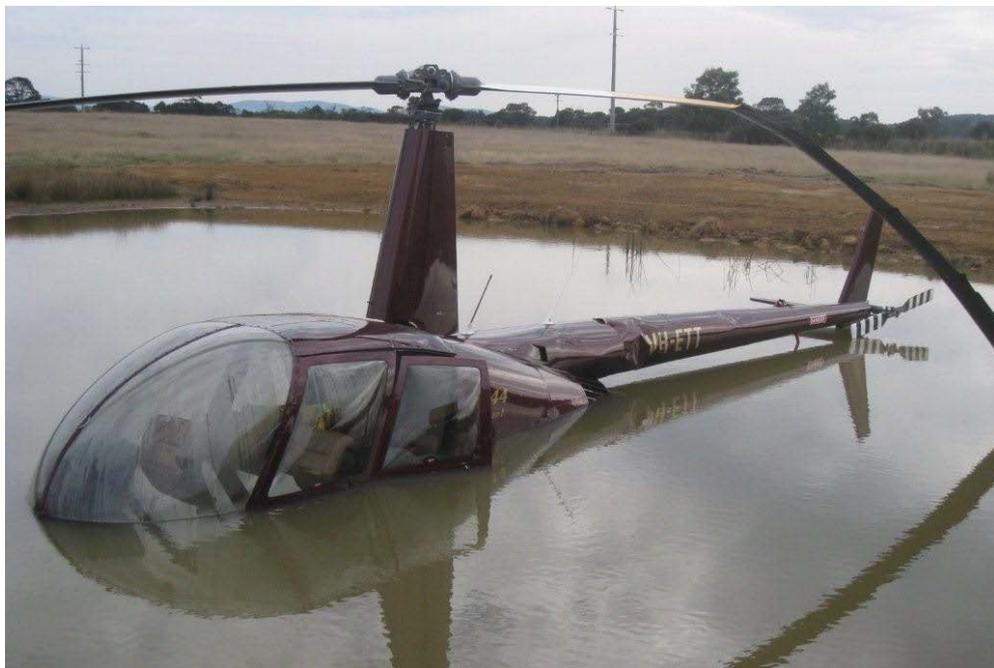
Loss of control, Robinson R44 helicopter (VH-ETT), 4 km SE of Kilmore, Victoria (AO-2011-055)

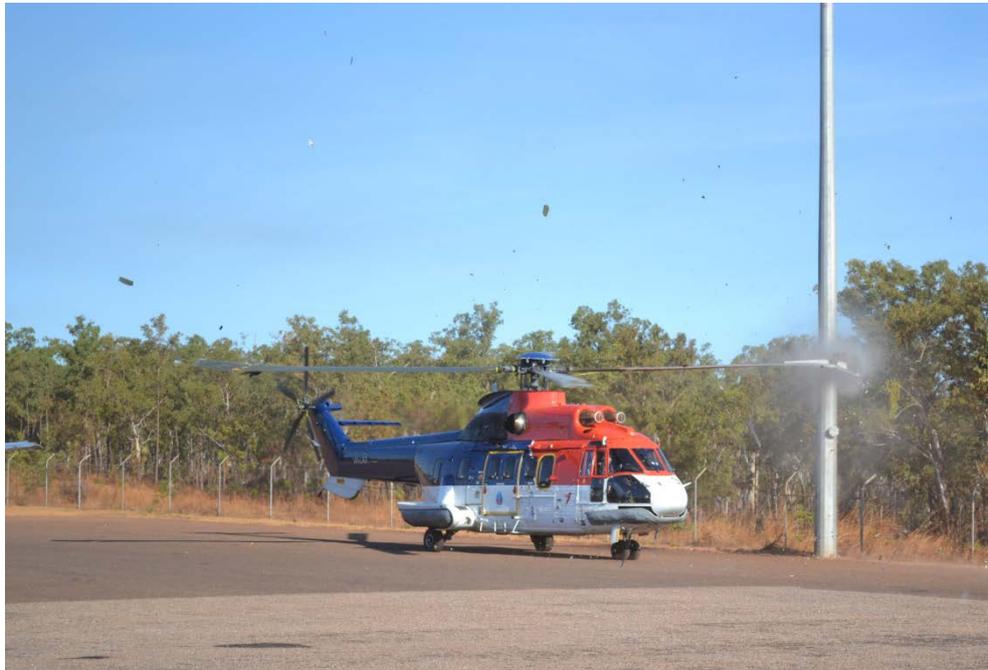
Collision with obstacle, Aérospatiale AS.332 L1 Super Puma (VH-LAG), Port Keats Airport, Northern Territory (AO-2011-083)

The collisions on ground included a large helicopter that collided with a light pole while taxiing and rolled onto its side at Port Keats Aerodrome, Northern Territory. In another accident, the wingtip of a Boeing 737 collided with the horizontal stabiliser of a parked aircraft.

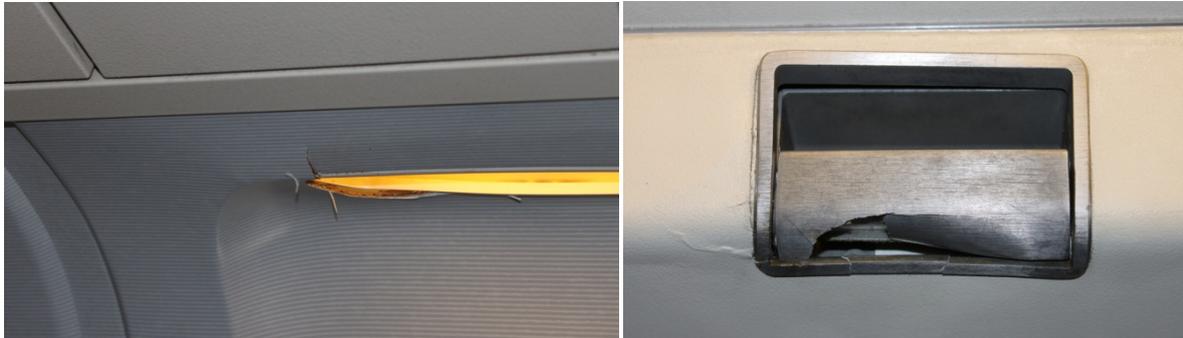
Damage to window reveal (L) and overhead locker (R) – Turbulence event, Boeing 767-300 (VH-OGR), near Perth Airport, Western Australia (AO-2011-064)
