# Aviation Occurrence Statistics 2003 to 2012

## ATSB Transport Safety Report

Aviation Research Report

AR-2013-067

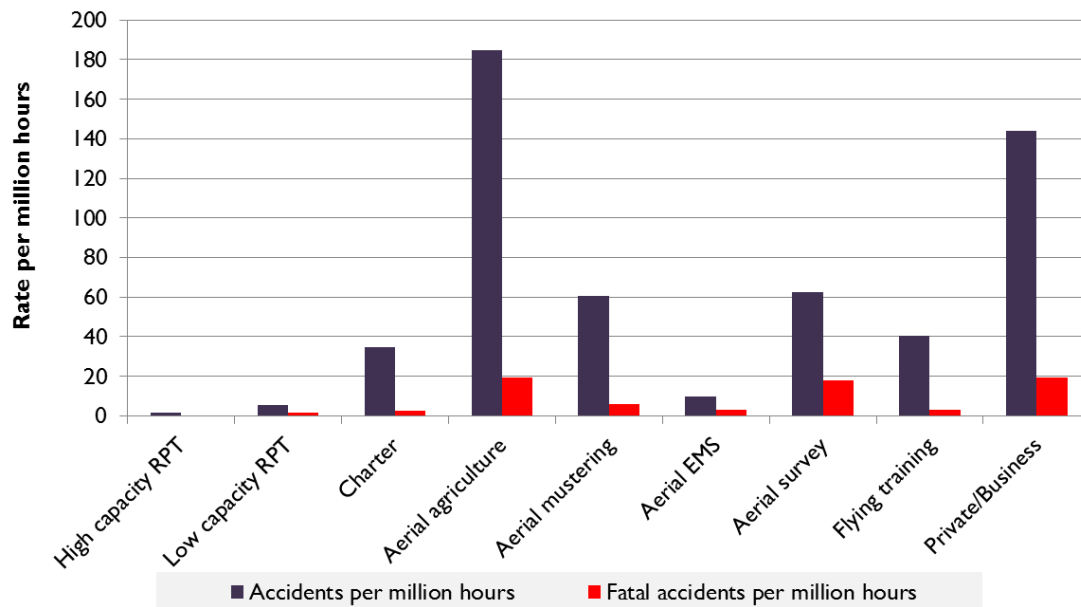
**Figure 6: Rate of accidents and fatal accidents (VH- registered aircraft only) by operation type, 2003 to 2011<sup>5</sup>**

<sup>5</sup> Activity data for each operation type is provided by the Bureau of Infrastructure, Transport and Regional Economics (BITRE), except for the following where information on hours flown and number of departures was not collected between 2003 and 2011: Fire control, Other/unknown GA, Sport aviation, Foreign registered GA.

Accident and fatal accident rates are based on those accidents from 2003 to 2011 only, as activity data was not yet available for 2012 at the time of writing.

Figure 6 below shows the rate of accidents and of fatal accidents for each of the specific operation types<sup>5</sup> over this period per million hours flown. General aviation operation types had higher accident rates when compared to air transport operations, with aerial agriculture and private/business flights the most likely to be involved in an accident. These operation types were also the most likely to result in a fatal accident when considering the amount of flying activity, although aerial survey and photography flights were involved in a much higher proportion of fatal accidents than other types of operations. More detailed information on accident rates for each operation type is provided in the following sections of this report.

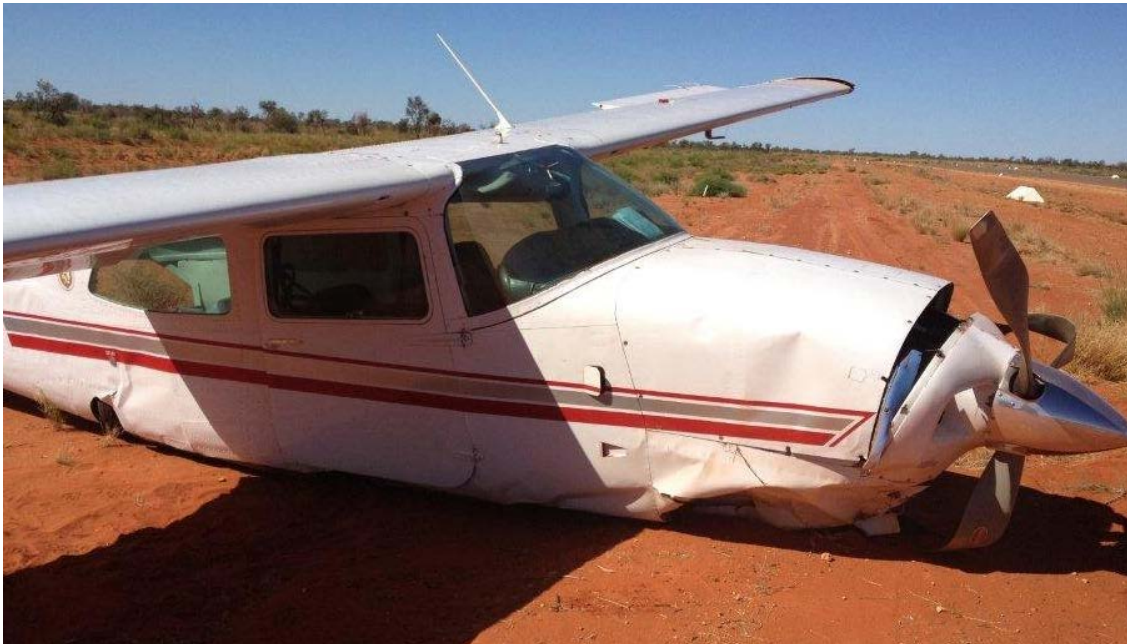
Collision with terrain, Cessna 210 Centurion (VH-TWP), Nyirripi aircraft landing area, Northern Territory (ATSB investigation AO-2012-056)

- On landing at Nyirripi airstrip, NT, the Cessna 210 Centurion being flown by a pilot in command under supervision (ICUS) on a line training flight ballooned twice. The supervisory pilot took control of the aircraft with the intent of recovering from the balloon to a normal landing. A dust devil caused the aircraft to yaw significantly to the left, and the supervisory pilot applied full

power to go-around but the aircraft did not climb. The supervisory pilot rolled the aircraft into a 30° right bank to remain over clear ground, closer to the runway. Realising that the aircraft was going to impact the ground, the supervisory pilot rolled the wings level. The aircraft impacted fairly hard and skidded about 100 m before coming to rest north of the runway and about 600 m from the threshold. The supervisory pilot was seriously injured with possible spinal injuries, and the pilot ICUS had minor injuries. This accident was investigated by the ATSB, and following the accident, the aircraft operator issued guidance notes on windshear recognition and recovery to all flight crew. This accident demonstrated that if an approach becomes unstable, conducting a go-around early is usually the safest course of action. A Bureau of Meteorology Research Centre report has noted that not all dust devils are visible and that they pose a major hazard to light aircraft during landing (ATSB investigation AO-2012-056).

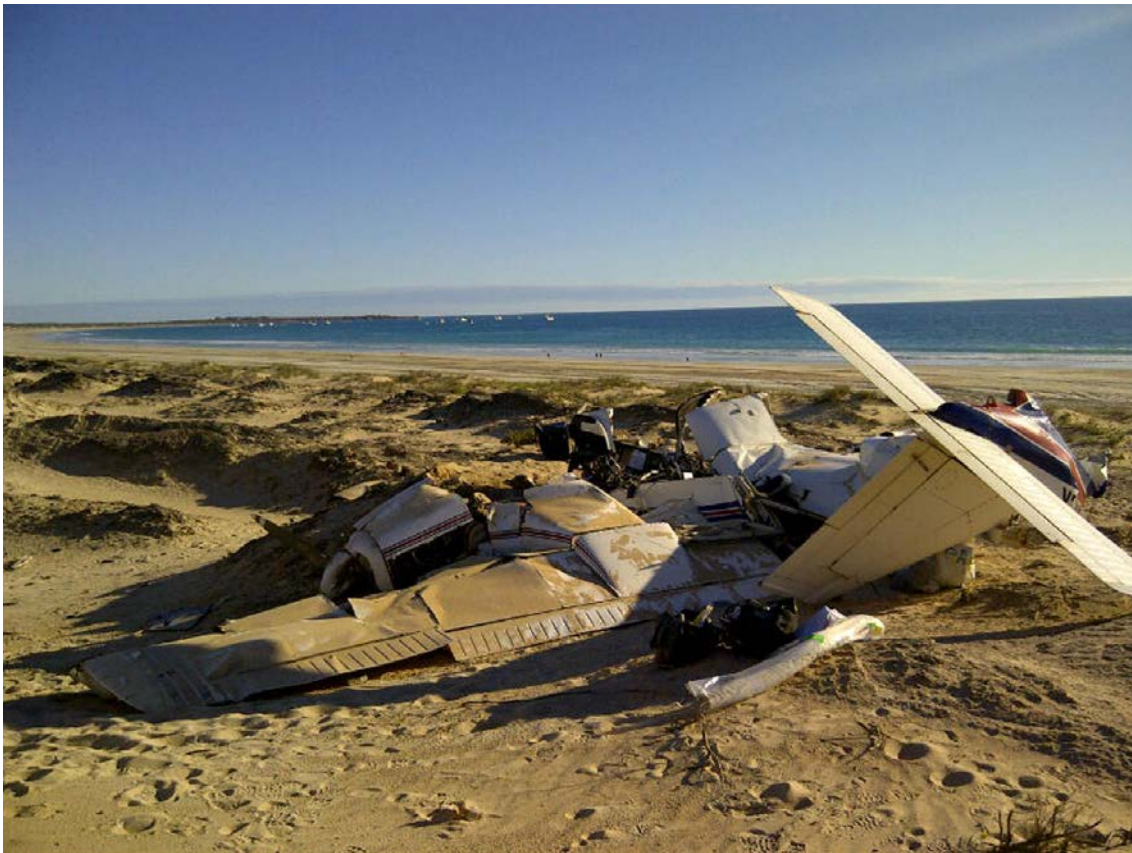
Collision with terrain, Piper PA-34-200 Seneca (VH-LCK), near Broome, Western Australia (ATSB investigation AO-2012-093)

- Shortly after takeoff from runway 28 at Broome Airport, WA, a Piper Seneca collided with terrain. The aircraft was on the outbound leg of a regular freight-carrying flight between Broome and Port Hedland, WA. A company employee, who was familiar with the aircraft and near the airport at the time of the accident, heard the engines during the initial takeoff roll and thought they sounded normal. Several witnesses reported that, during the period after the

takeoff, they heard unusual noises from the engines. Other witnesses that were closer to the accident site reported hearing the engines cut out and that they watched as the aircraft descended steeply towards the ground. Emergency services commenced a search for the missing aircraft and pilot and the wreckage was found during the latter part of the evening in sand dunes, about 880 m beyond the upwind end of the runway and close to the extended runway centreline. The pilot sustained fatal injuries and the aircraft, although substantially intact, was destroyed by impact forces. There was no post-impact fire. Damage to the wreckage was consistent with the aircraft descending steeply into terrain at relatively low forward speed and a high rate of descent. There was no evidence of in-flight structural failure. The fuel tanks ruptured on impact, the cockpit and cabin were severely disrupted and the landing gear was retracted. This accident was investigated by the ATSB (ATSB investigation AO-2012-093).

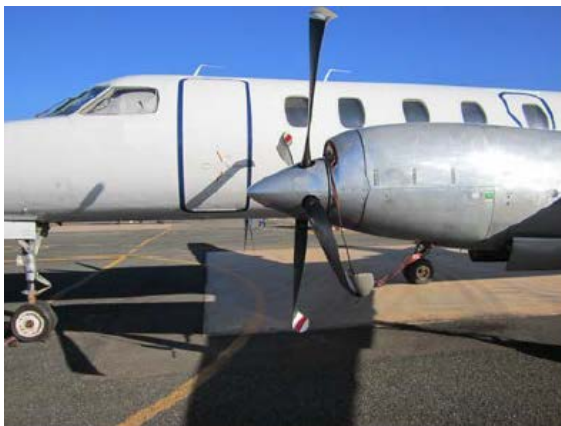
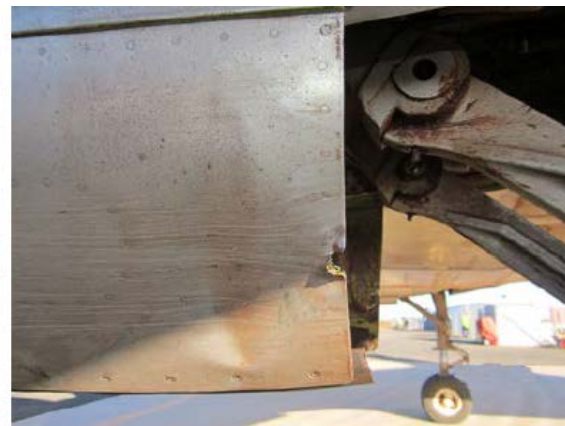
Propeller (left) and landing gear door (right) strike, Fairchild SA227-DC Metroliner (VH-WBQ), Granny Smith Aerodrome, Western Australia (ATSB investigation AO-2012-106)

- On arrival at Granny Smith Aerodrome, WA on a flight from Perth, the flight crew of a Fairchild Metro joined the circuit and extended the landing gear. In the circuit and again on approach to land, the flight crew confirmed that the three green down-locked lights ('three greens') were illuminated. During the landing flare, the left wing suddenly dropped. The first officer immediately applied right aileron in an attempt to counteract the wing drop and the aircraft touched down. After shutdown, the crew inspected the aircraft and determined that the left propeller had contacted the ground. The aircraft operator examined the aircraft and believed that there was uncommanded retraction of the left landing gear on, or just after touchdown, which resulted in the left wing dropping. Right aileron was applied, which raised the left wing, and with the forward momentum of the aircraft, the left landing gear extended. The flight crew could not recall hearing the landing gear warning horn activate during the landing. The left landing gear was later examined and ground tested and found to be working correctly. This occurrence was investigated by the ATSB, but the reason for the uncommanded retraction could not be determined (ATSB investigation AO-2012-106).

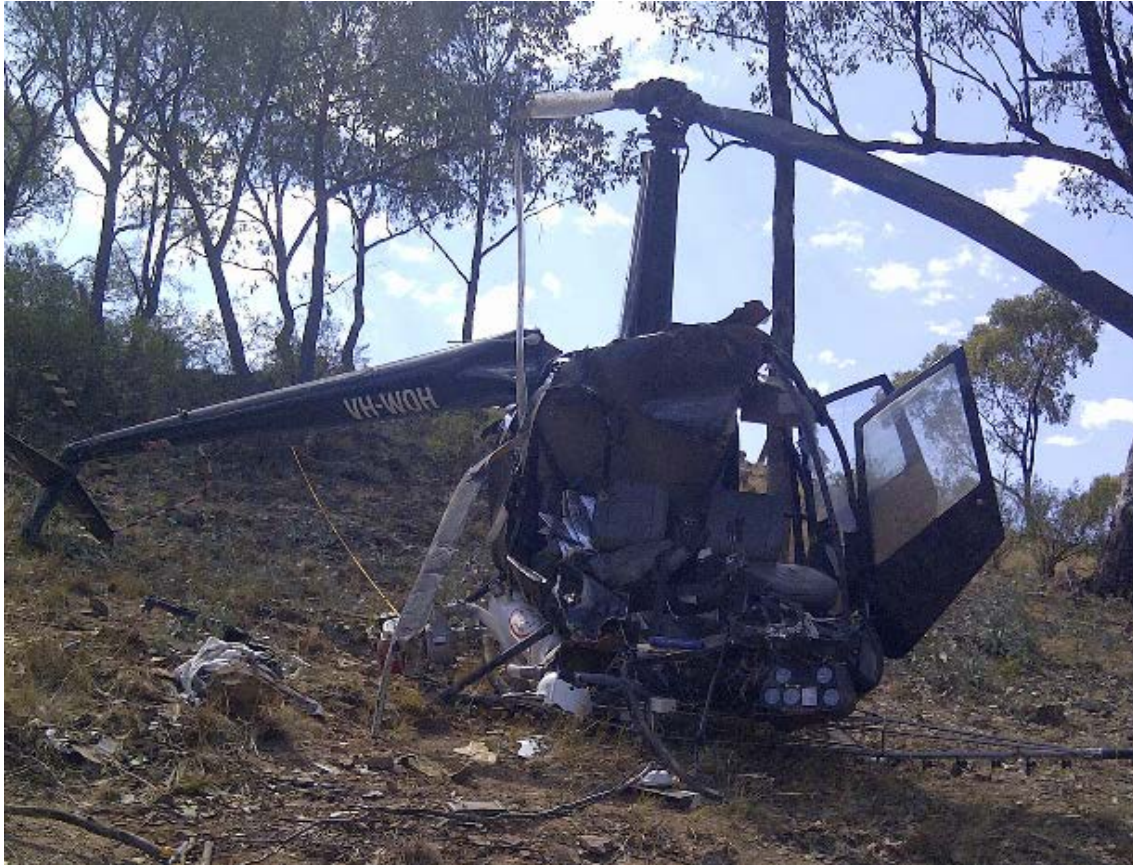
Loss of control, Robinson R44 helicopter (VH-WOH), 20 km SW of Mudgee, New South Wales (ATSB investigation AO-2012-165)

the engine. This resulted in a probable reduction in main rotor RPM (an overpitch condition) and a descent. The time between this point and the first contact with a tree was insufficient for the pilot to complete a recovery action (ATSB investigation AO-2012-165).

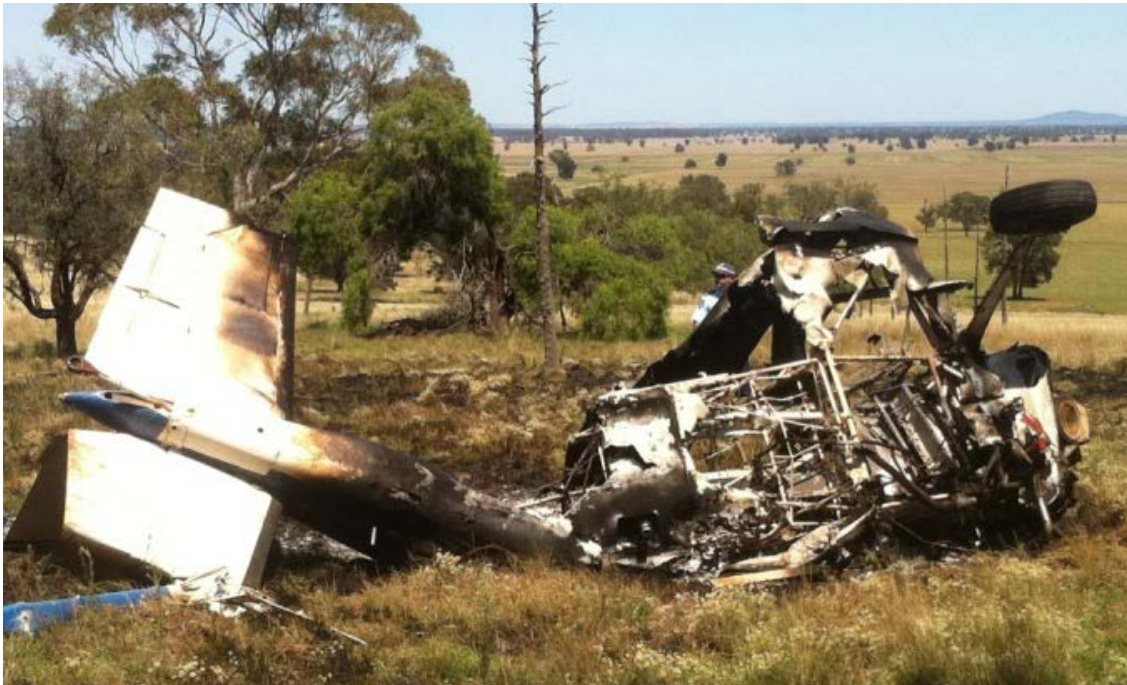
Collision with terrain, Cessna A118B/A1 (VH-ZAP), 40 km S of Forbes, New South Wales (ATSB investigation AO-2012-003)

- While applying chemicals in a field, a Cessna A188B developed a high sink rate as a result of a downdraught and the left wing impacted trees. The subsequent post-impact fire seriously damaged the aircraft and the pilot was injured. The ATSB investigated this accident, and the pilot reported that he had difficulties activating the emergency dump control system to lighten the aircraft. This accident highlights the risks associated with executing a turn when in close proximity to the ground. Such manoeuvres require heightened pilot vigilance regarding controlling the aircraft. In addition, pilots must be prepared to immediately identify the situation and act to control the aircraft, in order to compensate for a change in wind direction or downdraughts (ATSB investigation AO-2012-003).

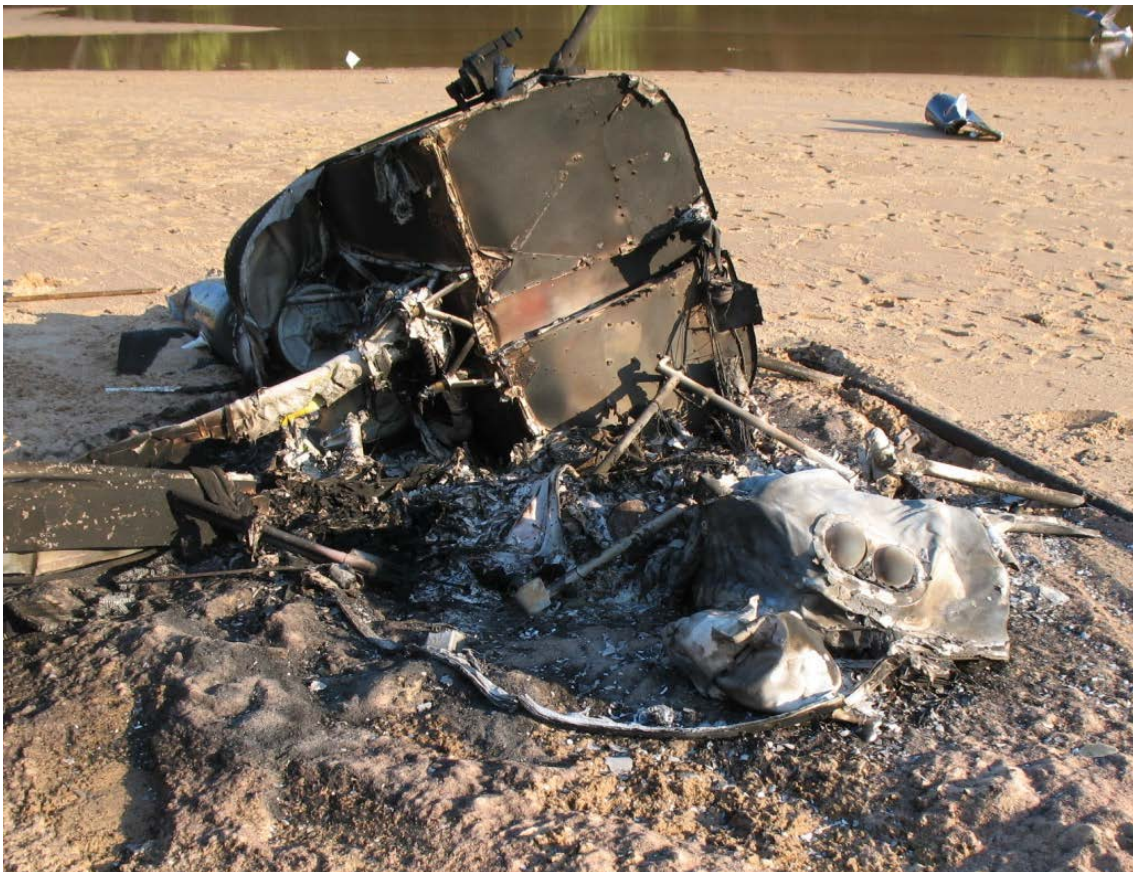
Collision with terrain, Robinson R22 helicopter (VH-FHR), 45 km ENE of Richmond Airport, Queensland (ATSB investigation AO-2012-006)

- While conducting low-level aerial work along the Dutton River near Richmond, Qld at low speed and low altitude, the pilot felt a 'kick' to the Robinson R22 helicopter and the machine suddenly yawed to the left. Shortly after, a second 'kick' and yaw occurred, followed by the sounding of the low rotor RPM warning horn. The pilot entered autorotation, and attempted to recover forward airspeed with the little height he had available (less than 250 ft). The pilot was unable to arrest the R22's descent, and it impacted the sandy river bed heavily and rolled onto its right side. A fire commenced immediately after impact, but the pilot was able to escape with minor burns. The ATSB investigation suggested that the 'kicks' and yaw experienced may have been due to environmental effects at low altitude, such as the effect of the gusting and swirling winds and mechanical turbulence. This accident highlights the need for helicopter pilots to be mindful of conducting operations with a combination of forward airspeed and altitude which may place the machine in the 'avoid' area of their helicopter's height-velocity diagram. The pilot in this accident was not wearing a helicopter safety helmet. The investigation determined that the post-impact fire initiated at the head height of the pilot, and that a helmet and visor may have reduced the severity and extent of the burns sustained (ATSB investigation AO-2012-006).

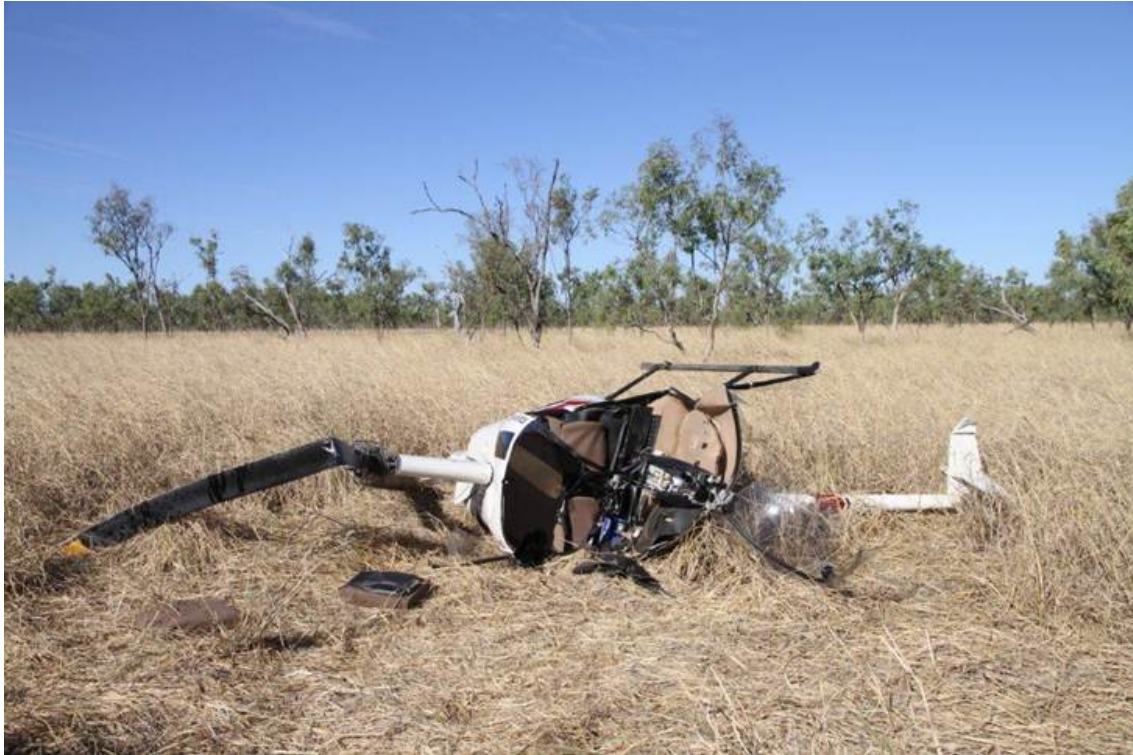
Collision with terrain, Robinson R22 helicopter (VH-STK), 23 km NE of Miranda Downs authorised landing area, Queensland (ATSB investigation AO-2012-091)

The first of these accidents involved a Robinson R22 helicopter conducting aerial mustering near Miranda Downs, Qld. During the mustering, the right skid struck a tree and the helicopter crashed. The pilot, the only occupant, was seriously injured and the helicopter sustained substantial damage. Both the ATSB and the helicopter's operator conducted an investigation into the accident and, using Global Positioning System (GPS) data, determined that the R22 had climbed to about 2,500 ft above sea level before commencing a left spiral descent. Bureau of Meteorology data, obtained by the operator, indicated that the temperature was 14.7° C and the dew point 1.3° C. The operator determined that this combination of temperature and dew point would indicate a moderate carburettor icing risk at cruise power and a serious icing risk at descent power. As a result of this occurrence, the aircraft operator advised the ATSB that they reminded their pilots of documentation in relation to carburettor icing and auto-rotations. This accident was a good reminder to all pilots of the importance of maintaining awareness of the weather conditions that are conducive to carburettor ice formation, and to closely monitor aircraft performance during times when the risk exists (ATSB investigation AO-2012-091).

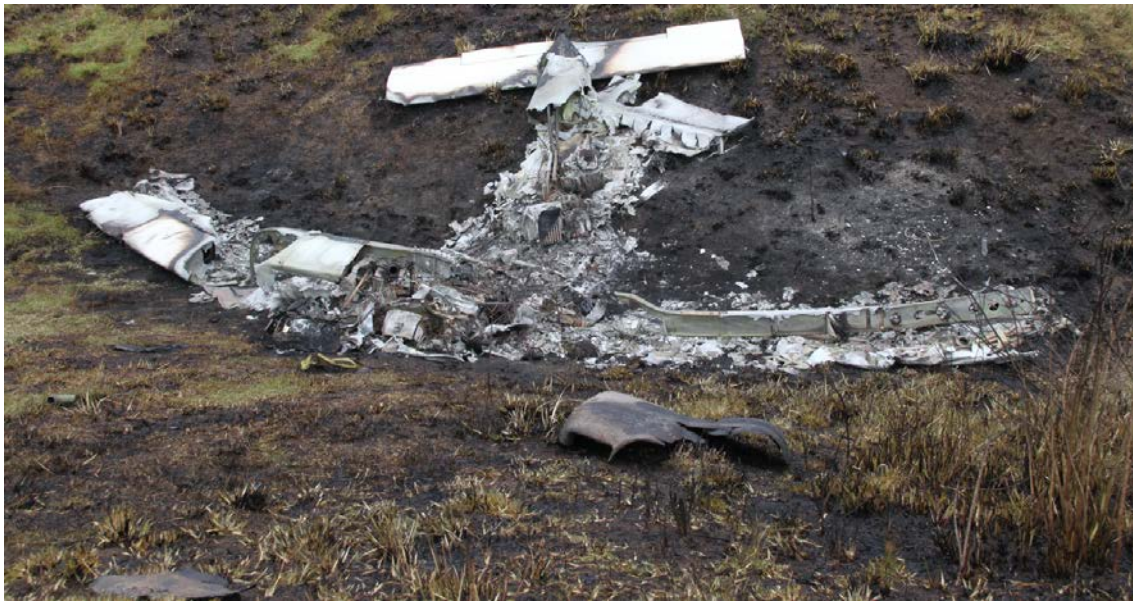
Collision with terrain, SOCATA TB-20 Trinidad (VH-HBB), 3 km S of Lismore, New South Wales (ATSB investigation AO-2012-149)

- On 9 November 2012, a student pilot and instructor departed Gold Coast Airport, Qld, for a training flight in a SOCATA TB-20 Trinidad. The student pilot had recently purchased the

TB-20, and was under the supervision of an instructor while undertaking transition training. The pilots had conducted a number of circuits at Lismore Airport, NSW, when several witnesses travelling along the Bruxner Highway observed the aircraft make an abrupt steep bank to the left, before pitching nose down and rapidly descending. Some of these witnesses then saw the aircraft's nose raise and the descent rate to reduce, before crossing the highway at a very low height and colliding with the ground in a paddock adjacent to the highway. The aircraft skidded along the ground, colliding with a fence, rupturing the fuel tanks before the aircraft flipped over. Both occupants on board the aircraft were fatally injured and a fuel-fed fire destroyed a substantial amount of the aircraft structure. At the time of writing, this accident was under investigation by the ATSB. This investigation is considering whether the operation of the engine and propeller, the aircraft's handling qualities, or the experience of the student or instructor contributed to the accident (ATSB investigation AO-2012-149).

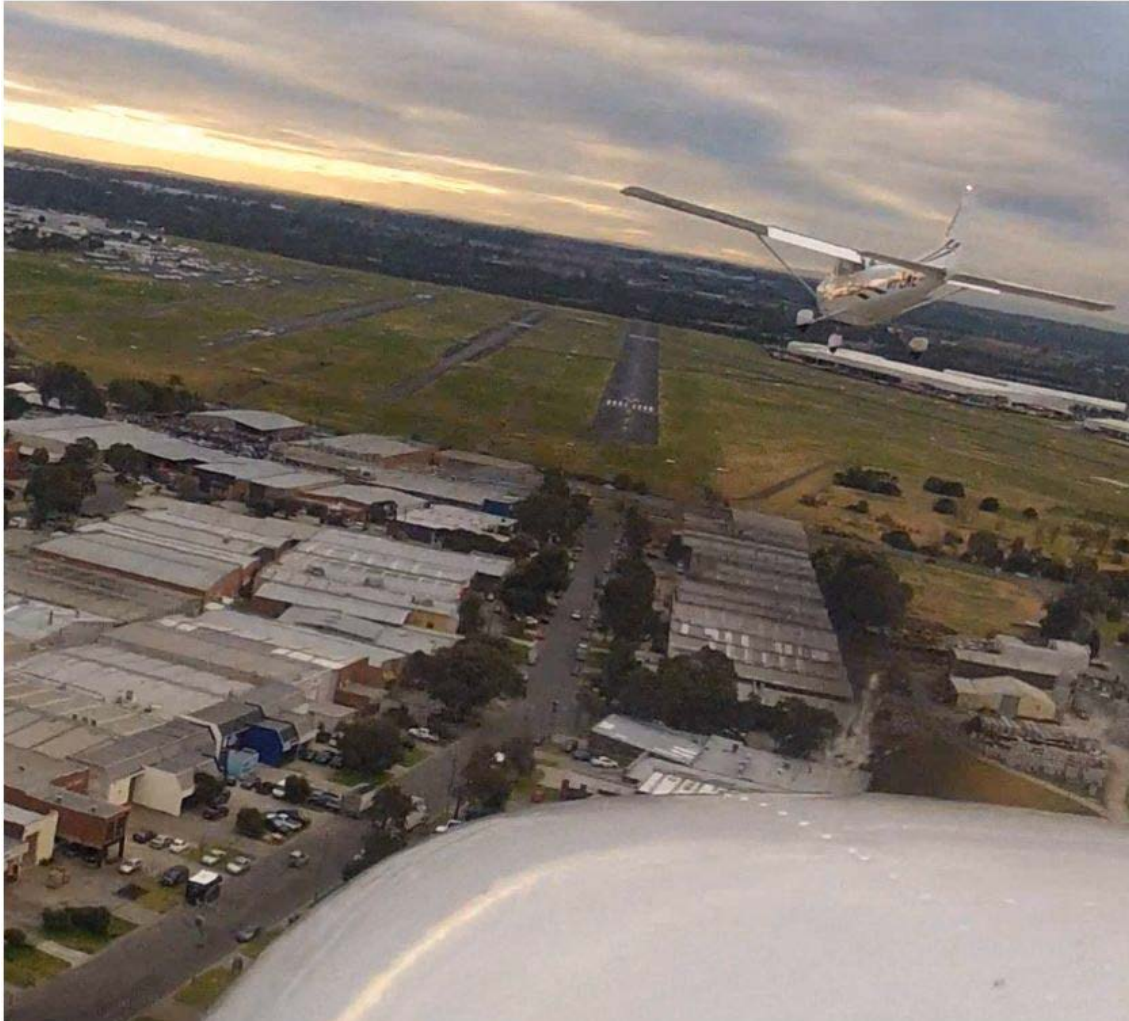
Near collision between two Cessna 172S Skyhawk aircraft (VH-EWE and VH-EOP), Moorabbin Airport, Victoria (ATSB investigation AO-2012-099)

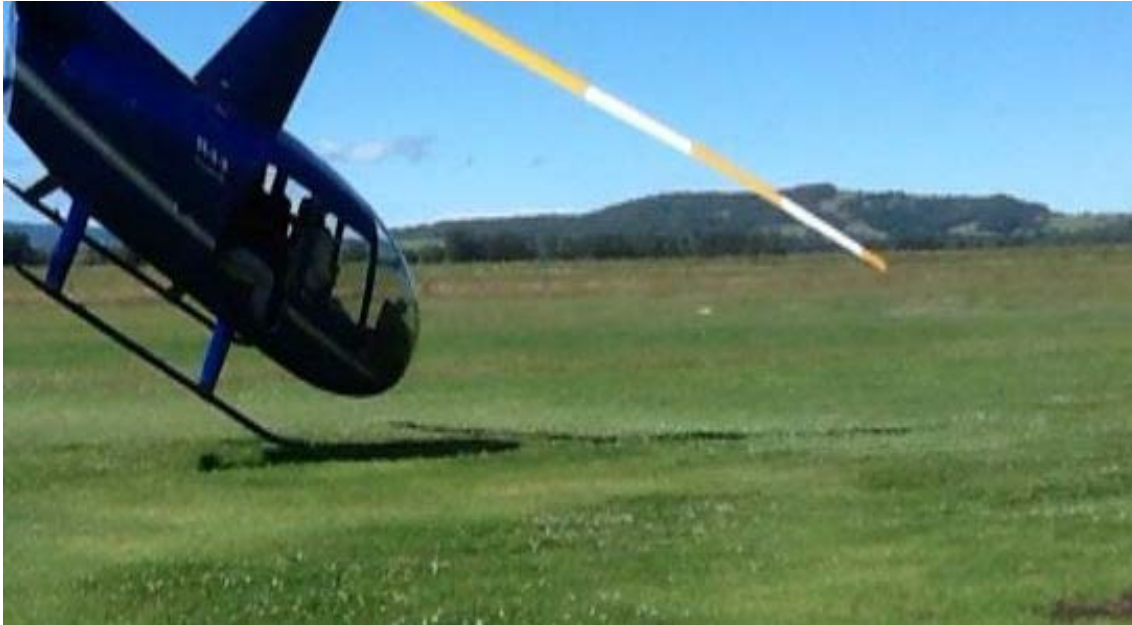
Loss of control, Robinson R44 helicopter (VH-COK), Jaspers Brush Aerodrome, New South Wales (ATSB investigation AO-2012-021)

- On 4 February 2012, a Robinson R44 helicopter lifted off from Jaspers Brush Aerodrome, NSW for aerial photography of the launching of a deep sea submarine in nearby Jervis Bay. On board were the pilot and a camera operator. Soon after lifting off, the pilot's door opened and the pilot reached out to close the door. Simultaneously the helicopter abruptly pitched nose-up then steeply nose-down, rolling to the right before the right landing gear skid and main rotor blades struck the ground. A fuel-fed fire started in the vicinity of the fuel tanks and lower mast area prior to the helicopter coming to a stop. Both occupants were fatally injured, and the helicopter was destroyed. The ATSB investigation into this accident found that the pilot's door was not properly latched prior to lift off and opened during the turn to depart. In attempting to shut the door the pilot probably let go of the cyclic control from the normal (right) control hand, allowing for an unintended, abrupt nose-up pitch and the helicopter tail hitting the ground. The helicopter then nosed over and impacted the ground. A fire began when one of the fuel tanks was breached. An important aspect of this investigation was post-accident survivability, and the ATSB identified that the fatal injuries in this and several other accidents involving R44 helicopters were due to the post-impact fire. In this and the other accidents, the R44's had not (and were not yet required to have been) modified in accordance with a manufacturer service bulletin that specified replacement of aluminium fuel tanks with more impact-resistant bladder-type fuel tanks, which decrease the risk of a post-accident fire. Both the ATSB and CASA have separately highlighted the benefits of the upgraded bladder-type fuel tank and related modifications to operational and maintenance personnel, and as of 30 April 2013, all R44 helicopters operating in Australia are now required by CASA to be fitted with bladder-type fuel tanks. This accident highlighted the importance of ensuring all doors are secured prior to takeoff. That said, the opening of a door in flight will not normally affect the operation of an R44, but the instinctive reaction to immediately deal with such an event can be quite strong. Pilots need to be aware that this reaction may be hard to overcome and in the event of an unexpected situation occurring such as the opening of the door, it is vital that pilots should continue to 'fly the aircraft'. This includes choosing to land to close the door if necessary (ATSB investigation AO-2012-021).

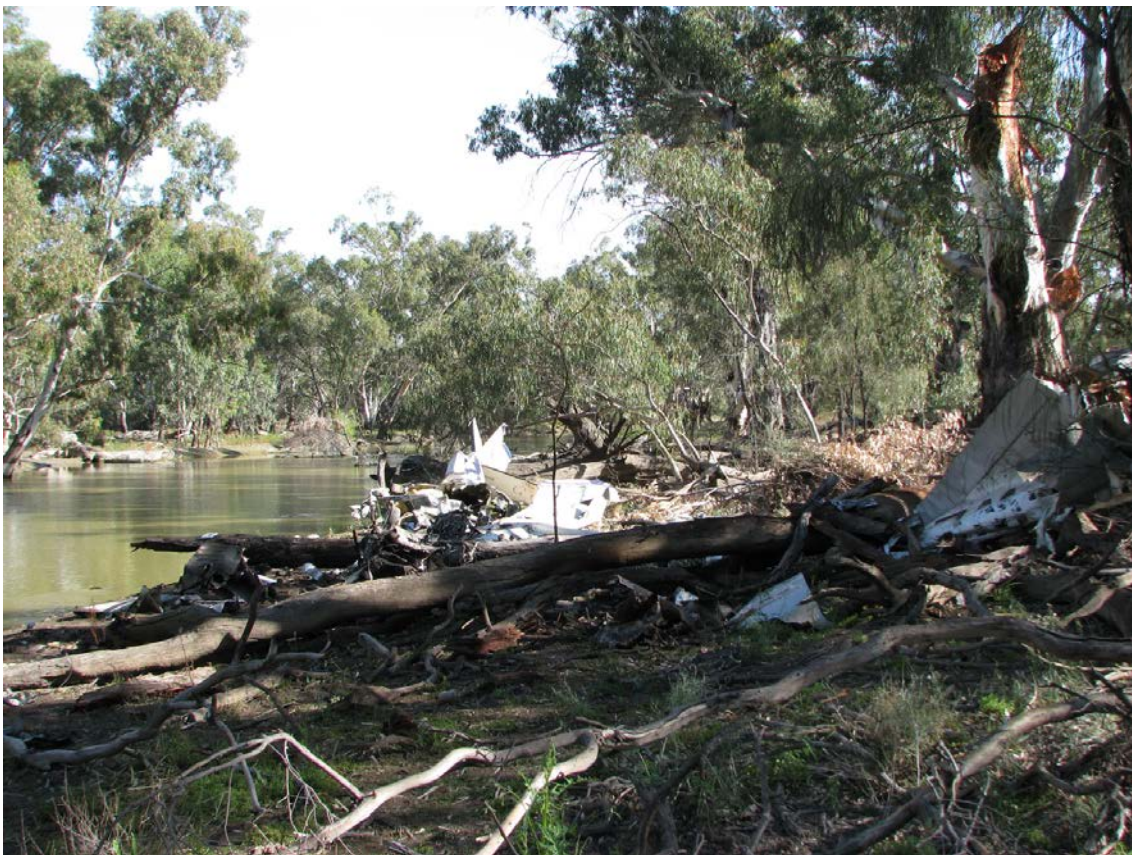
Collision with terrain, Cessna 172 Skyhawk (VH-WLF), 10 km W of Wentworth, New South Wales (ATSB investigation AO-2012-072)

- On 28 May 2012, a Cessna 172 Skyhawk collided with terrain near Wentworth, NSW while on a solo private flight in the local area. No details of the flight were submitted to ATC, or left with any other person. After a two day search and rescue operation, the aircraft wreckage was found 10 km west south west of Wentworth Airport. The pilot had been fatally injured, and the

aircraft destroyed by the impact and a post-impact fire. Examination of the wreckage by the ATSB identified that the aircraft collided steeply with the terrain at high speed. All of the major aircraft components were accounted for in the vicinity of the accident site, with the exception of the left cabin door. There was no evidence of any pre-impact damage or fire. Continuity of the flight control system to the cockpit area was established. A number of cockpit instruments were retained for further technical examination. On-site examination of the aircraft's propeller and engine revealed no pre-impact abnormalities, and damage to the propeller and engine crankshaft was consistent with their failure while under power. Fuel and other aircraft records indicated that the aircraft was fully refuelled at the aerodrome on 10 May 2012 and had likely not flown since that date. Weather at the time of the accident was calm, with no significant low cloud and good visibility. At the time of writing, this accident was still under investigation by the ATSB, with a focus on the pilot's flying experience, licence, endorsements and medical history, the recovered cockpit instruments, and the aircraft's weight, balance, performance, and maintenance records (ATSB investigation AO-2012-072).

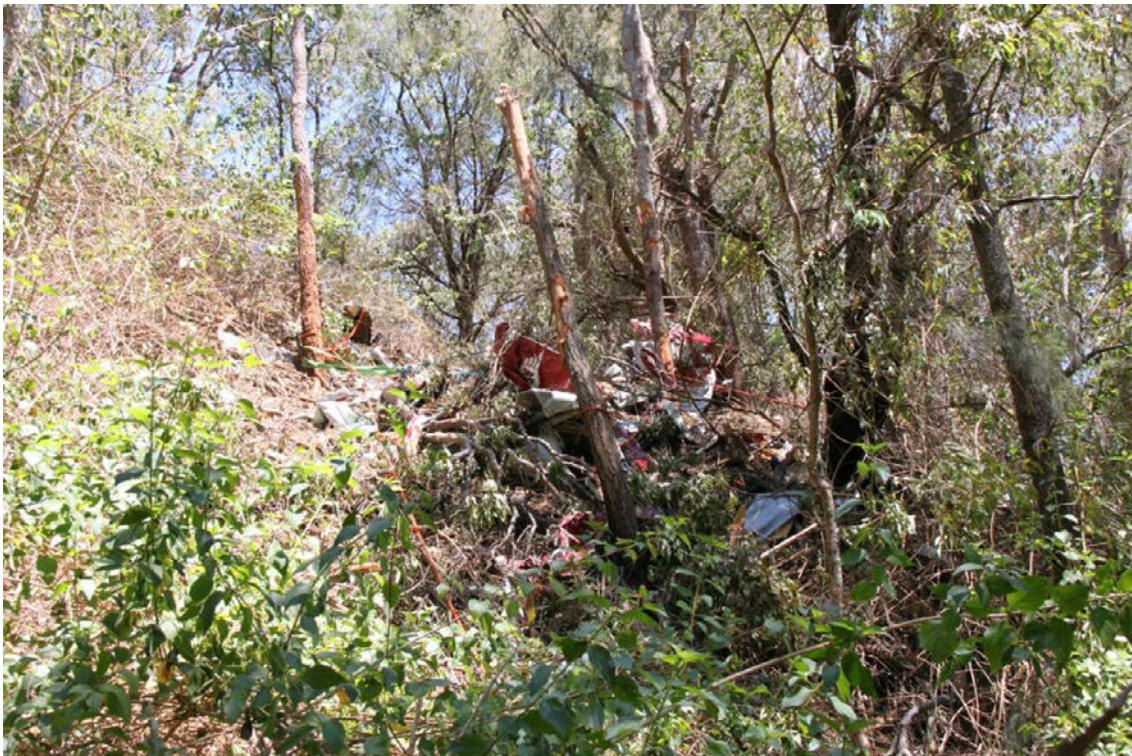
Collision with terrain, de Havilland DH.84 Dragon (VH-UXG), 36 km SW of Gympie, Queensland (ATSB investigation AO-2012-130)

- On 1 October 2012, a de Havilland DH-84 Dragon took off from Monto, Qld on a private VFR flight to Caboolture with the pilot and five passengers on board. About two hours into the flight, the pilot requested air traffic control assistance and reported that the aircraft was in 'full cloud'. For most of the remainder of the flight, the pilot and ATC exchanged communications, at times relayed through a commercial flight and a rescue flight in the area due to the limited ATC radio coverage in the area at low altitude. Air traffic control was unable to direct the pilot to an area of known visual conditions because of the extent of the cloud cover and uncertainty over the aircraft's position. Communication with the aircraft was subsequently lost. A two day search and rescue effort found the wreckage of the aircraft in a remote area to the south-west of Gympie. The accident was not survivable, and the six occupants were fatally injured. At the time of writing, this accident was still under active investigation by the ATSB. Several items and components that were retrieved from the accident site have already been examined, including a GPS unit and some aircraft instruments, and no indications of an aircraft malfunction have been found. The investigation will continue to examine air traffic radar and radio recordings, the aircraft wreckage, instruments and maintenance records, the emergency response, weather information, and witness reports (ATSB investigation AO-2012-130).

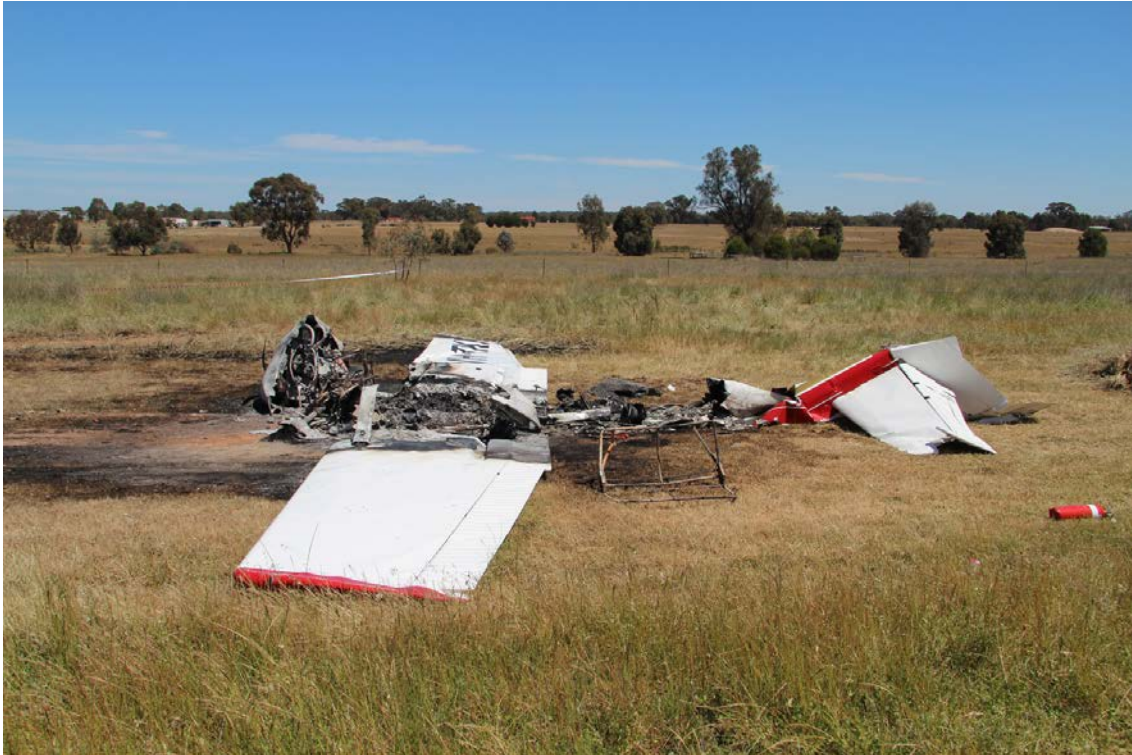
Wirestrike, Cessna 172N Skyhawk (VH-TKI), 9 km NE of Bendigo, Victoria (ATSB investigation AO-2012-142)

- On 29 October 2012, a Cessna 172N was being operated on a maintenance positioning flight from Coldstream, Vic. to a private airstrip at Bagshot, Vic. with a pilot and two passengers on board. The aircraft arrived in the circuit at Bagshot as another aircraft was on final approach to land from the south. A passenger in the aircraft reported that both the pilot and passengers were focussing on the aircraft that had just landed as they completed their circuit and commenced final approach. A witness at the airfield saw the Cessna contact a powerline while on short final approach, rotated over the powerline, and impacted the runway in an almost inverted attitude. A post-impact, fuel-fed fire destroyed the aircraft, and all occupants of the aircraft were injured, one fatally. The ATSB investigation into this accident was still underway at the time of writing, but found that the nose landing gear contacted the powerline. The powerline had no markers fitted, and was was not required to under the current Australian Standards for private landing strips. The owner of the landing strip advised he routinely advised pilots using the airstrip of the location of the powerlines, and that there was a need to land a significant distance down the airstrip if approaching from the south to avoid the powerlines (ATSB investigation AO-2012-142).

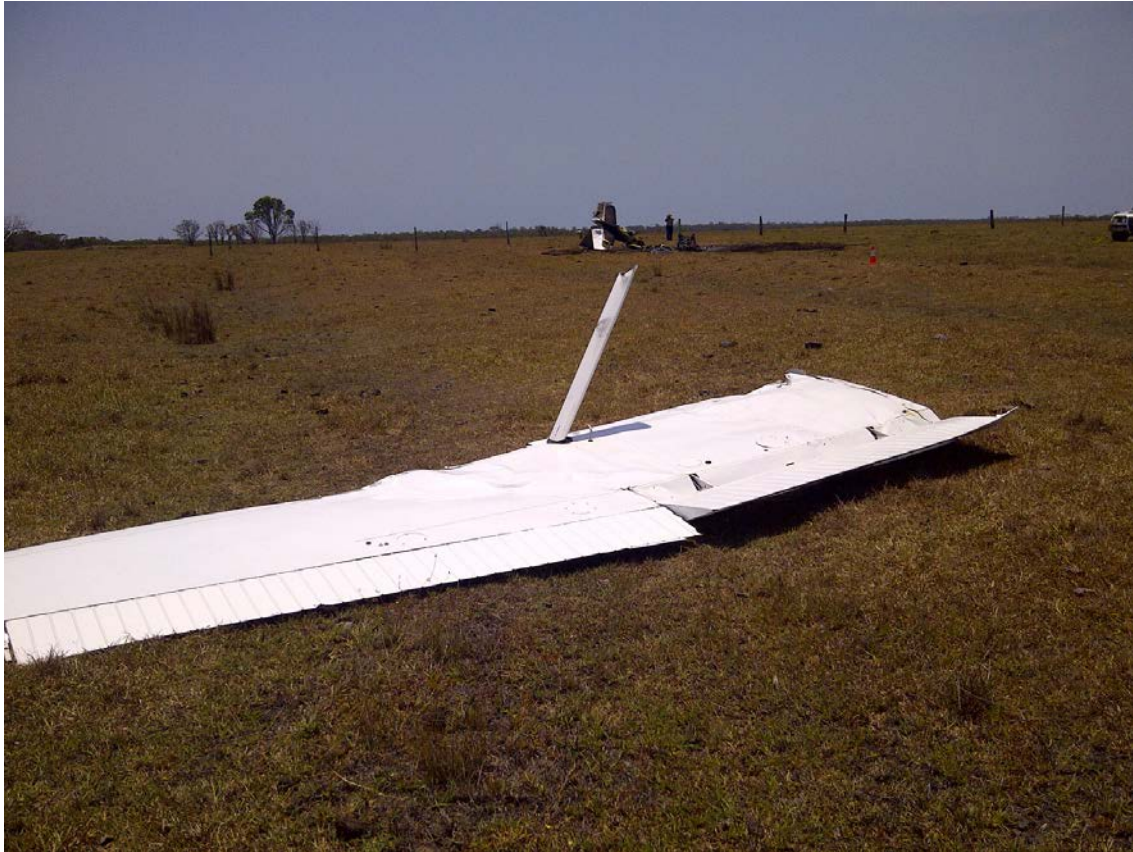
Collision with terrain, Cessna 182A Skylane (VH-SGB), Burrum Heads, Queensland (ATSB investigation AO-2012-170)

- On 17 December 2012, a Cessna 182A took off on a private flight from the pilot's own airstrip near Gympie, Qld. The pilot was flying in to a Christmas function at a parachute drop zone at Burrum Heads, about 100 km away, and was intending to land in a paddock about 1,500 m to the north of the drop zone. Several witnesses gathered at the drop zone saw the Cessna fly almost overhead at low altitude, and sever two powerlines at a height of about 9 m above the ground. The aircraft was then seen to climb, still trailing the cables, before turning slightly right and disappearing from sight behind trees. The ATSB investigation, which was still underway at the time of writing, found that the aircraft impacted the ground in a nose down attitude of almost 90° with little forward airspeed, and that the right wing had separated from the aircraft prior to impact. A post-impact, fuel-fed fire had consumed most of the wreckage and the pilot was fatally injured (ATSB investigation AO-2012-170).

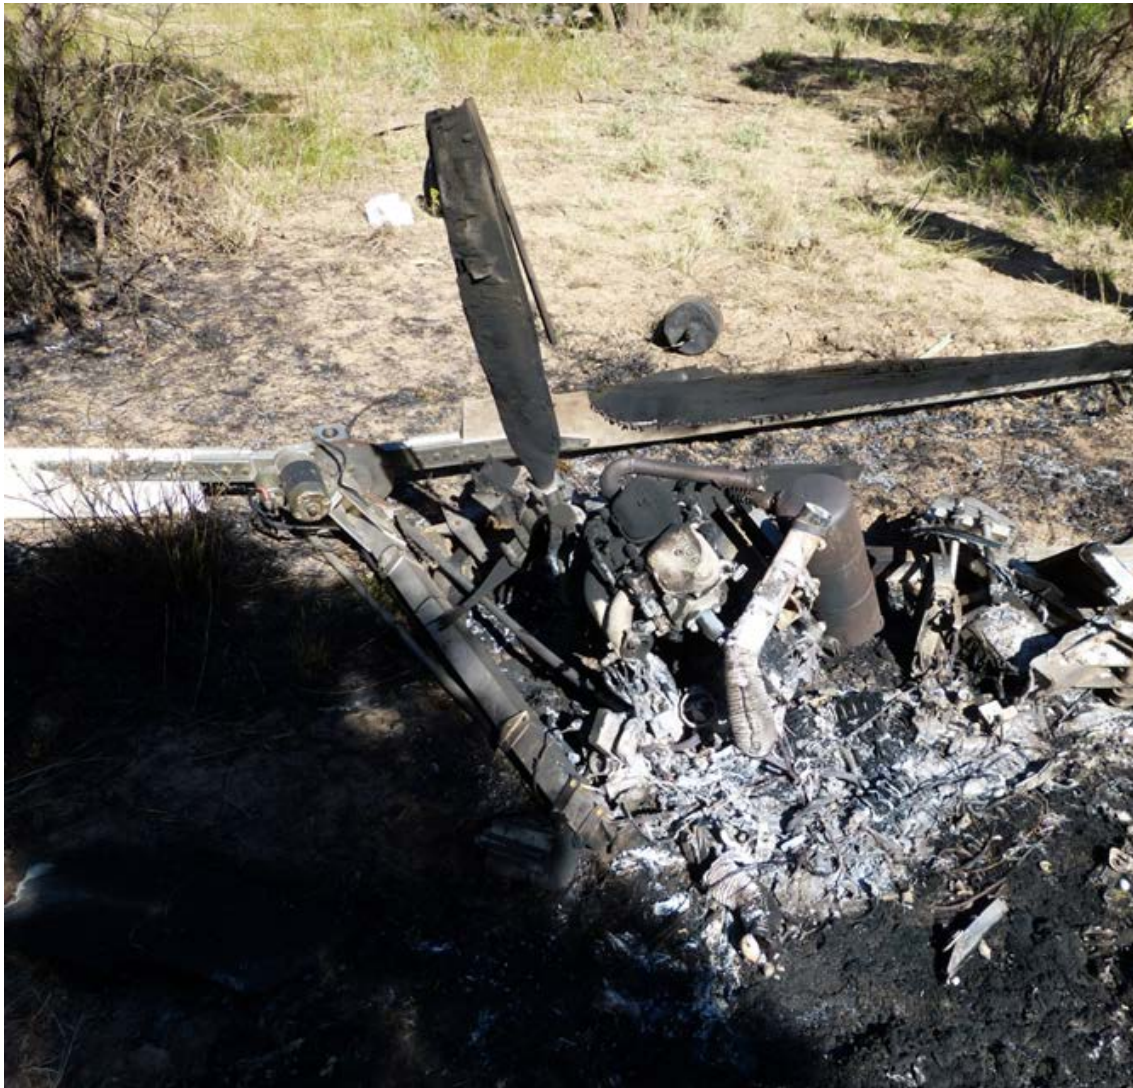
Collision with terrain, Gyroscopic Rotorcraft gyrocopter, near Bollon, Queensland (ATSB occurrence 201203961). Photo source: Australian Sports Rotorcraft Association

- On 6 May 2012, a Gyroscopic Rotorcraft gyrocopter collided with terrain at a cattle station near Bollon, Qld while conducting aerial mustering. The pilot, who was the sole occupant, was fatally injured, and the gyrocopter was destroyed by the impact and a post-impact fire. An investigation was conducted by ASRA into this accident. The ground party involved in the muster observed the gyrocopter 'swooping' down to attempt to move stubborn cattle, a manoeuvre that was considered as normal practice when using a gyrocopter for aerial mustering. The ground parties were generally able to keep the gyrocopter in sight, except during the swooping manoeuvres when they lost sight of it below the tree line. One witness observed the gyrocopter swoop down until obscured from view by the tree line, and then heard a 'crack' and observed smoke from where he had last seen the gyrocopter. The ASRA investigation identified that the pilot did not hold a current ASRA pilot licence, and that the gyrocopter's logbook was not up to date. An ELT was identified at the accident site, however, it was an older model of ELT that required manual activation, and was not activated in the accident. Investigators from ASRA determined from damage to the pilot's helmet and the propeller that during flight at or below tree top level, the helmet became dislodged due to a worn press stud used to fasten the helmet's chin strap, and passed through the arc of the propeller. The helmet was destroyed, and the propeller blade dislodged from its hub. It is likely that the pilot lost control of the gyrocopter at this point, and at low altitude, the gyrocopter rolled to the right and struck trees and terrain. The ATSB assisted ASRA by providing an assessment of a GPS unit that was located at the accident site, however, the unit was badly fire damaged and was unlikely to still contain useful data (ATSB occurrence 201203961).

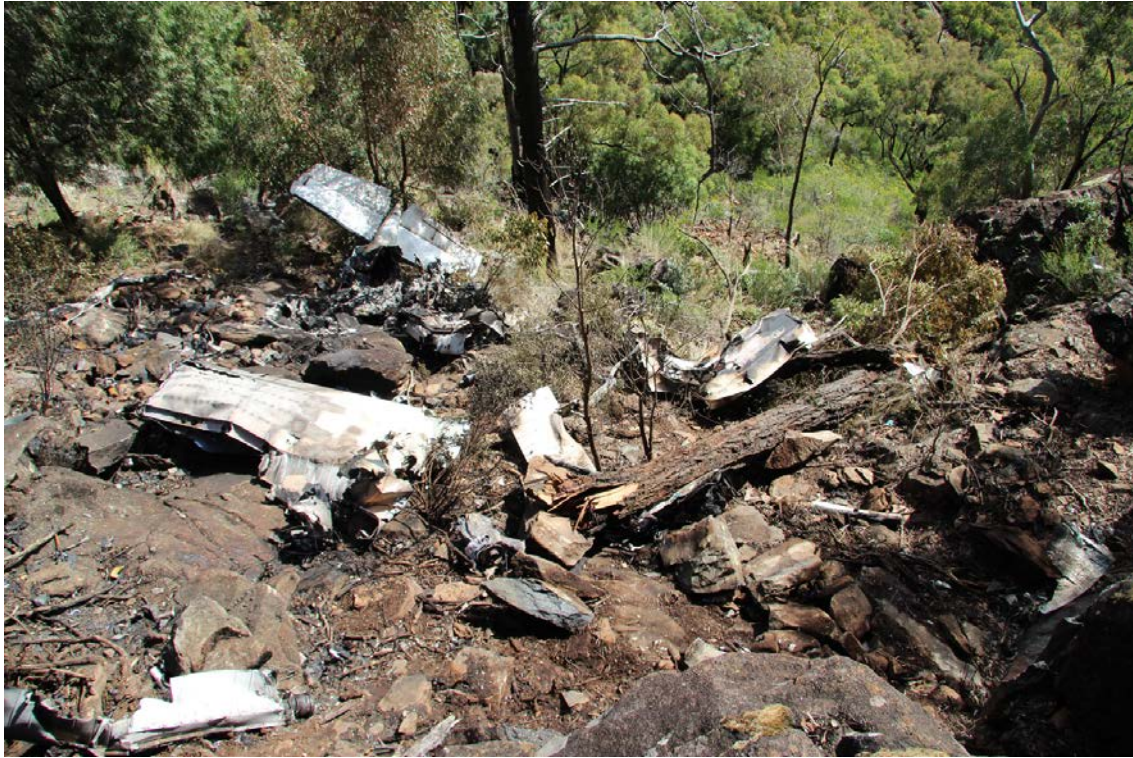
Visual flight rules in instrument meteorological conditions and controlled flight into terrain, Cessna 182Q Skylane (VH-CWQ), 15 km N of Tooraweenah, New South Wales (ATSB investigation AO-2012-076)

- On 4 June 2012, the pilot of a Cessna 182Q took off from Walgett, NSW in good weather conditions for a flight to Mudgee, initially climbing to 5,500 ft. During the flight, the cloud base lowered. About 25 minutes after the pilot departed, he rang a friend who lived near Mudgee, and asked for an appraisal of the weather there. The friend reported weather conditions suggesting that it might not be suitable to fly to Mudgee in VFR conditions. The friend recalled that the pilot said that if the weather conditions deteriorated too much, he would turn around and return to Walgett. For the next 10 minutes, the pilot continued to descend until the aircraft was flying about 1,000 ft above flat terrain, either close to or in the base of the cloud. The terrain ahead and to the left of this track continued to rise to an altitude significantly above that at which the aircraft was flying. About 13 minutes later, the aircraft impacted a rock face in the Warrumbungles near Tooraweenah, NSW, destroying the aircraft and fatally injuring the pilot. The ATSB investigation into this accident found that the risk to flight was increased by

deteriorating weather conditions, and the pilot was probably flying with forward visibility sufficiently obscured by cloud to not be able to see and avoid the rising terrain. In addition, the pilot did not select a flight track to avoid the rising terrain, or conduct a diversion to a suitable aerodrome, which would have been an effective measure to manage the deteriorating weather. The ATSB *Avoidable Accidents* publication *Accidents involving Visual Flight Rules (VFR) pilots in Instrument Meteorological Conditions* is a good reminder to pilots of the insidious risks associated with reduced forward visibility when flying in or near the cloud base (ATSB investigation AO-2012-076).
