# Aviation Occurrence Statistics 2003 to 2012

## ATSB Transport Safety Report

Aviation Research Report

AR-2013-067

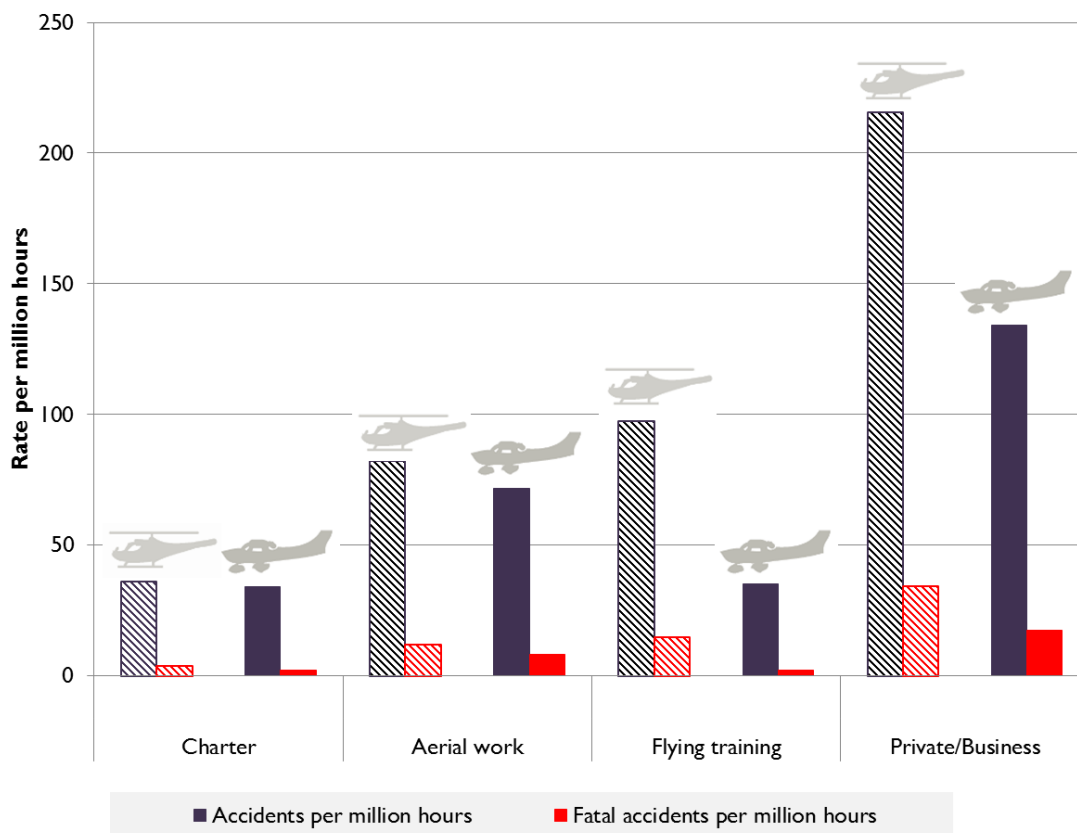
**Figure 18: Rate of accidents and fatal accidents by operation and aircraft type, 2003 to 2011**

When comparing the accident rate of aeroplanes and helicopters by operation type, there is significant difference between some types of GA operations (Table 25 and Figure 18). Flying activity data is not yet available for recreational aviation in Australia.

Aeroplanes and helicopters involved in charter air transport operations had similar accident rates (34 versus 36 accidents per million hours flown over the last 10 years).

The fatal accident rate over the last 10 years for helicopter flying training was more than seven times higher than that for aeroplanes being used for training (about 15 fatal accidents per million hours flown, compared to 2 fatal accidents per million hours flown for aeroplanes), although the number of fatalities was lower for helicopter fatal accidents. A review of the fatal accidents involving helicopters involved in flying training since 2003 found that most involved a loss of control from a hover, or a catastrophic failure in-flight (such as the loss of rotor blade). In both of these situations, an irrecoverable loss of control and collision with terrain was likely, even if the pilot was experienced. In comparison, fatal flying training accidents involving aeroplanes often involved collisions with other aircraft, or objects on the ground during a forced landing or runway excursion.

Helicopters performing private or business flying had an accident rate over the last 10 years that was about 50 per cent higher than that for aeroplanes (about 216 accidents per million hours for helicopters, compared to 134 per million hours flown for aeroplanes).

Helicopters also had a higher fatal accident rate, with about twice as many fatal accidents involving helicopters than aeroplanes when corrected for flying activity (34 versus 17 fatal accidents per million hours flown). There were, however, significantly more fatalities in those fatal accidents involving aeroplanes than in helicopter accidents. The difference in the number of accidents between helicopters and aeroplanes is reflective of the difference in their use in private and business flying – in 2011, aeroplanes in Australia were utilised for about 327,000 hours of private and business flying, whereas helicopters flew less than 56,000 hours in this type of operation.

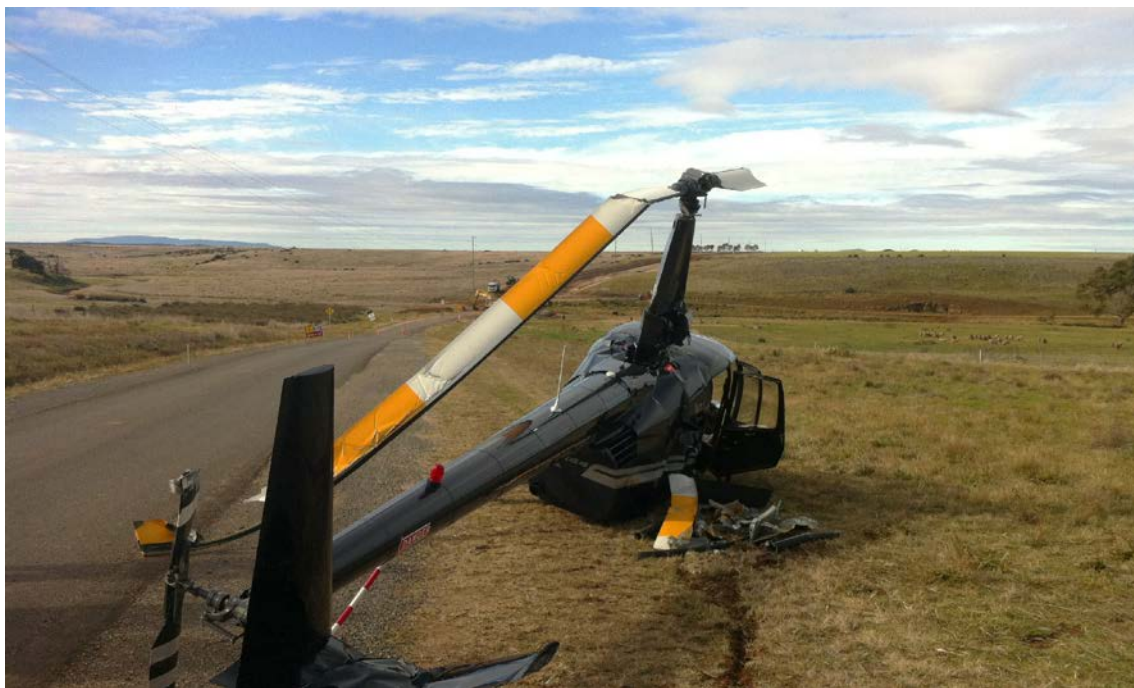
Wirestrike, Robinson R44 Raven I helicopter (VH-HIE), 21 km E of Maryborough Airport, Victoria (ATSB investigation AO-2012-079)

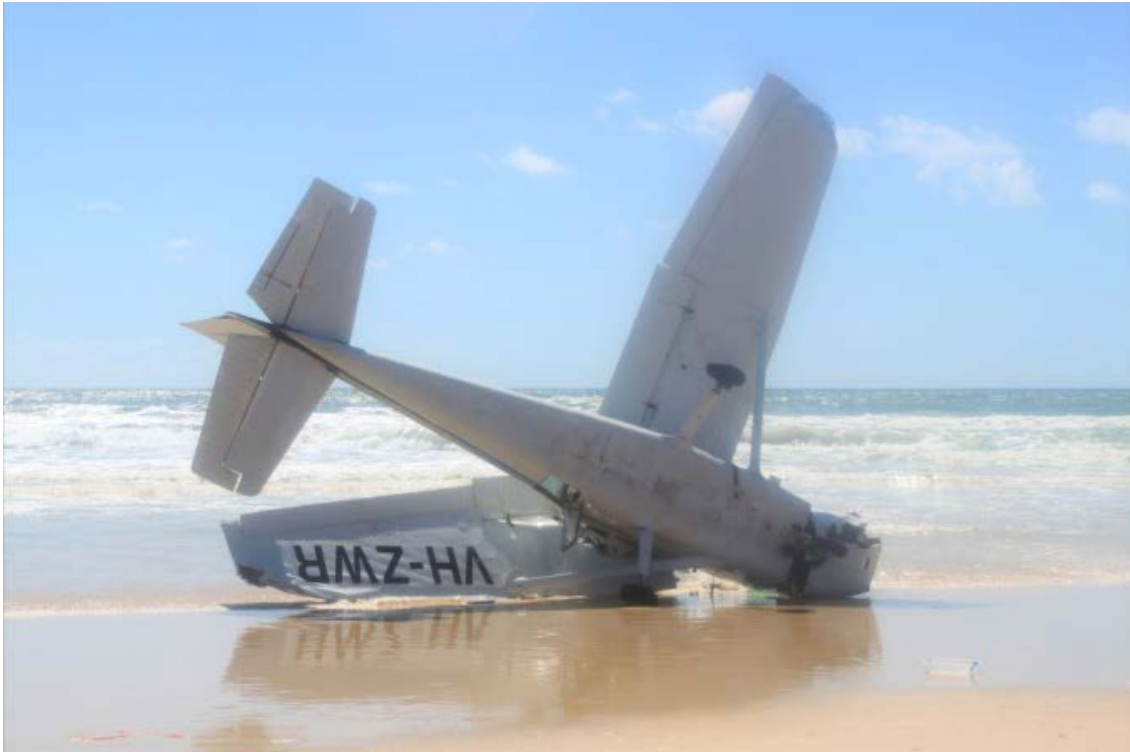
Collision with terrain, Cessna 172N Skyhawk (VH-ZWR), The Oaks, 6 km S of Happy Valley, Fraser Island, Queensland (ATSB investigation AO-2012-007)

- A Cessna 172N aircraft was taking off from Happy Valley airstrip, Qld to conduct a visual flight rules charter flight with the pilot and three passengers on board. After takeoff at about 25 to 30 ft above ground level, the aircraft descended and impacted the ground. The ATSB investigated

this accident, and found that the circumstances of the aircraft's descent were consistent with an aerodynamic stall as it climbed out of ground effect while flying at an airspeed and configuration where the airspeed would not normally remain constant (ATSB investigation AO-2012-007).

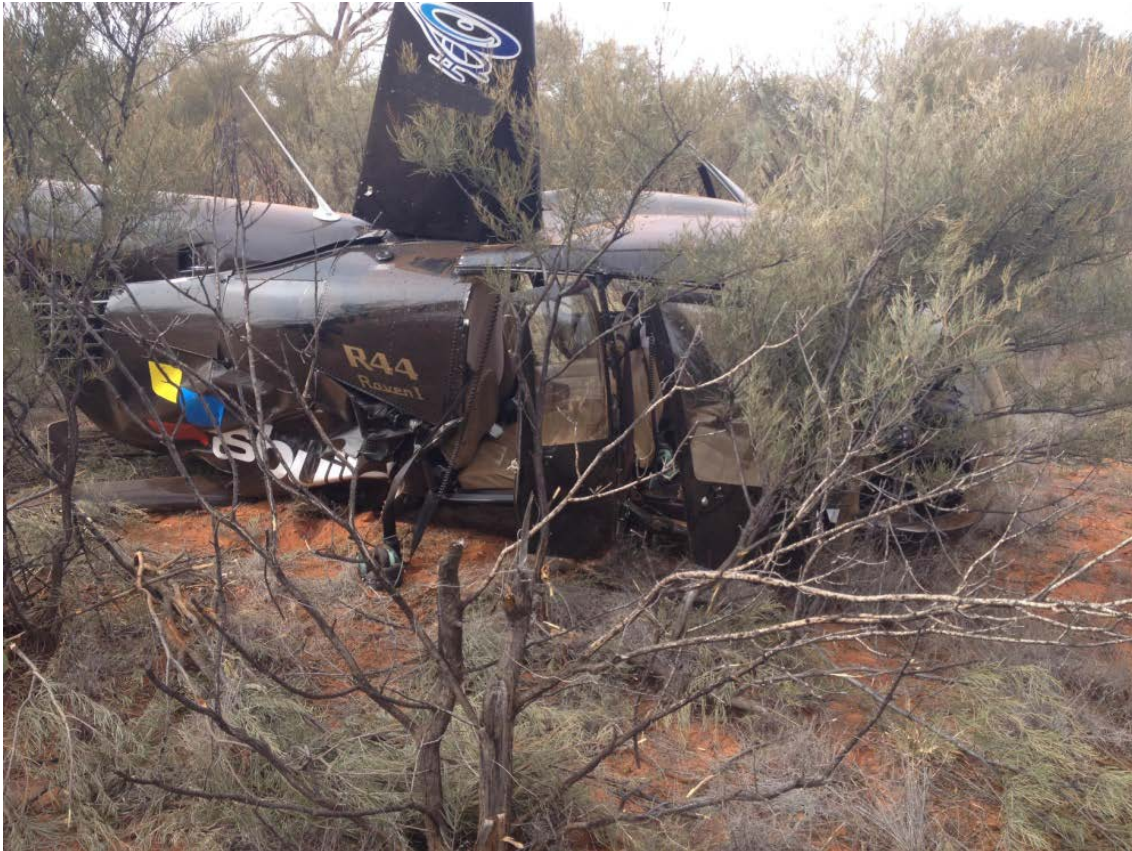
Collision with terrain, Robinson R44 Raven I helicopter (VH-HOU), near Maryvale, Northern Territory (ATSB investigation AO-2012-078)

- During a manoeuvre to slow down the helicopter by initiating a descent and flare, the Robinson R44 was seriously damaged when it lost power and collided with terrain near Maryvale, NT. On board the helicopter were a pilot and three passengers, one of whom was seriously injured as a result of the accident. The ATSB investigated this accident, and while a definitive cause for the engine power loss could not be identified, a review of the carburettor icing chart for the R44 revealed that the temperature / dew point spread at the time of the accident put the flight in the 'Serious Icing – Descent Power' operating realm (ATSB investigation AO-2012-078).

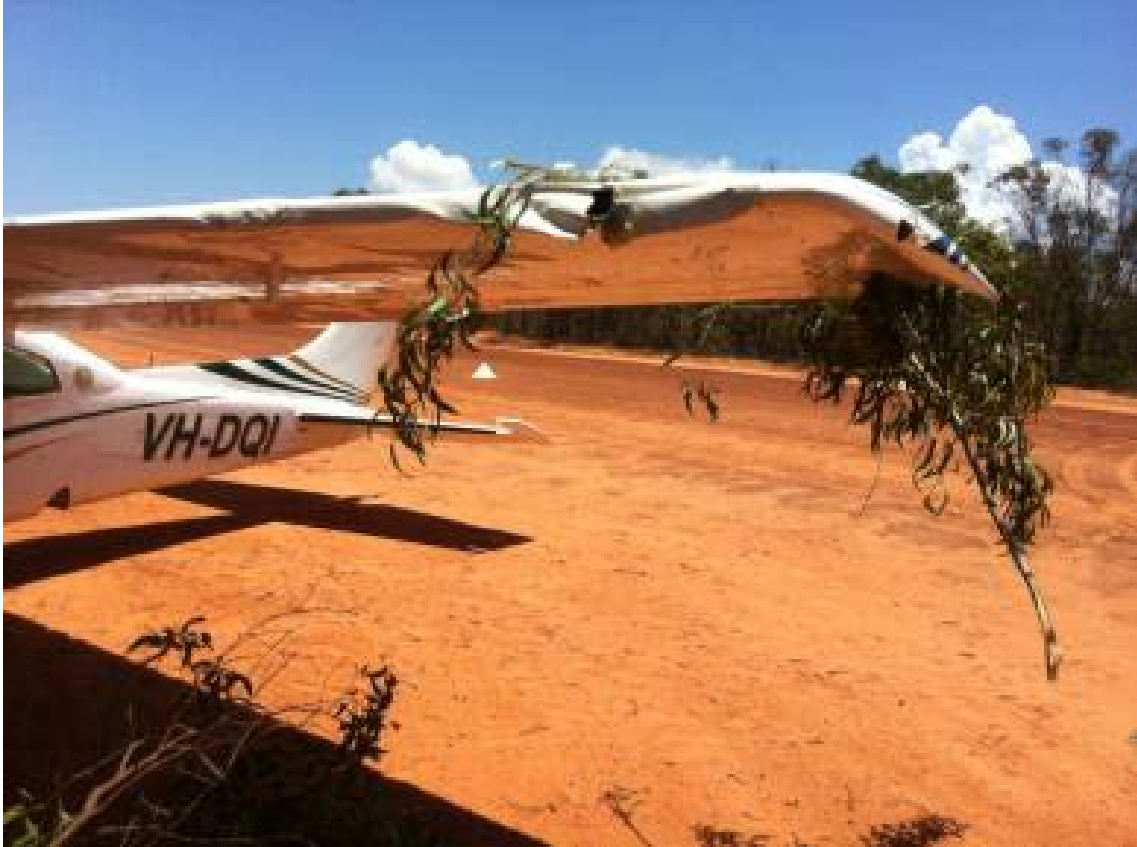
Runway excursion, Cessna T210 Centurion (VH-DQI), Cape Leveque, Western Australia (ATSB investigation AO-2013-001)

- Another Cessna 210 was departing from Cape Leveque, WA on the return leg of a scenic charter. On board were the pilot and five passengers. Early in the take-off run, the aircraft veered to the left, and the pilot applied right rudder. The pilot elected to continue the takeoff. At about 45 kts, the aircraft again veered to the left. With the aircraft about one metre off the centreline of the runway, the pilot attempted to re-align the aircraft, but it did not respond. The aircraft main wheels were now in contact with washed-out areas of ground on the edge of the runway. The aircraft's left wing clipped trees and the Cessna swung almost 90°, striking the right wing on the ground. The ATSB conducted an investigation into this accident, and the airport operator closed the airstrip the day after the accident to grade the runway surface and repair the washouts (ATSB investigation AO-2013-001).
