# Aviation Occurrence Statistics

2004 to 2013

## ATSB Transport Safety Report

AR-2014-084

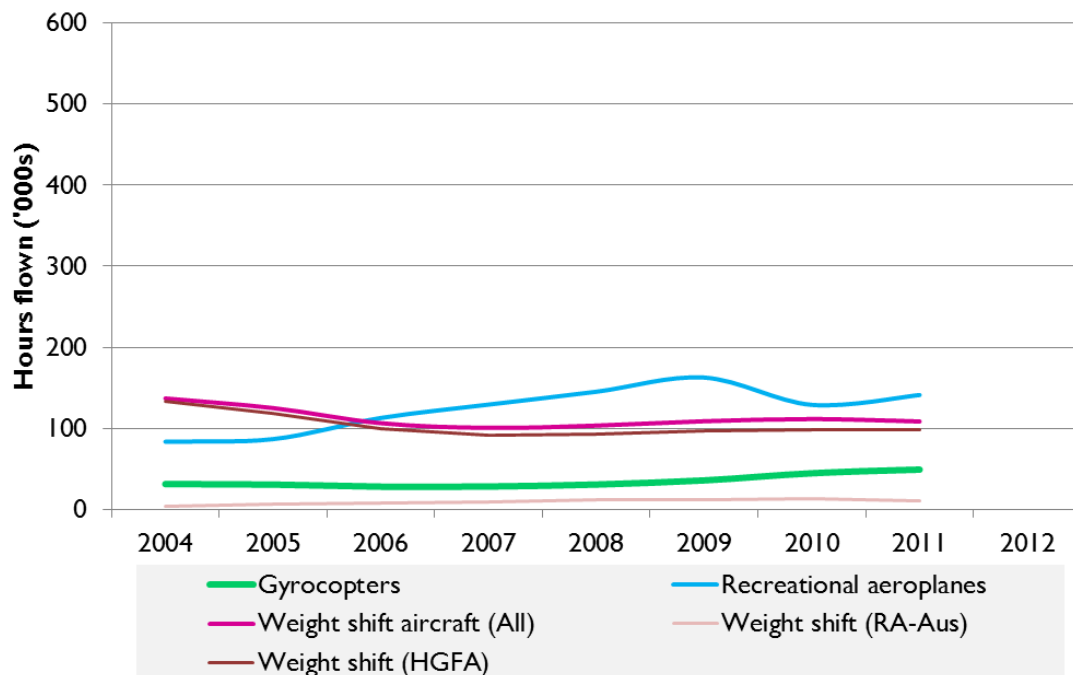
**Figure 6: Hours flown in recreational aviation, 2004 to 2012**

Activity data (hours flown) is now available for Australian (non-VH) recreational aviation for limited years. Figure 6 shows a comparison of flying activity across different types of RAAO, as reported by each RAAO to the BITRE. For most types of recreational aviation, data was not available for 2012 at the time of publication. RA-Aus registered recreational aeroplanes have shown a significant growth in flying hours over the last 10 years, with two-thirds more hours reported in 2011 when compared to 2004. This is notably higher than other common flying operations, such as high capacity RPT (42 per cent increase over this period), aerial work (24 per cent increase), charter (1 per cent increase), flying training (10 per cent increase), and private and business (decrease of eight per cent over this period). Recreational aeroplane activity differed from other types of recreational flying which showed only a small increase (gyrocopters registered with ASRA) or decreased (weight shift aircraft registered with HGFA) over a similar period.

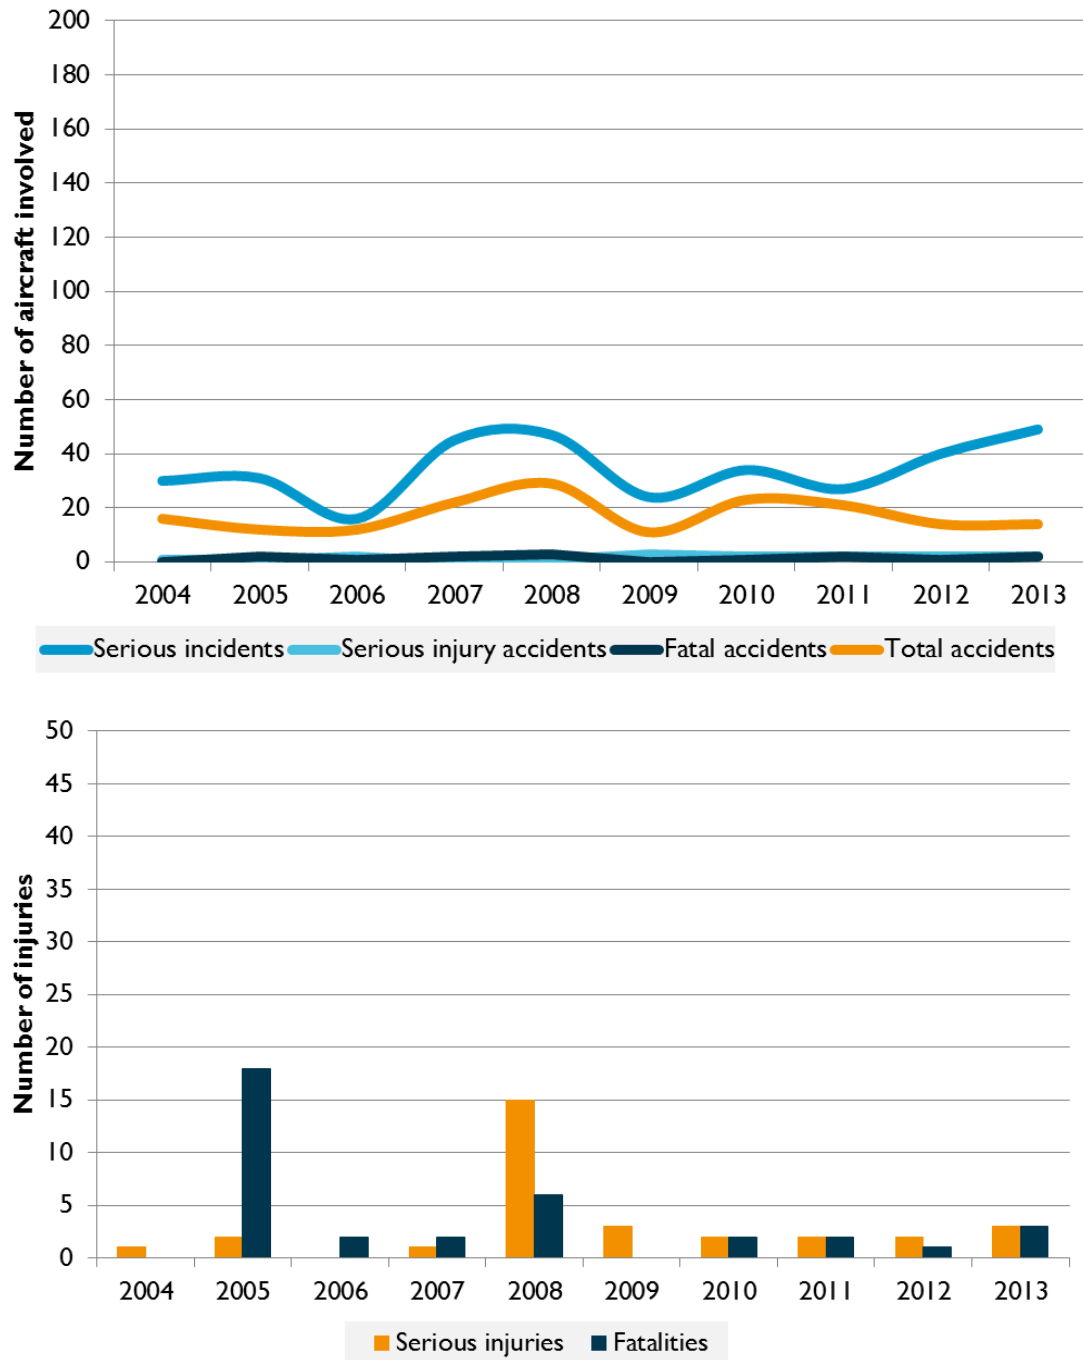
**Figure 8: Commercial air transport occurrences and injuries, 2004 to 2013**

Serious incidents are indicators of events that almost led to accidents. As such, they represent occurrences which could have had more serious consequences. The number of serious incidents in 2013 in commercial air transport was higher than average, and was the highest number in the last 10 years (Figure 8). Compared to 2012 (where a rise in serious incidents was contained to charter operations), the number of serious incidents in high capacity RPT almost doubled.

2004	2005	2006	2007	2008	2009	2010	2011	2012	2013
<b>Number of aircraft involved</b>										
Incidents	2,760	3,229	2,982	3,059	3,216	3,038	3,375	3,885	4,067	4,261
Serious incidents	30	31	16	45	47	24	34	27	40	49
Serious injury accidents	1	1	2	0	1	3	2	2	2	2
Fatal accidents	0	2	1	2	3	0	1	2	1	2
Total accidents	16	12	12	22	29	11	23	21	14	14
<b>Number of people involved</b>										
Serious injuries	1	2	0	1	15	3	2	2	2	3
Fatalities	0	18	2	2	6	0	2	2	1	3
<b>Rate of aircraft involved</b>										
Accidents per million departures	13.1	9.2	9.5	16.7	22.3	8.7	16.7	15.2	9.9	N/A
Fatal accidents per million departures	0	1.5	0.8	1.5	2.3	0	0.7	1.4	0.7	N/A

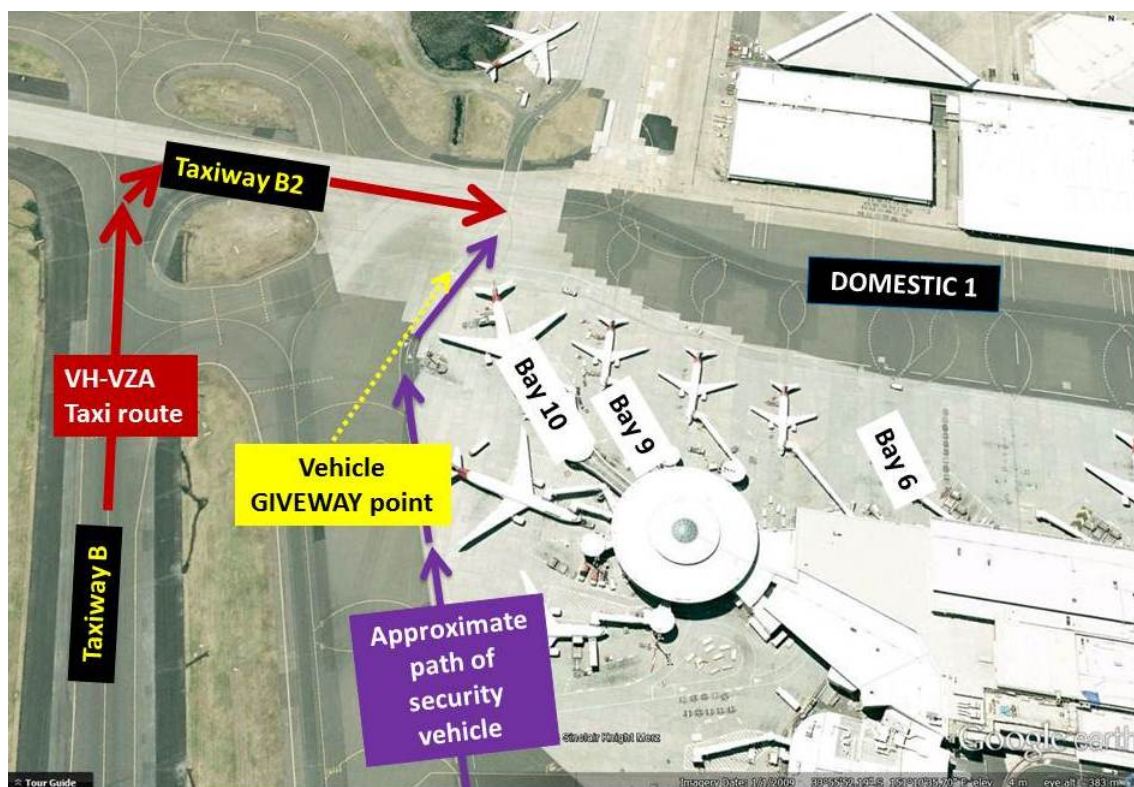
- During the taxi to the parking bay area at Cairns Airport, the captain of a Qantas Boeing 737 observed the lights of a security vehicle approaching about 50 m from the right side of the aircraft near the intersection of the airside road and taxiway B2. The captain thought the vehicle would continue along the airside road, however, as the car continued in a northerly direction across the intersection the captain believed it was on a collision course with the Boeing. Realising the vehicle driver had not seen the aircraft, the captain immediately stopped the aircraft. The security vehicle continued toward the aircraft, then came to an abrupt stop about 10 m to the right of the aircraft's nose. The ATSB investigation determined that the vehicle driver had slowed down as he approached the taxiway B2 intersection and looked towards the taxiway on his left, but did not see the lights of the Boeing and continued to drive into the parking bay area to the right assuming the area was clear (ATSB investigation AO-2013-135).

Ground proximity event between Boeing 737-800 (VH-VZA) and a security vehicle at Sydney Airport, New South Wales (ATSB investigation AO-2013-135) – diagram shows the relative positions of the aircraft and vehicle

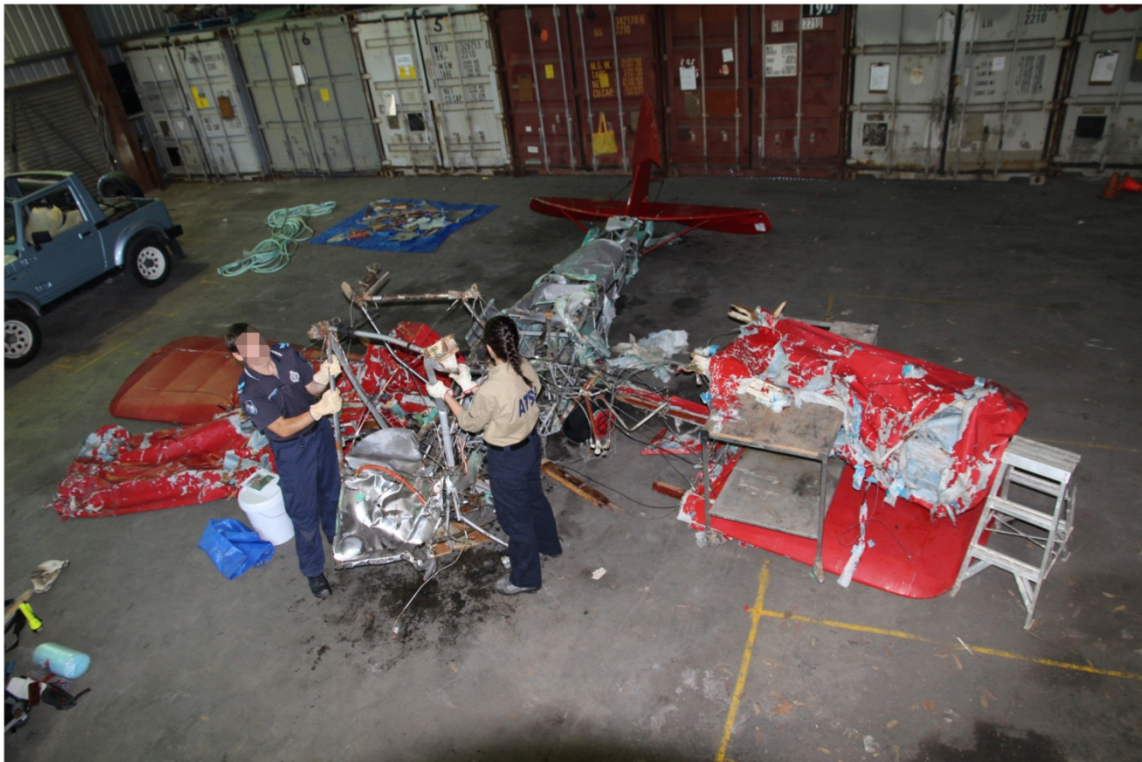
- A de Havilland DH.82A Tiger Moth took off from Pimpama, Qld with a pilot and passenger on board to conduct a joy flight in the Gold Coast area. Shortly after the pilot commenced aerobatics, the aircraft's left wings failed and it descended steeply into the water about 300 m from the eastern shoreline of South Stradbroke Island. The aircraft was destroyed and both occupants fatally injured. Preliminary examination of the wreckage by the ATSB indicated that both of the aircraft's fuselage lateral tie rods (which join the lower wings to the fuselage) had fractured, despite a service life for these parts that was significantly less than the published retirement life for DH.82A tie rods. The fractures occurred at areas of significant, pre-existing fatigue cracking in the threaded section near the join with the left wing. The ongoing ATSB investigation will examine whether the failure of the fuselage lateral tie rods, or another mode of wing structural failure, was the initiator of the left wing separations. The ATSB has released a Safety Advisory Notice to all Tiger Moth operators, the Civil Aviation Safety Authority (CASA), the tie rod manufacturer, the New Zealand and United Kingdom aviation authorities advising of the premature failure of the tie rods in this accident (ATSB investigation AO-2013-226).

In-flight break-up involving de Havilland DH.82A Tiger Moth (VH-TSG), South Stradbroke Island, Queensland (ATSB investigation AO-2013-226)

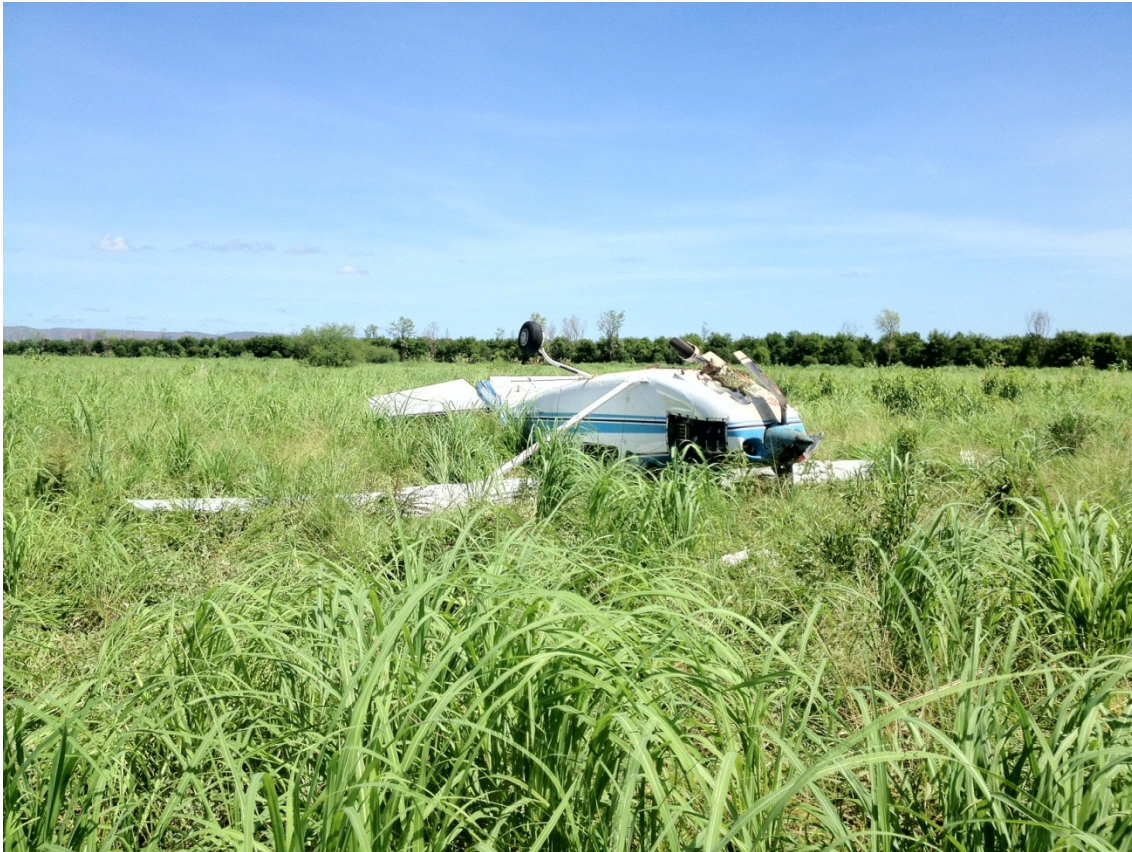
Engine failure involving a Cessna 182R Skylane (VH-OWZ), Kununurra Airport, Western Australia (ATSB investigation AO-2013-023)

- A Cessna 182R took off from Kununurra Airport, WA on a charter flight with one passenger. When at about 100 ft above ground level, with insufficient runway distance remaining to abort the takeoff, the pilot retracted the landing gear. Immediately after, the engine failed. Due to the low altitude, the pilot confirmed that the engine controls were in the full forward position and that the fuel tank selector was on 'both'. The pilot then looked for a suitable place to land and saw a suitable field to the north. After extending the landing gear and selecting full flap, the main landing gear touched down in long grass and the aircraft decelerated rapidly. When the nose gear touched down, it dug into boggy ground and the aircraft flipped over, coming to rest inverted. The pilot and passenger received minor injuries and the aircraft sustained substantial damage. An engineering examination of the aircraft found no contaminants in the fuel or filters, and could not determine the reason for the engine failure (ATSB investigation AO-2013-023).

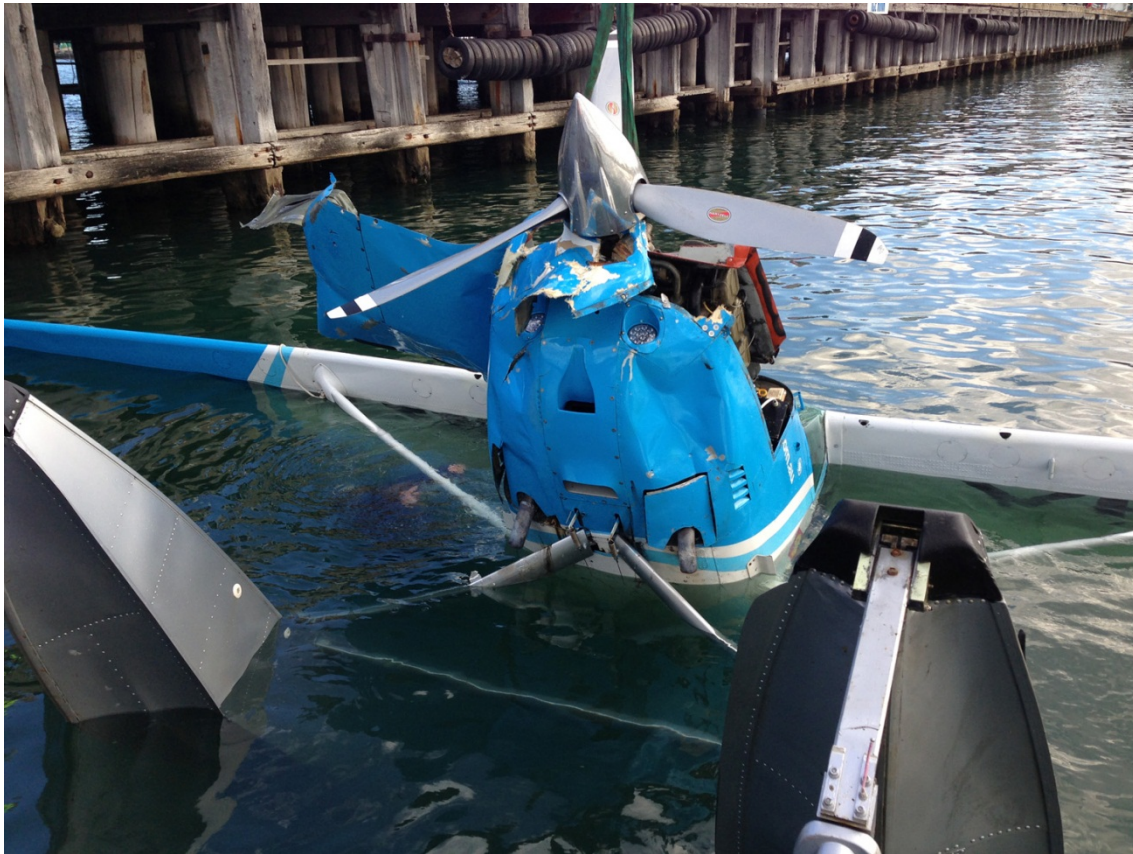
Wheels-down water landing involving a Cessna U206F Stationair floatplane (VH-UBI), Corio Bay, Victoria (ATSB investigation AO-2013-020)

- A Cessna U206F amphibious aircraft was conducting a seaplane joy flight from Corio Bay, Vic. with two passengers on board. During the flight the pilot refuelled the aircraft at Barwon Heads Airport, necessitating the use of the landing wheels. On the return trip, the pilot detoured for local sightseeing before heading back to Corio Bay for a water landing. On touchdown, the aircraft pitched over and came to rest inverted. The pilot assisted the two passengers to evacuate the aircraft before rescue vessels arrived. All three occupants sustained minor injuries, and the aircraft was substantially damaged. The ATSB investigation found that the pilot was distracted during the departure from Barwon Heads, and as a result did not retract the landing wheels during the after take-off checks. On returning to Corio Bay, the pilot shortened the approach due to perceived time pressure and did not complete the normal downwind and short final checks. In not completing those checks, the pilot reduced the likelihood of identifying that the landing wheels were still extended. The operator's requirement for passengers to wear life jackets throughout the flight enhanced the survivability of the passengers (ATSB investigation AO-2013-020).

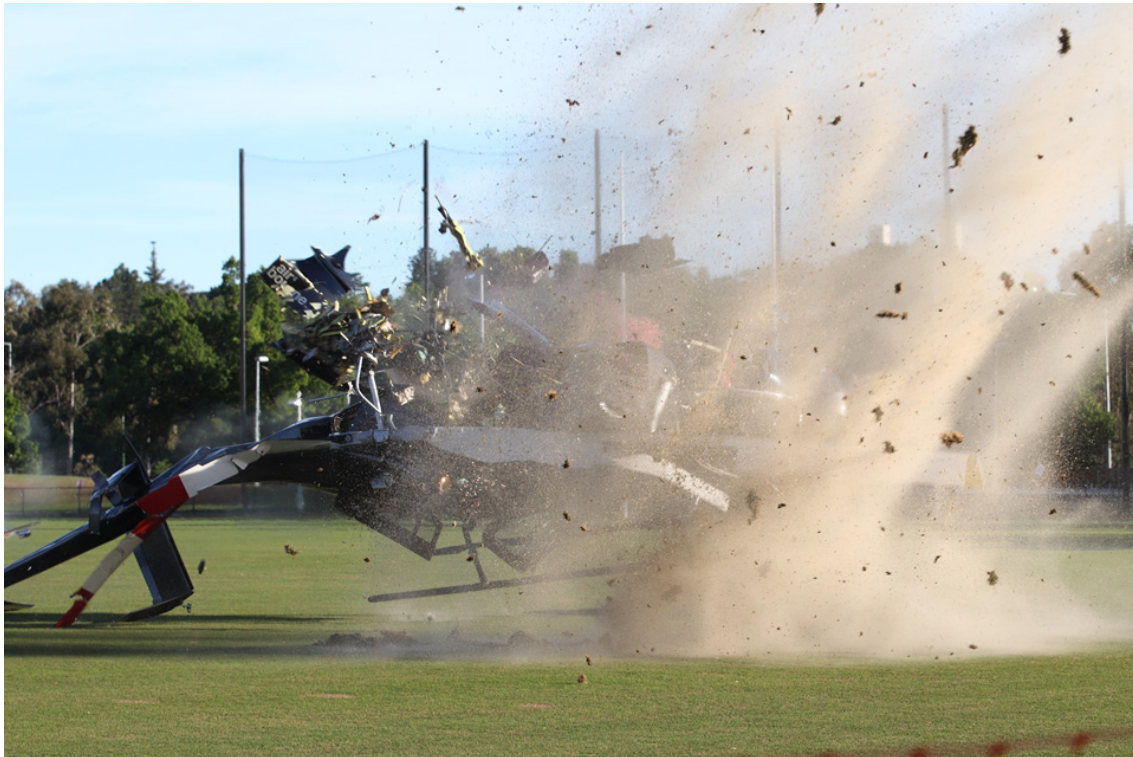
Collision with terrain involving a Bell 206L helicopter (VH-VDZ), Melbourne, Victoria (ATSB investigation AO-2013-199) – picture shows right roll and main rotor ground strike

- A Bell 206L helicopter was conducting passenger ferry operations between Olympic Park and Flemington racecourse in Melbourne. Prior to the accident, the pilot was preparing to reposition the helicopter from one of the temporary helipads on the western side of the oval to a position that would allow the helicopter to depart for the racecourse. As the pilot began to lift the helicopter into a hover, witnesses observed the helicopter commencing to roll about the right skid. In rapid succession the left skid continued to rise and the helicopter rolled further right until the helicopter's main rotor blades contacted the ground. A large amount of high energy debris was released from the helicopter and impacted a nearby marquee and vehicles, including the helicopter on the adjacent helipad. The helicopter was extensively damaged, but no bystanders or persons in the cars or marquee were injured. The pilot sustained minor injuries and was able to exit the wreckage. The ATSB is currently investigating this accident and will be reviewing the planning of the charter operation, including the consideration of public safety. In the interim, the ATSB advises owners, operators and pilots of aircraft involved in public events to review their operations to assure themselves that existing risk controls address the hazards associated with operating aircraft in such environments (ATSB investigation AO-2013-199).

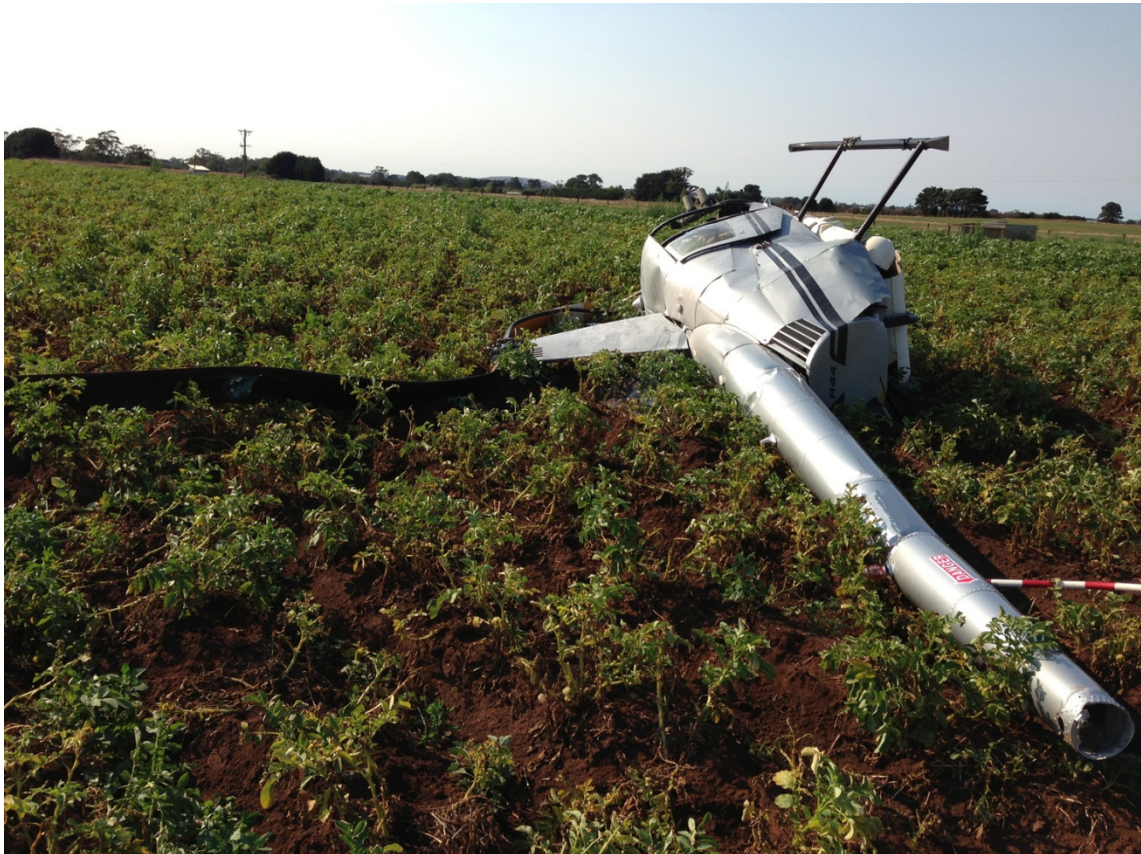
Wirestrike involving a Robinson R44 helicopter (VH-HGF), near Ballarat, Victoria  
(ATSB investigation AO-2013-042)

- A Robinson R44 helicopter was engaged in agricultural operations in a paddock near Clarks Hill, Vic. As the helicopter approached the paddock from the south at 50 kt and at spray height, the pilot remembered a wire that extended halfway across the southern boundary of the paddock to a pump house. The pilot judged that it was too late to attempt to pull up over the wire and attempted to avoid the wire by flying underneath it. The vertical stabiliser contacted the wire and the tail rotor gearbox separated from the tail boom. The pilot was able to exit the helicopter with minor injuries, however, the helicopter was substantially damaged (ATSB investigation AO-2013-042).

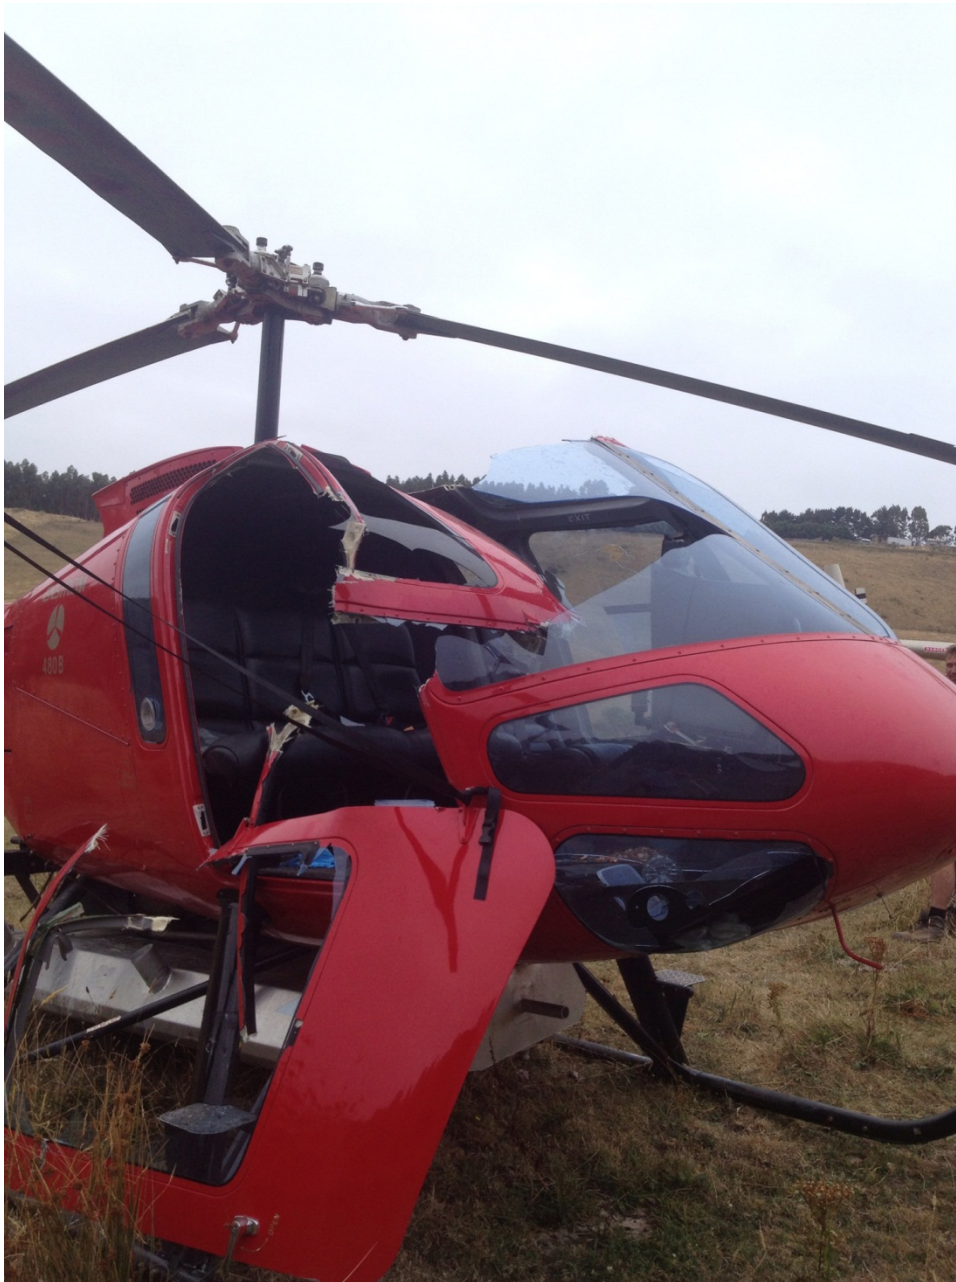
Wirestrike involving an Enstrom 480B helicopter (VH-VDC), near Ballarat, Victoria  
(ATSB investigation AO-2013-031)

- An Enstrom 480B helicopter was engaged in aerial spraying near Trinda, Vic. During the application run to spray the final load of chemical to the paddock, the Global Positioning System (GPS) lost reception. The pilot immediately aborted the run and climbed to about 400 ft above ground level and attempted to resolve the issue with the GPS. Once the GPS regained

reception, the pilot commenced a left turn at about 50 kt indicated airspeed to return to the paddock and recommence the application run. The pilot then heard a loud bang and felt a shudder through the airframe as the helicopter struck a wire. The pilot performed a run-on landing in the nearest clearing but had difficulty in maintaining yaw control because the tail rotor control cables had lost tension. The pilot was able to exit the helicopter without injury, however, the helicopter was substantially damaged. The ATSB was advised by the owner of the wire that it was marked with five marker discs, however, the pilot advised that the wire was unmarked at the time of the wirestrike. The ATSB investigation was unable to independently confirm that the marker discs were still in place at the time of the wirestrike. As a result of this accident, the wire was replaced and arrangements are being made to install markers on the line (ATSB investigation AO-2013-031).

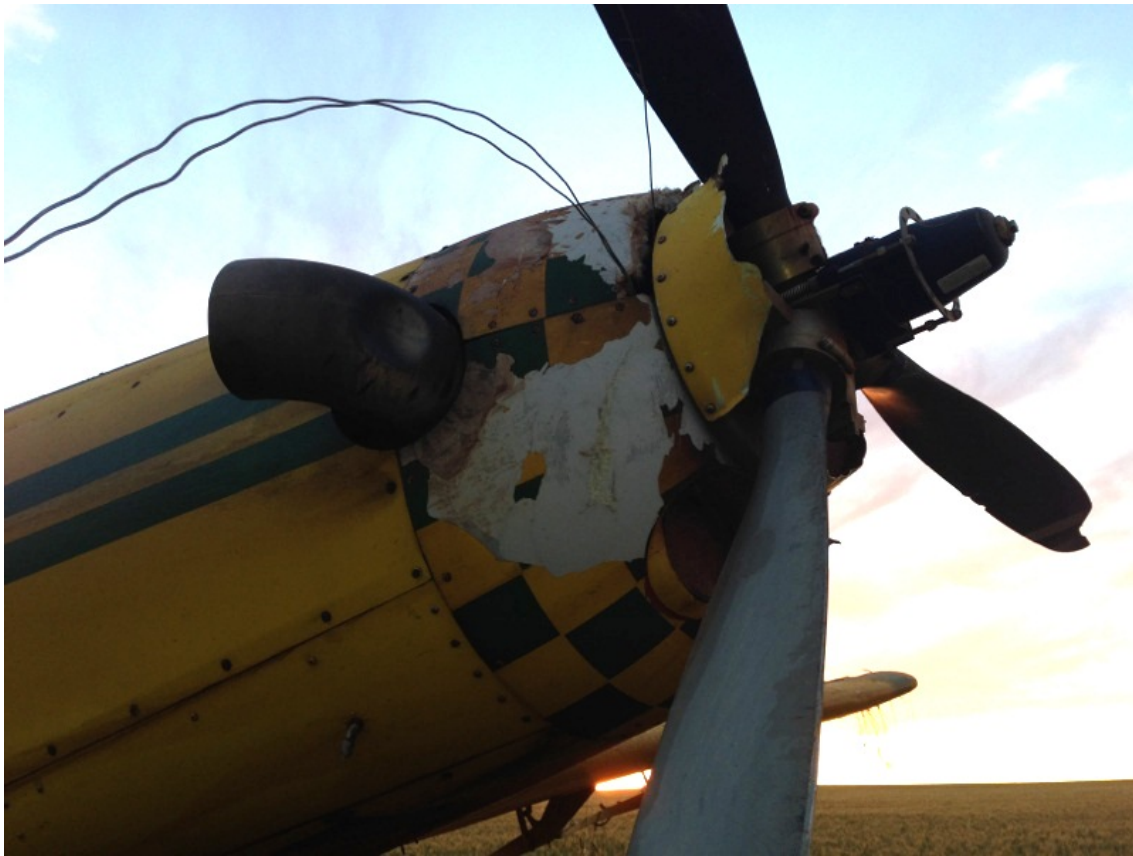
Wirestrike involving an Air Tractor AT-502 (VH-CJY), near Temora, New South Wales (ATSB investigation AO-2013-180)

- The pilot of an Air Tractor AT-502 was preparing to conduct aerial spraying on a property near Temora, NSW. The owner of the property had provided the pilot with a map of the area to be sprayed, which included power lines. There was a road and a row of trees to the south of the

paddock, with double power lines (marked on the map) about 130 m north of the tree-line. The pilot planned to fly over the trees and under the power lines on each leg, before turning to commence the next run. When the Air Tractor was south of the paddock at about 15 to 20 ft AGL, after turning to commence the next run, the pilot saw a cross arm indicating the presence of a wire attached to a derelict homestead. He decided not to climb the aircraft as it would have collided with the larger double power lines. The pilot then heard a bang, with the aircraft's propeller spinner contacting the wire. The pilot flew the aircraft under the double power lines and climbed to about 150 ft AGL. The engine was vibrating and then steadily lost power. The pilot secured the engine and conducted a forced landing in a paddock, during which the Air Tractor ground-looped and the left wing contacted the ground. The aircraft was substantially damaged but the pilot was not injured. The pilot reported to the ATSB that he did not see the wire at any stage, nor was it marked on the map provided to the pilot by the property owner (ATSB investigation AO-2013-180).

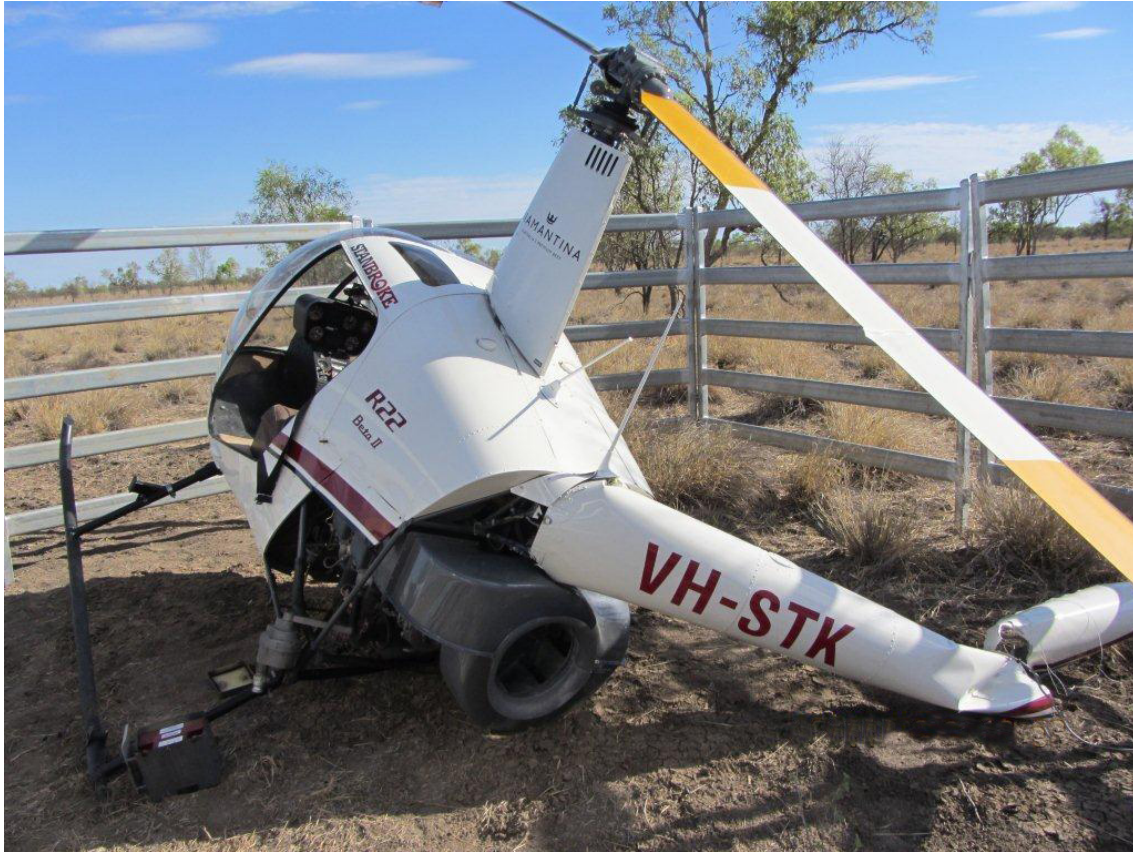
Total power loss involving a Robinson R22 helicopter (VH-STK), 155 km south-west of Normanton, Queensland (ATSB investigation AO-2013-211)

- A Robinson R22 helicopter was being used for mustering cattle on a property about 155 km from Normanton, Qld. As the helicopter was hovering behind a herd of cattle, the pilot felt the helicopter jerking. Suspecting an ignition system problem, he landed and checked the magnetos. On selecting the left magneto, the engine rapidly lost power, whereas the engine ran normally on selecting the right magneto. He reselected the magneto switch to 'BOTH' and attempted to contact the property manager. Unable to make contact with the manager, the pilot elected to take-off, and once airborne was able to communicate with the manager via UHF radio. He turned the helicopter towards a road and commenced an approach to land on the road. At about 20 ft AGL, the engine stopped. The pilot lowered the collective and flared the helicopter for landing. On impact, the helicopter spun around 180° and was substantially damaged, but the pilot was not injured. An engineering inspection of the left magneto revealed that a loose distributor bushing and play in the plastic gear wheel resulted in the magneto providing the ignition spark to an incorrect engine cylinder at the wrong time (ATSB investigation AO-2013-211).

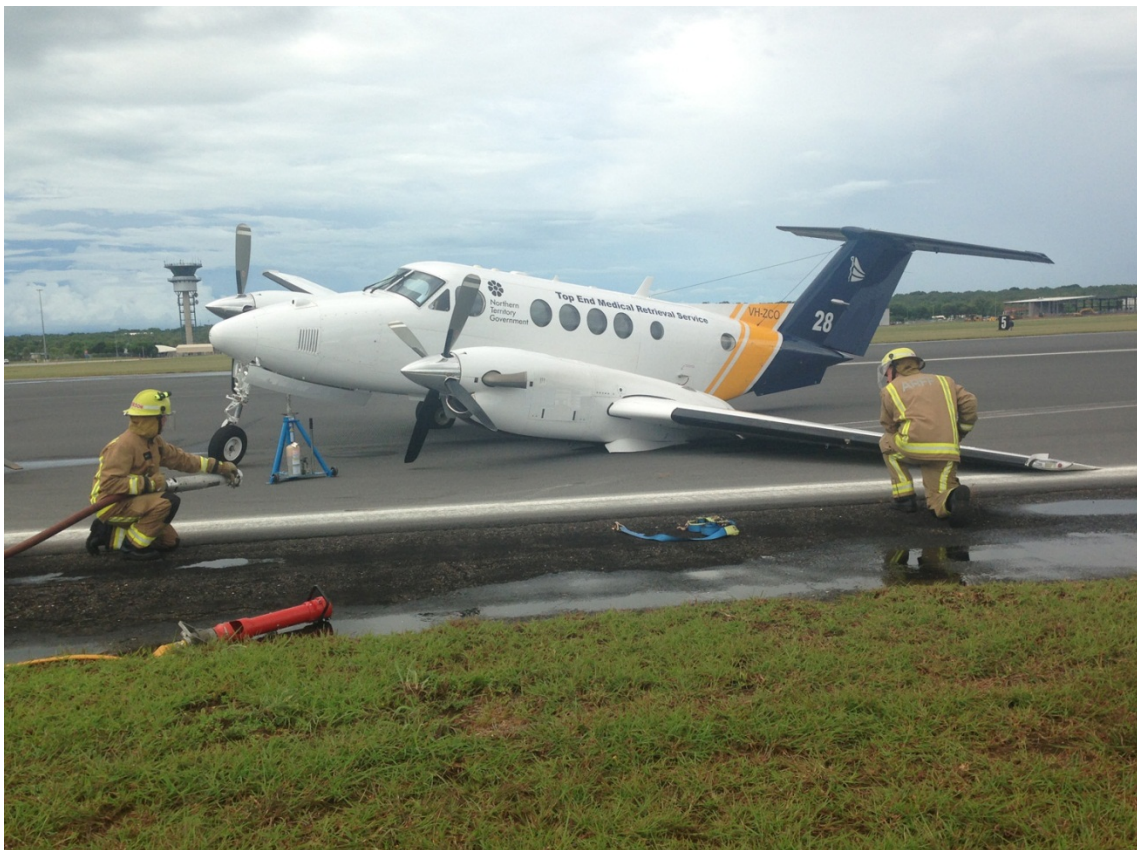
Left main landing gear collapse involving a Beech B200 King Air (VH-ZCO), at Darwin Airport, Northern Territory (ATSB investigation AO-2013-062)

- A Beech King Air was on approach to land at Port Keats, NT after conducting an aeromedical flight from Darwin. In preparation for landing, the pilot selected the gear down. However, while the nose landing gear down indication light (green) illuminated, the left and right main landing gear down indication lights did not illuminate.. The pilot elected to return to Darwin and advised air traffic control. On landing at Darwin, the pilot reported that the right main landing gear wheel touched down first. When the left landing gear wheel touched down, the pilot felt the left side of the aircraft start to sink. The pilot shut down the left engine and feathered the left propeller, then shut down the right engine and feathered the right propeller. The left wing then contacted the runway and the aircraft skidded to a stop. The pilot and flight nurses evacuated the aircraft via the over-wing exit without injuries (ATSB investigation AO-2013-062).

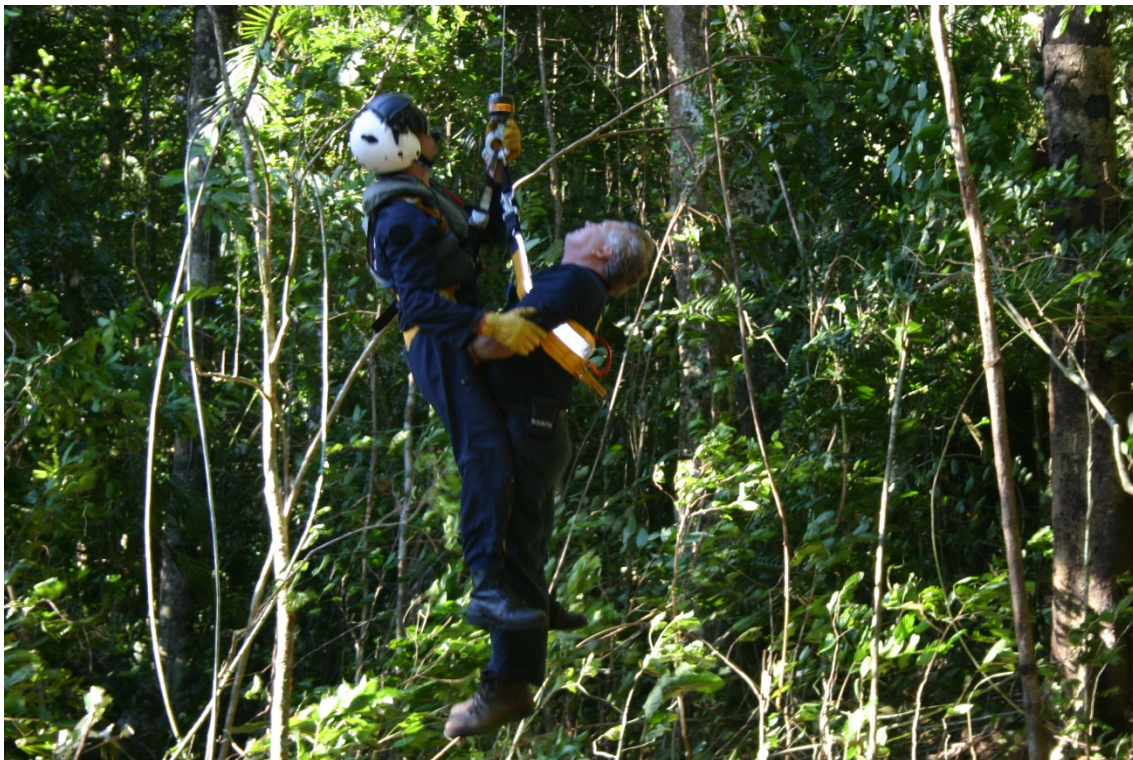
Operational accident involving a Bell 412 helicopter (VH-VAS), near Mansfield, Victoria  
(ATSB investigation AO-2013-136) – example of a double-lift with a rescue/retrieval strop

- The crew of a Bell 412 helicopter was tasked to pick up a patient who was reported to have fallen in a heavily-wooded area in steep terrain about 1 to 1.5 km from the nearest road near Lake Eildon, Vic. The crew consisted of a pilot, aircrewman and a flight paramedic. The crew decided that a stretcher winch would be too dangerous so elected for a double-lift extraction with the patient in a rescue/retrieval strop. The helicopter was positioned at 80 ft AGL (about 20 ft above the tree canopy) for the winch.

Initially the winching procedure appeared to proceed normally, despite the paramedic coming into contact with some branches on the way up. The helicopter was moved slightly and the winch continued. The aircrewman reported that once the paramedic and patient were clear of the canopy, at about 15 ft below the aircraft, he noticed that the patient was moving or wriggling. The aircrewman stopped the winch for a control check, and shortly after resuming the winch noticed that the patient's arms were not in the usual position in the strop and that the paramedic appeared to be shouting at the patient. The aircrewman elected to continue winching in, and informed the pilot that the patient was slipping. The paramedic reported attempting to pin the patient against the skid in an attempt to stop him slipping. The aircrewman continued winching until the paramedic's head was level with the middle of the door opening. At this stage the aircrewman informed the pilot that he could see the patient slipping further. He dropped the winch pendant and reached down, grabbing the patient's shoulder in an attempt to stop his fall. The aircrewman stated that by

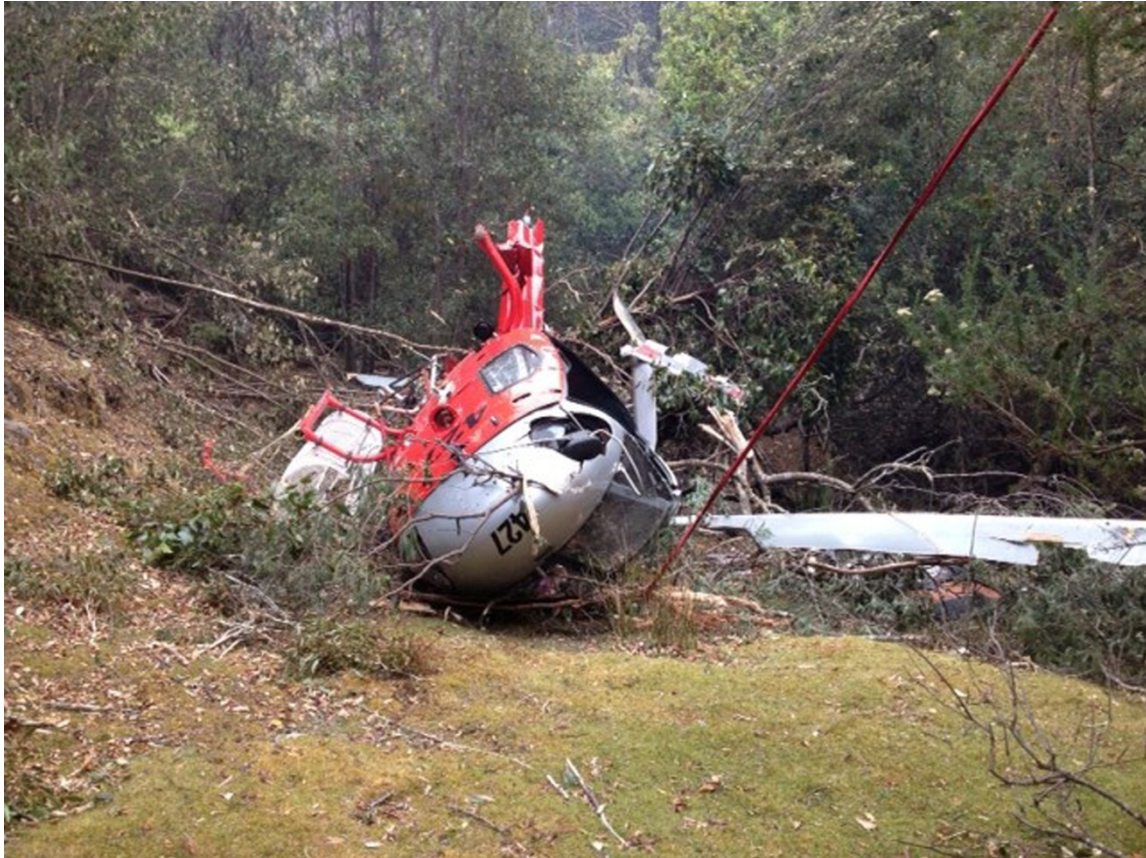
Collision with terrain involving a Eurocopter AS.350 B2 helicopter (VH-EWM), near Hobart, Tasmania (ATSB investigation AO-2013-026)

- A Eurocopter AS.350 was conducting water bombing of a fire near Hobart when it collided with terrain. The pilot, who was the sole person on board, suffered minor injuries while the helicopter was substantially damaged. The spot fire that the helicopter was working on was not particularly large, but was on a downhill slope and in a gully. The pilot reported that the overall wind was north-north-westerly, but the fire created a localised westerly in-draft within the gully. The pilot slowed the helicopter in preparation for the water drop. Approaching the hover at about 80 ft AGL, and immediately following the loss of translational lift, the helicopter suddenly commenced an uncommanded left yaw and descent. Without any warnings or alarms, the helicopter rotated rapidly two to three times to the left. The pilot raised the collective to decrease the rate of descent, and countered the yaw with anti-torque pedal input; however, the rate of yaw increased. The pilot reported that 'in a very short period of time', the helicopter was in the trees. Although the reason for the accident could not be conclusively established, the described behaviour of the helicopter by the pilot was consistent with a loss of tail rotor effectiveness (ATSB investigation AO-2013-026).

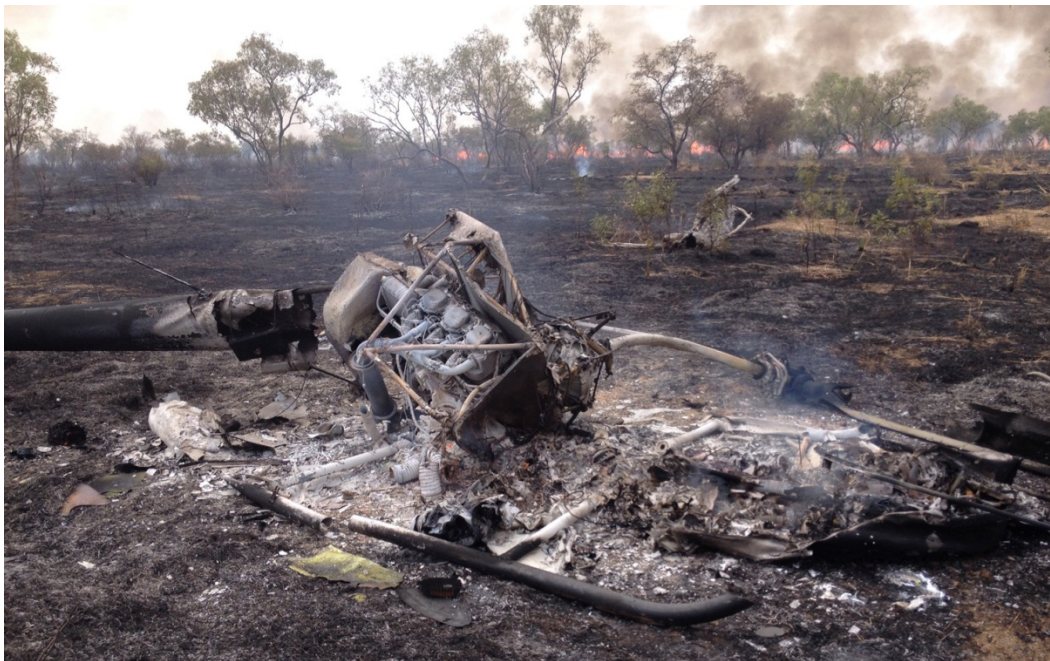
Ground fire involving a Robinson R44 helicopter (VH-TZE), near Daly Waters, Northern Territory (ATSB investigation AO-2013-192)

- A Robinson R44 helicopter was being used to conduct gravity survey work near Daly Waters, NT. On board were the pilot and a geophysical field technician. The survey consisted on landing about every 4 km along a planned grid to collect data. After a routine landing at a designated grid point, the technician left the helicopter with his equipment to carry out a reading about 5 m from the helicopter. A short time later, the pilot noticed that the technician was waving his arms to get his attention. The pilot looked towards the rear of the helicopter and saw a fire underneath, which was spreading into the engine bay. The pilot exited the helicopter and notified the landholders via phone so they could construct fire breaks to contain the ensuing grass fire. The occupants were uninjured, however, the helicopter was destroyed by the fire. The ATSB has been notified of 13 occurrences since 2000 where a helicopter has been destroyed by grass fire, with many reports highlighting the speed with which the grass ignited and the fire spread beyond control (ATSB investigation AO-2013-192).

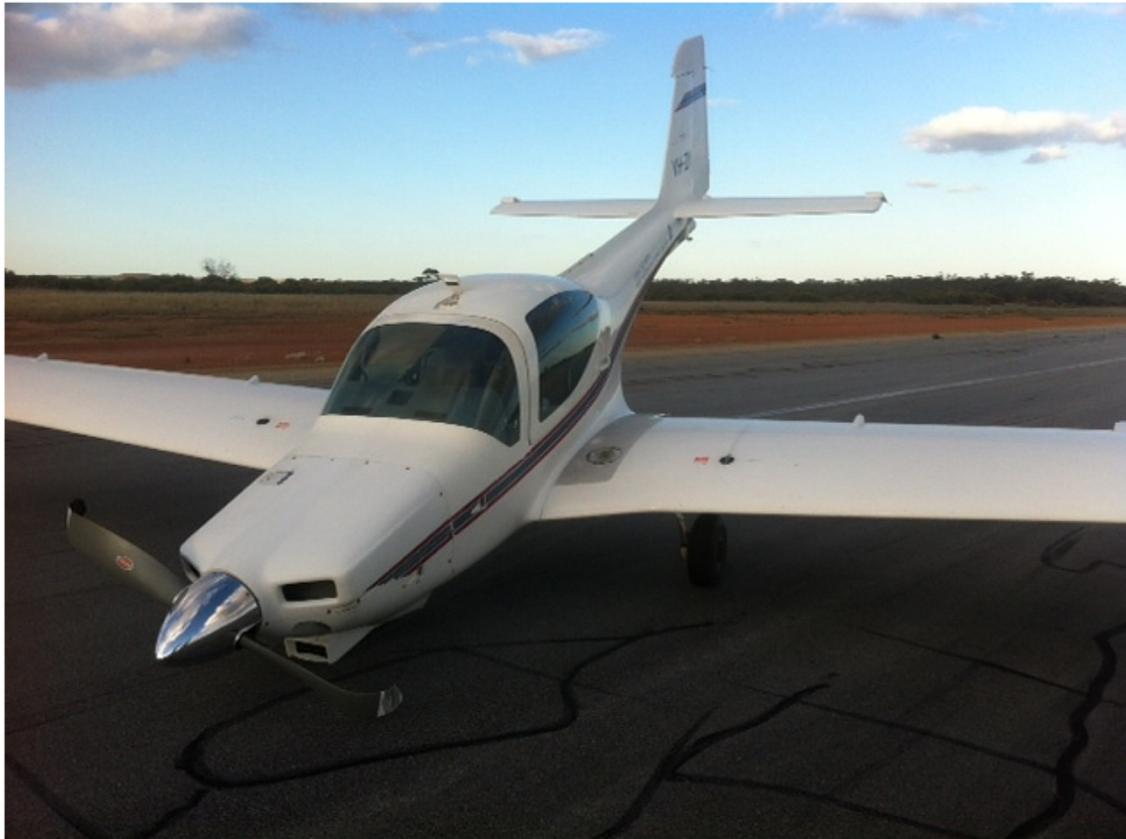
Hard landing involving a Grob G-115 (VH-ZIV), at Merredin, Western Australia (ATSB investigation AO-2013-178)

- The student pilot of a Grob G-115 departed Merredin on his first solo flight to a training area located near Lake Brown, WA. About one and a half hours into the flight, the student elected to return to Merredin, tracking via Burracoppin. The student pilot was unable to identify Merredin airstrip, and made a broadcast on the universal communications (UNICOM) frequency that he

was unsure of his position. The UNICOM operator gave him directions shortly before about 1700 local time. On short final, he determined that he was too high and initiated a go-around. On the second circuit, the student reported that there was a crosswind with slight windshear, and sun glare was making it increasingly difficult to see the runway. The aircraft touched down heavily and bounced. The student reported that the sun glare made it very difficult to judge the height of the aircraft. He touched down again on the nose landing gear, which collapsed, and the Grob slid along the runway to a stop. The pilot was uninjured but the aircraft was substantially damaged. (ATSB investigation AO-2013-178).

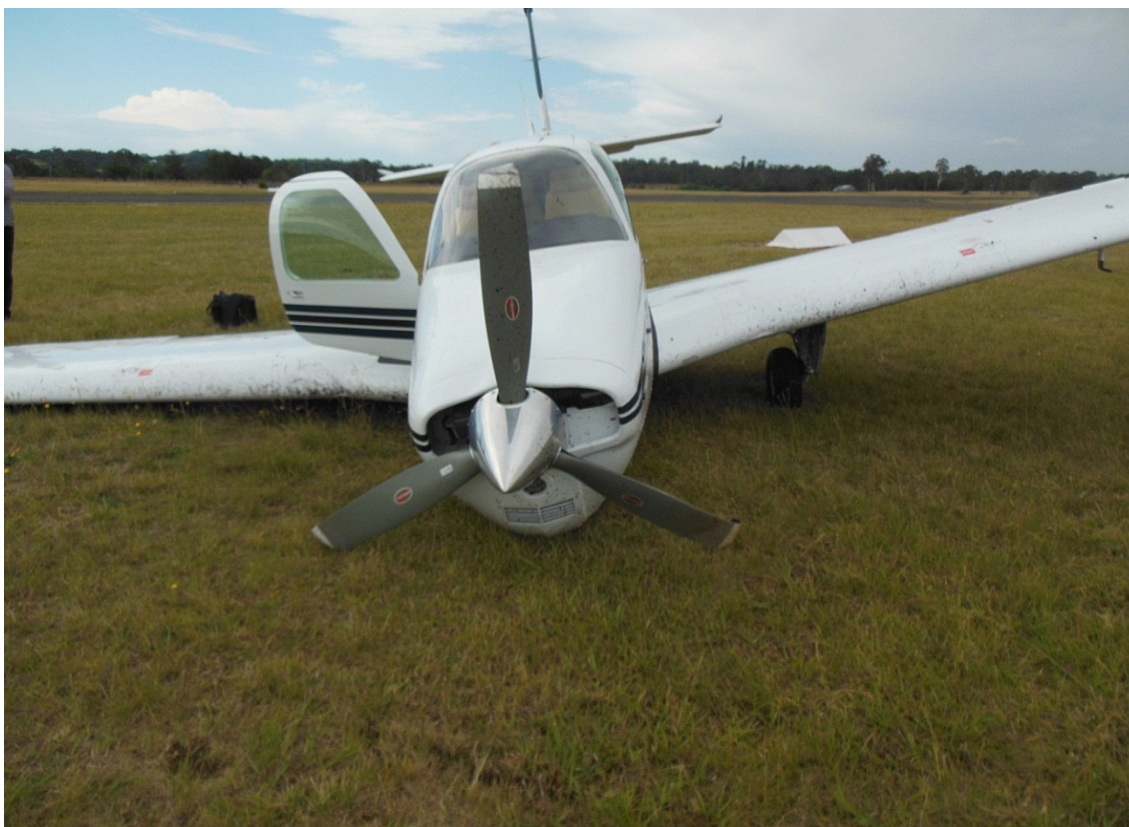
Incorrect configuration event involving a Beech A36 Bonanza (VH-YEN), at Camden Airport, New South Wales (ATSB investigation AO-2013-207)

- A flight instructor and a student pilot were conducting flying training in a Beech A36 Bonanza at Camden, NSW. The purpose of the flight was to enable the student to obtain a retractable undercarriage (landing gear) endorsement. After completing about 45 minutes upper air training in the local training area, they obtained a clearance from ATC for a straight-in approach to runway 06 at Camden. During the approach, the student completed the pre-landing checks, which included extending the landing gear and selecting flap. The aircraft touched down about 50 to 100 m past the runway threshold and about 2 m left of the centreline. The instructor advised the student to re-align the aircraft with the runway centreline, focusing his attention outside the cockpit watching the re-alignment. The student became concerned about the length of runway remaining and quickly moved to retract the flaps and prepare the aircraft for take-off. The student had completed all his recent training in a Cessna 182 which has the flap control to the right of the power quadrant. This led to him inadvertently manipulating the landing gear lever in the Beech. The instructor attempted to recover the aircraft, but it veered right and the nose dug into the grass verge alongside the runway. As a result of this accident, the aircraft operator advised the ATSB that the company has changed their procedure for retractable design type endorsements. From now, instructors undertaking this type of endorsement training with students are required to conduct a full stop landing on the first approach (ATSB investigation AO-2013-207).
