# Aviation Occurrence Statistics

2004 to 2013

## ATSB Transport Safety Report

AR-2014-084

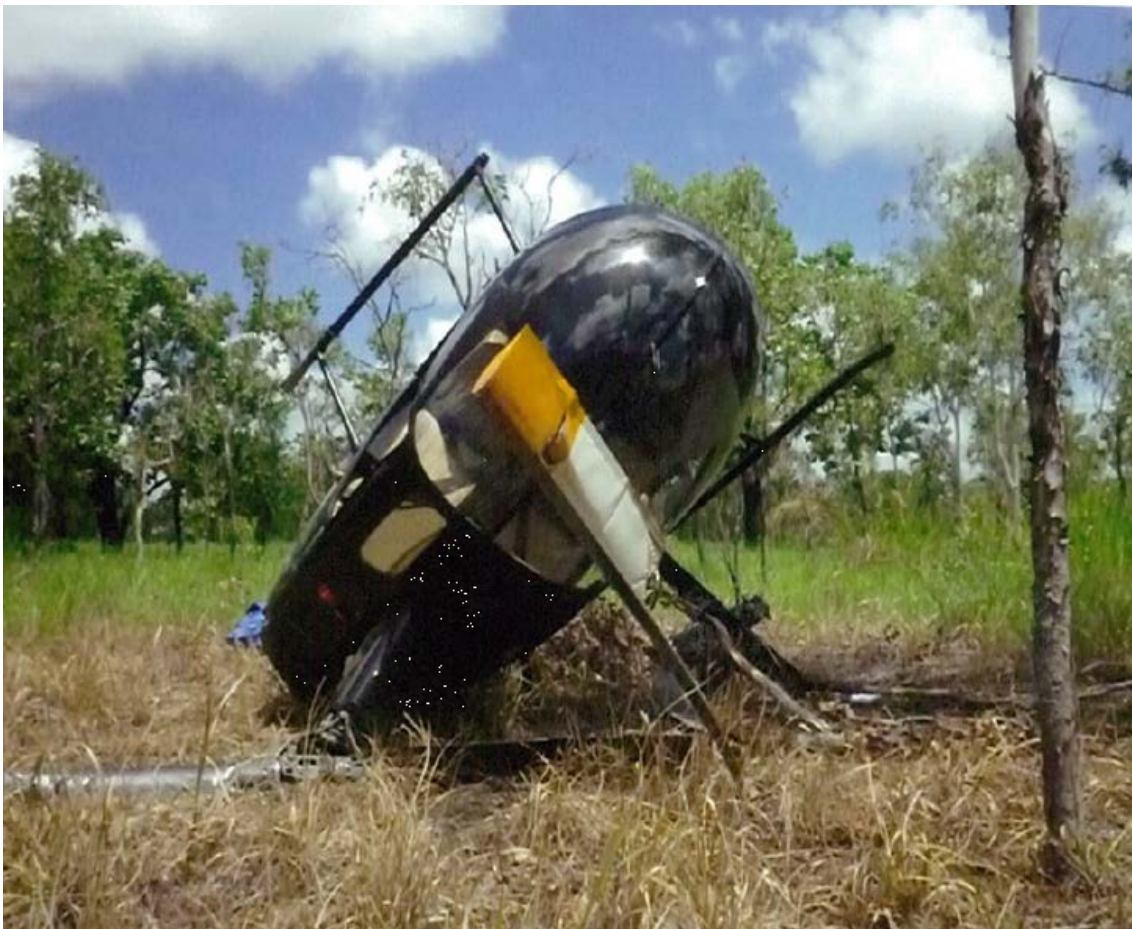
Loss of control involving a Robinson R22 helicopter (VH-HGI), at Adelaide River Station, Northern Territory (ATSB investigation AO-2013-021)

- A Robinson R22 helicopter with a pilot and passenger on board went on a return flight from a station homestead near Manton Dam, NT. On return to the homestead and on approach to land, the pilot turned the helicopter in a northerly direction to terminate in a hover. The pilot reported that he had difficulty maintaining control of the helicopter in the hover and decided to conduct a go-around. As the pilot had previously turned the helicopter to face the north, his departure path was not the usual one he used and required a steeper profile to clear trees located near the landing area. During the go-around at about 40 ft AGL and at an airspeed of between 25 to 30 kt, the helicopter suddenly yawed to the right and completed 3 to 4 revolutions before impacting trees. The helicopter came to rest inverted and was seriously damaged. The pilot was able to exit with minor injuries and assisted the passenger, who was seriously injured, to exit the helicopter. The ATSB investigation into this accident found that the

pilot had returned early to the homestead to avoid windy and rainy conditions. The pilot reported that if he was unsure of the wind, he would overfly the airstrip and confirm the direction of the wind via the windsock, as the windsock was not visible on approach to the homestead. The pilot commented that during the wet season the wind was always from the north-west and he did not overfly the airstrip windsock on the day of the accident. On the day of the accident, light winds (3 to 7 kt) at 280° were recorded at a nearby monitoring station. Wind will cause anti-torque system thrust variations to occur in helicopters. Certain relative wind directions are more likely to cause tail rotor thrust variations than others. Knowing which direction the wind is coming from is critical – especially in light wind conditions. Any manoeuvre which requires the pilot to operate in a high-power, low-airspeed environment with a left crosswind or tailwind creates an environment where unanticipated right yaw may occur. During the go around, the pilot may have inadvertently placed the wind relative to the helicopter in the critical azimuth area, between 288° and 315°, where main rotor vortices may interact with the tail rotor, increasing the likelihood of LTE (ATSB investigation AO-2013-021).

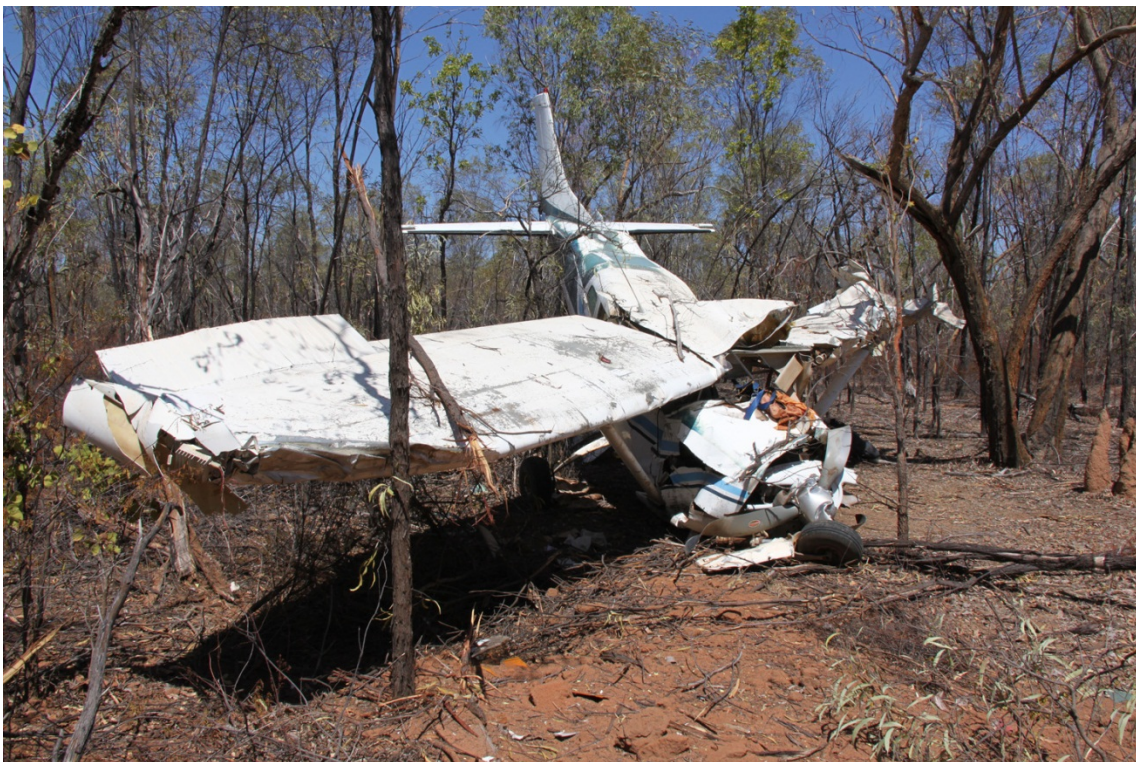
Collision with terrain involving a Cessna 206 Stationair (VH-WAV), 156 km south-southeast of Croydon, Queensland (ATSB investigation AO-2013-151)

- The pilot-owner of a Cessna 206 landed on a public road to repair a truck at a remote work camp, 156 km south-southeast of Croydon, Qld. A few hours later, the pilot took off from a different, curved road with a passenger on board. At a height of about 30 ft AGL, the left wing of the Cessna struck a tree, and the wingtip and aileron separated from the aircraft. The aircraft

impacted terrain, fatally injuring both occupants and destroying the aircraft. The ATSB investigation into this accident found that the distance available from where the pilot increased power for take-off was much shorter than the distance advised in the aircraft's pilot operating handbook under the prevailing conditions. There was no apparent reason for the pilot to attempt a take-off from that location when a more suitable location was nearby. It is most likely that the pilot misjudged the distance available, the prevailing conditions and their effect on the aircraft's performance, or had a false recollection of the relative layout of the two roads and thought that there was more take-off room available beyond the curve. However, it is also possible that the pilot's judgement of the available distance, or his decision-making capability, was affected by a serious medical condition and/or prescribed medications that had not been reported to CASA until after the pilot's previous medical certificate had expired. In addition, the ATSB found that the pilot's seat had broken from its mounts, probably as the result of heavy, unsecured cargo striking it during the accident sequence. This could have had a detrimental effect on the survivability of the accident (ATSB investigation AO-2013-151).

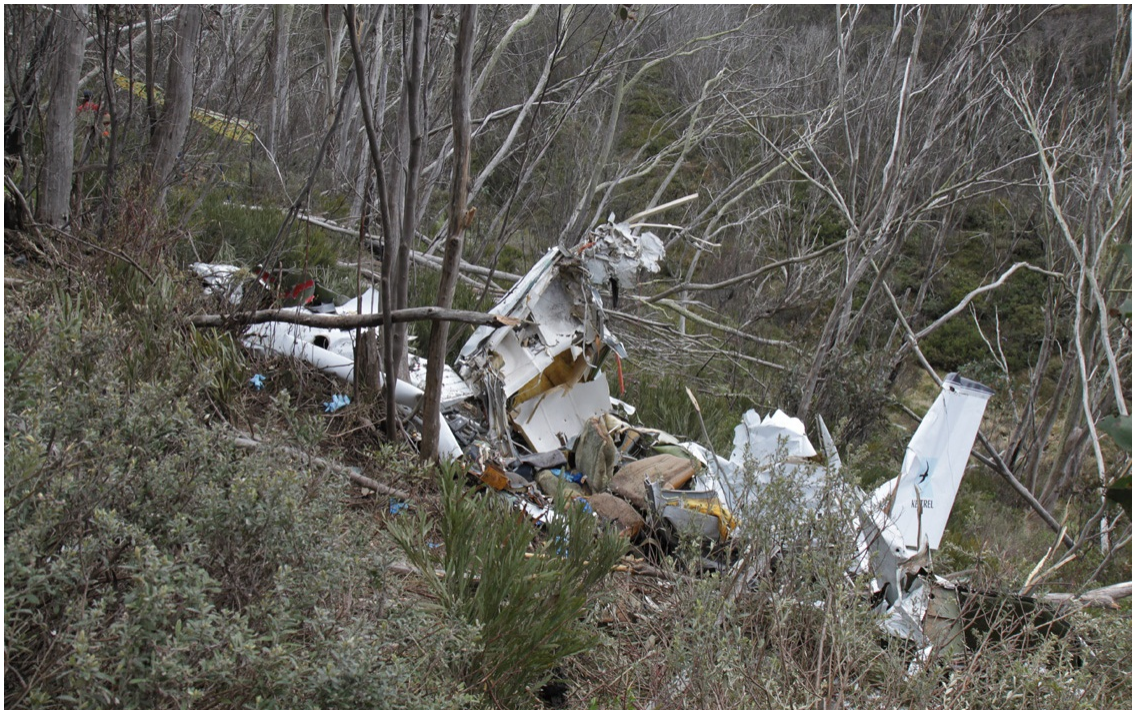
Collision with terrain involving a Cessna 182 Skylane (VH-KKM), near Mount Hotham, Victoria (ATSB investigation AO-2013-186)

- The pilot of a Cessna 182 departed from Moruya, NSW on a morning flight to Mangalore, Vic. A witness at Mount Hotham Airport reported hearing and seeing a high wing aircraft flying near the airport mid-morning. The witness reported that the aircraft, the description of which was consistent with the accident aircraft, was heading in the direction of Melbourne. Another witness (who was camping about 4 km from the accident site) reported that at about the same time he heard an aircraft in the valley to the south-east of his location but 'could not see it due to the fog or cloud'. By early afternoon, the aircraft was two hours overdue at Mangalore and a search and rescue operation commenced. The aircraft wreckage was located the next morning at about 5,000 ft AMSL on the north-east side of Mt Blue Rag, Vic. The pilot was fatally injured and the aircraft destroyed. Examination of the wreckage by the ATSB found that the aircraft impacted rising terrain in a south-westerly direction with the wings level and a nose-down attitude of about 10°. The impact severely compressed the wings and fuselage. The fuel tanks, located within the wings, ruptured at impact but there was no fire. The engine, propeller and part of the forward fuselage were buried into the rising terrain from impact forces. Following the recovery of the engine and propeller from beneath the ground, an examination established that the engine was operating, and that the propeller was rotating with power being delivered by the

engine at impact. Examination of the aircraft's attitude indicator and airspeed indicator established that they were functioning at impact. The aircraft's altimeter indicator was 'captured' at an indication of 5,000 ft, which was consistent with the elevation of the accident site. Continuity and security of the airframe flight controls were established. The on-site inspection of the aircraft did not identify any defects that may have contributed to the accident. The local weather conditions at the time and location of the accident appeared to be poor. The witness at Mt Hotham Airport reported that when they saw the high wing aircraft 'clouds were around the tops of, and tumbling down the mountains, it was also raining or foggy at Hotham'. The witness at the campsite reported that the visibility at the camp site was less than 20 m at the time. The ATSB investigation is continuing to examine weather information pertaining to the flight, as well as aircraft maintenance documents, items recovered from the aircraft, and the pilot's medical and flying history (ATSB investigation AO-2013-186).

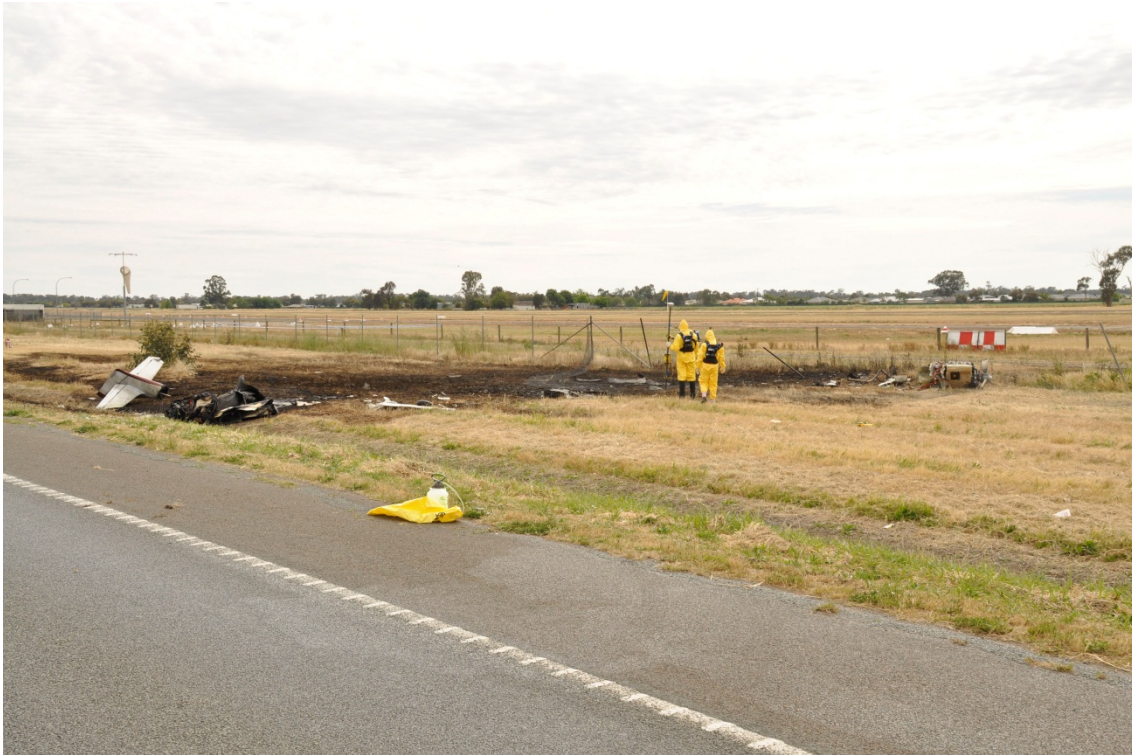
Collision with terrain involving a Lancair Legacy (VH-ICZ), at Shepparton Airport, Victoria (ATSB investigation AO-2013-193)

- An amateur-built Lancair Legacy took off from Shepparton, Vic. with a pilot and passenger on board for a flight to Yarrawonga. Witnesses reported that the take-off and initial climb appeared normal, but shortly after the aircraft's pitch angle increased. This was followed by a descending right turn that continued until the aircraft collided with terrain alongside the airport boundary. The pilot and passenger were fatally injured. The weather forecast for Shepparton Airport at the time of the accident was for westerly winds up to 12 kt, with scattered cloud at 4,500 ft and visibility greater than 10 km. The impact with terrain separated the aircraft's left wing, empennage and engine from the main fuselage. Both wing fuel tanks ruptured and an intense post-impact fire ensued, destroying much of the aircraft's composite structure and liberating a large amount of fragmented carbon fibre material. When present as free fragments and particles, carbon fibre presents a respiratory hazard. This required a large area around the accident site to be cordoned off and investigators to use suitable protective equipment while examining the wreckage. The ATSB did not identify any pre-existing faults with the aircraft wreckage during the on-site phase of the investigation, although the examination was limited by the degree of damage sustained. The Lancair involved in the accident was assembled in South Africa by the previous owner, and prior to being imported to Australia, had been involved in an engine failure and forced landing in 2010. That accident caused substantial damage to the underside of the airframe that was repaired before the aircraft was sold. The ATSB

investigation is currently examining the history of the repair work after the 2010 accident, the assembly and maintenance of the aircraft after its importation to Australia, instruments and electronic equipment recovered from the aircraft, and the pilot's flying history and training (ATSB investigation AO-2013-193).

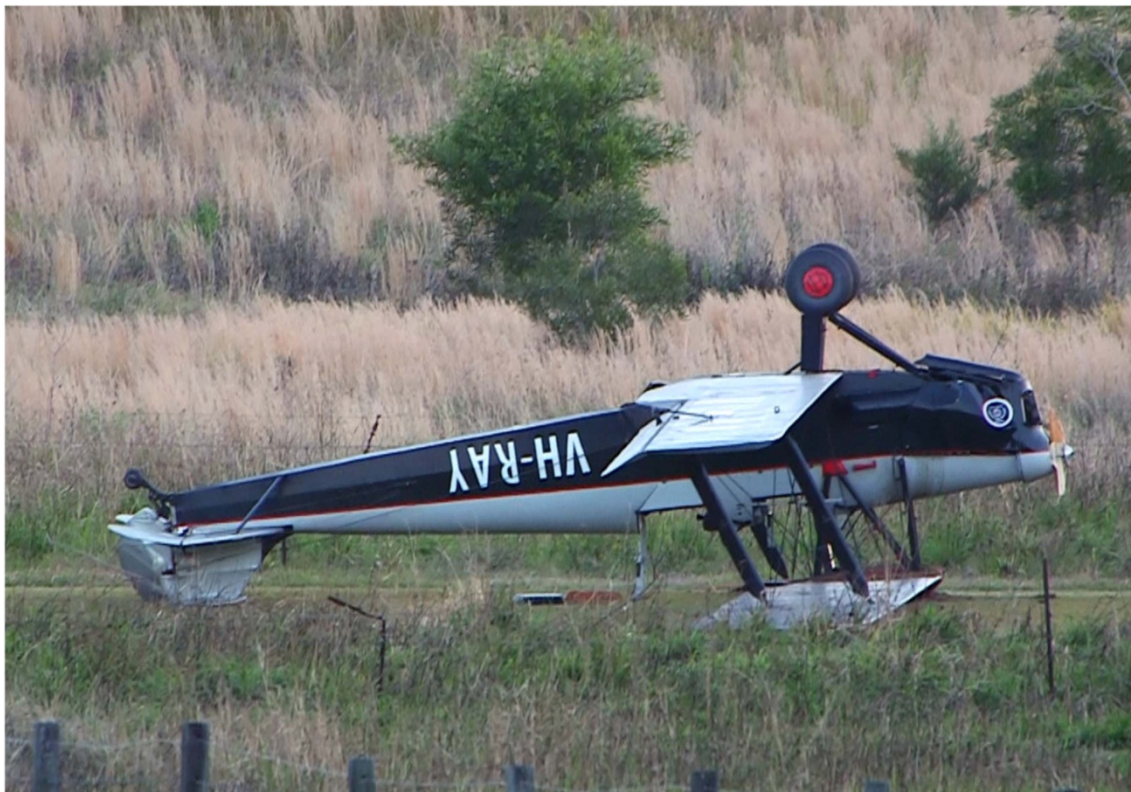
Take-off event involving a de Havilland DH.82 Tiger Moth (VH-RAY), near Coffs Harbour, New South Wales (ATSB investigation AO-2013-190)

- The pilot of a de Havilland DH.82 Tiger Moth was taxiing at Sandy Beach, NSW to conduct circuits. The pilot taxied to the end of the runway and applied the brakes to conduct engine run-up checks. The pilot released the brakes and lined up on the runway heading and then applied full power for take-off. The aircraft accelerated down the runway. As the airspeed increased, the tail rose to the take-off position at about 200 m down the runway and at about 30 kt. Suddenly, the nose of the aircraft dropped and the aircraft flipped onto its back. An engineering inspection of the aircraft determined that the left main landing gear brake drum had evidence of corrosion, and the brake operating rod was found stiff to operate. When the brakes were applied and released, the left brake did not release fully. After the brake was cleaned and lubricated, the brake operated normally. The maintenance organisation reported to the ATSB that the left brake was probably partially engaged on take-off. This was the aircraft's first flight in more than 7 months and it was normally stored in a high corrosion environment (ATSB investigation AO-2013-190).

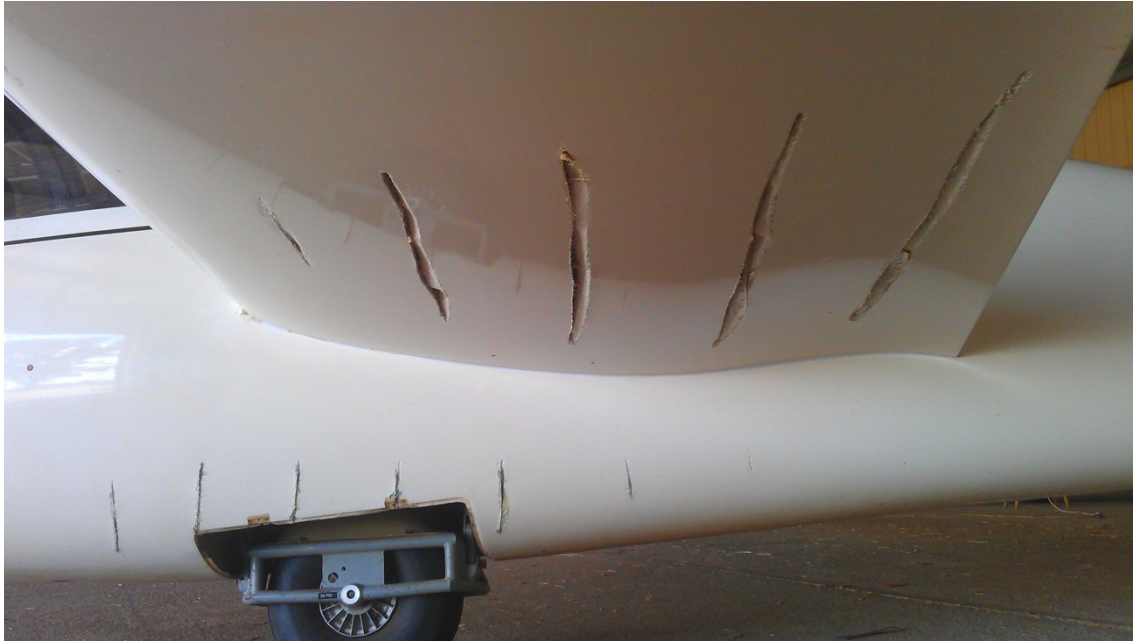
Collision on runway between a Grob G103 Twin Astir glider (VH-UIZ) (pictured) and a Cessna 150 (VH-ROZ), at Tocumwal Airport, New South Wales (ATSB investigation AO-2013-048)

- Two glider clubs were conducting gliding operations at Tocumwal, NSW. A Grob Twin Astir glider from one gliding club was towed airborne, however, after a number of orbits looking for rising air the pilot decided to return to the circuit and land. A few minutes later, a Cessna 150 took off towing a glider from the other club. Following the release of the glider, the Cessna pilot turned left and tracked for a left downwind on runway 36L. Witnesses on the ground reported hearing both pilots making all necessary CTAF broadcasts. Just as the Cessna touched down on runway 36L, the pilot felt a heavy jolt on the top of the cockpit and heard a loud noise. Immediately, he saw the windscreen fill with the underside of a glider (the Twin Astir). He observed the glider continue down the runway at about 5 to 10 ft above ground level. The Cessna pilot was uninjured, and on exiting the aircraft, observed a wheel contact print on the top of the aircraft. The pilot of the Twin Astir was uninjured and landed the glider well down the runway. On exiting the glider, the pilot observed damage on the left wing and fuselage (ATSB investigation AO-2013-048).

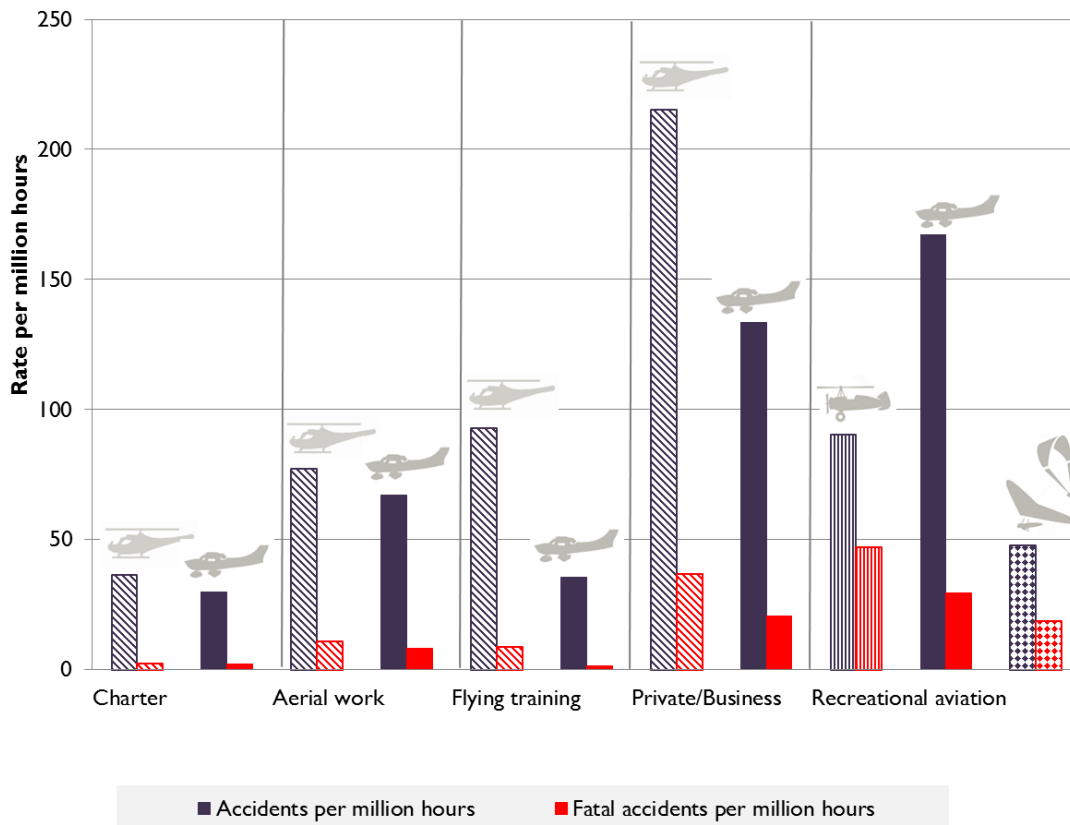
**Figure 23: Rate of accidents and fatal accidents by operation and aircraft type**

When comparing the accident rate of aircraft types<sup>20</sup> by operation type, there is significant difference between air transport (charter), GA, and recreational aviation (Table 28 and Figure 23). These differences are discussed below.

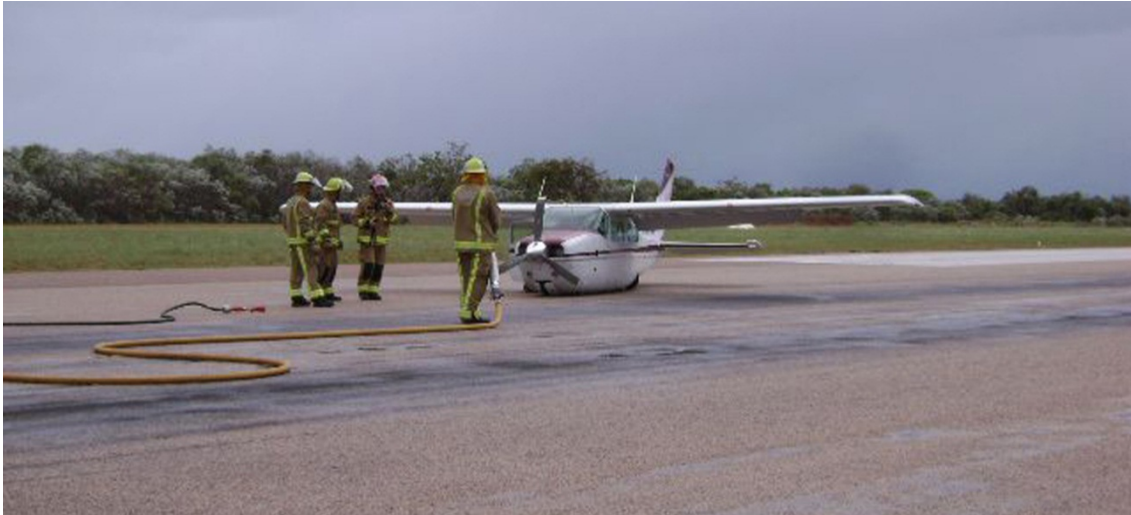
Collapsed landing gear involving a Cessna 210 Centurion (VH-PBV), at Broome Airport, Western Australia (ATSB investigation AO-2013-039)

A Cessna 210M was returning to Broome Airport, WA via a position north of the airport to land on runway 10. The conditions on the day were windy and wet with thunderstorms and rain moving through the area, requiring the pilot to alter the aircraft's flight plan and flight path to divert around the weather. The pilot reported selecting the landing gear down as part of his landing checks, and a passenger later reported that he heard what he believed to be the landing gear being lowered. The pilot was advised of an 18 kt crosswind when cleared to land. Shortly before landing the pilot completed his final checks, but did not look out the window to visually check that the landing gear was down. To compensate for the crosswind, the pilot operated the aircraft at a slightly higher throttle setting, until flaring to land. The Cessna landed on the runway with the landing gear retracted and skidded about 300 to 350 m down the runway on the underbelly. The controller activated the airfield emergency response.
