Emerging trends in Australian aviation safety

January – June 2014

ATSB Transport Safety Report

AR-2014-127

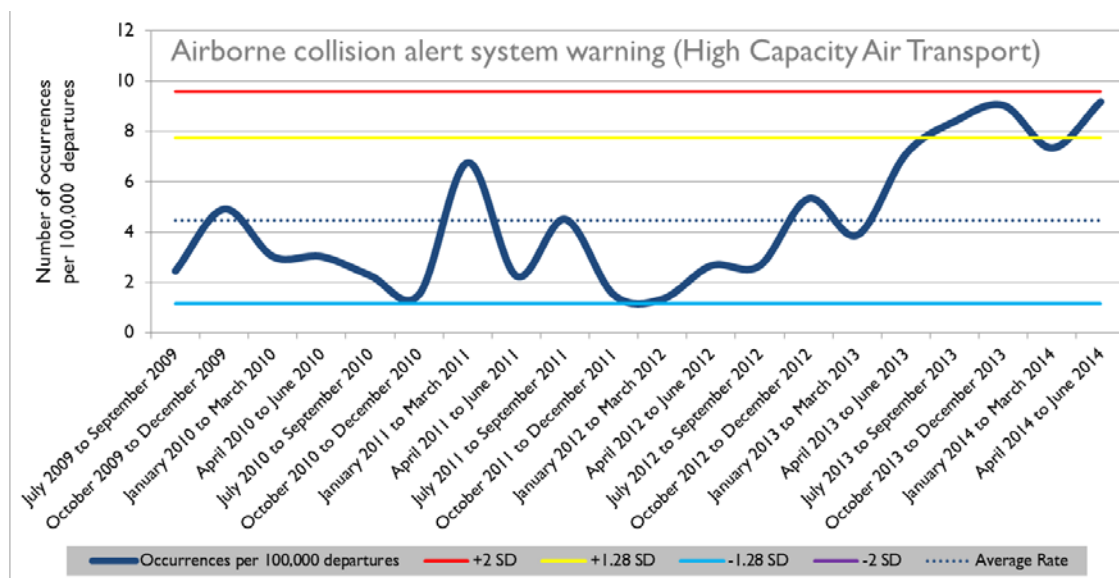
Airborne collision alert warnings – High capacity air transport

The rate of *Airborne collision alert system warnings* reported in high capacity air transport operations has been significantly above average in the last few quarters, and showed a slight increase in Apr-Jun 2014.

The most common location for these occurrences was Sydney, with TCAS-RA alerts on approach to that airport making up 12 of the 28 occurrences in the last 6 months. All of those occurrences happened during independent visual approaches (IVAs). The majority of occurrences involving an IVA involved runway 34L/R approaches (only two occurred on runway 16L/R approaches). Further investigation by the ATSB has found that IVAs at Sydney Airport have contributed to most of the rise seen in this type of occurrence over the last 2 years.

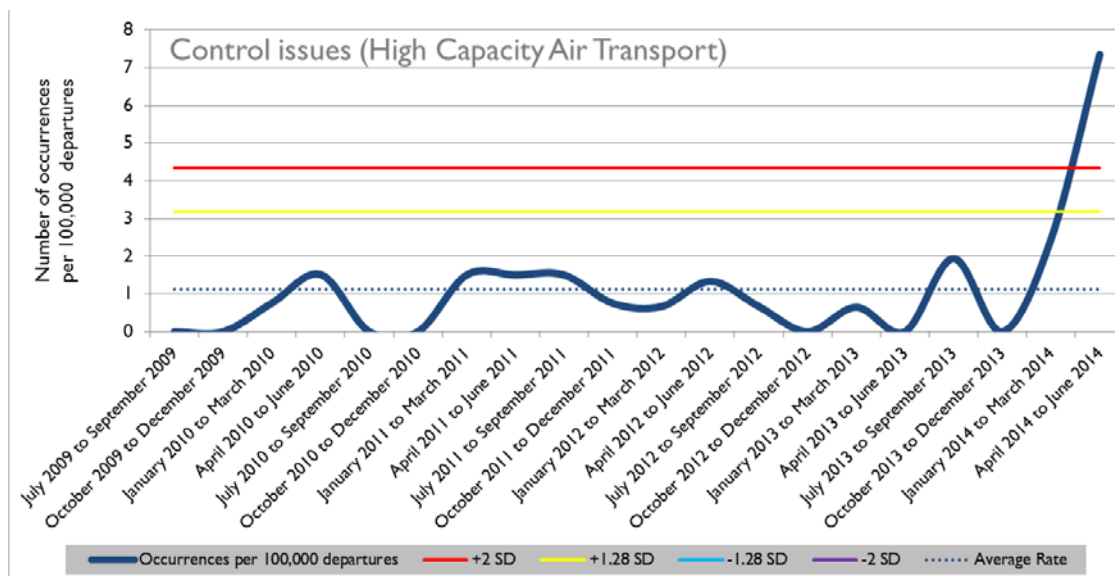
Control issues – High capacity air transport

Control issues involving high capacity air transport aircraft are a low frequency occurrence type, but there was a significant increase in occurrences in January to June 2014.

A large proportion of these occurrences were reported by one airline (10 of 16 occurrences), and the Fokker 100 was overrepresented when considering the fleet size and activity (5 occurrences).

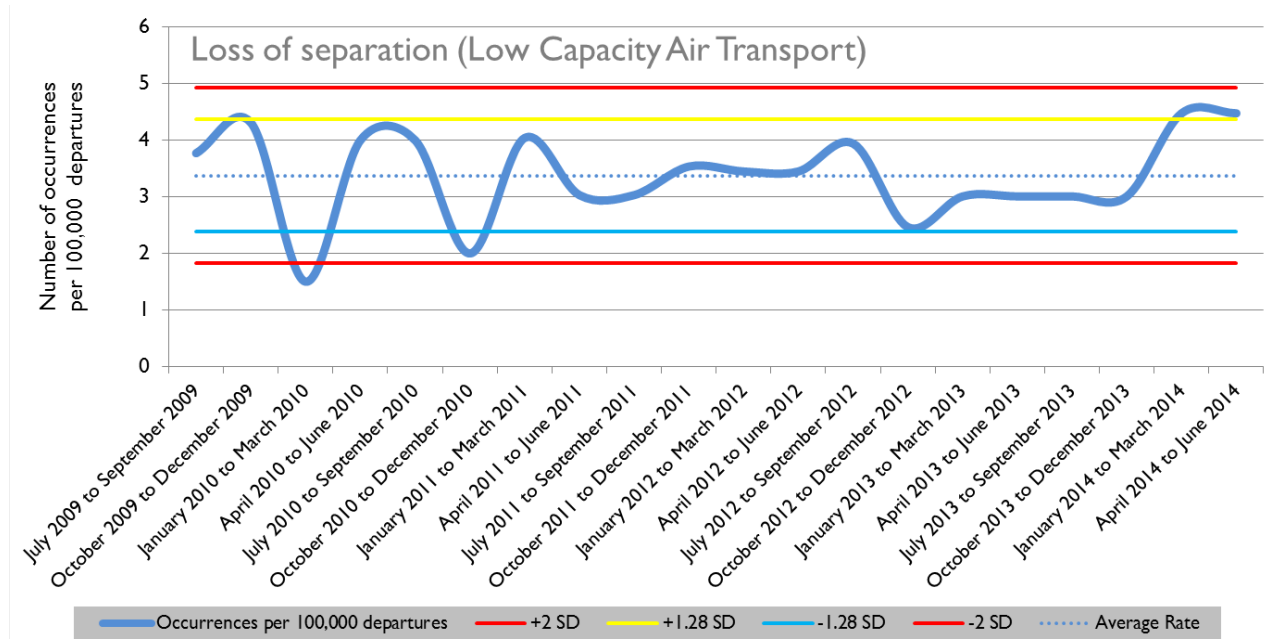
Loss of separation – Low capacity air transport

The rate of Loss of separation (LOS) occurrences involving low capacity RPT and charter aircraft was above average across the January to June 2014 period. Most of the 18 occurrences over the last 6 months were low risk occurrences, although there was one high risk LOS which involved a Cessna 206 and a military Boeing 737 in close proximity near Darwin Airport. Air traffic control was most often alerted to the LOS by a Short Term Conflict Alert (STCA), or there was no alert. Occurrences while aircraft were under radar control (10 of 18 occurrences) were most common.

No particular operators or aircraft types stood out. Darwin/Northern Territory (NT) were the most common locations for occurrences in the 6 months (three occurrences close to Darwin, four occurrences elsewhere in northern NT).

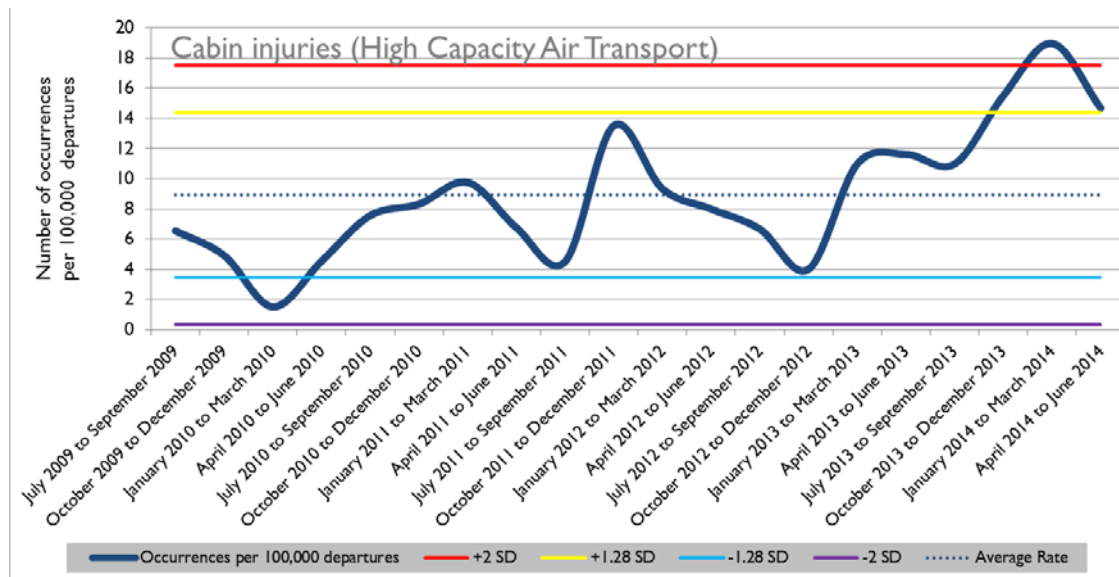
The rate of *Cabin injury* occurrences in high capacity air transport spiked in the January to April 2014 quarter, but has since been decreasing.

Almost all reported *Cabin injuries* (95 per cent) involved injuries to cabin crew, particularly on domestically-operated aircraft types. Minor bruises and sprains were the most common types of injury. Most involved some sort of turbulence or aircraft disturbance, with 22 per cent occurring in severe turbulence.
