NASA Contractor Report 3875

Fuel Containment, Lightning Protection, and Damage Tolerance in Large Composite Primary Aircraft Structures

Charles F. Griffin and Arthur M. James
Lockheed-California Company
Burbank, California

Prepared for
Langley Research Center
under Contract NAS1-16856

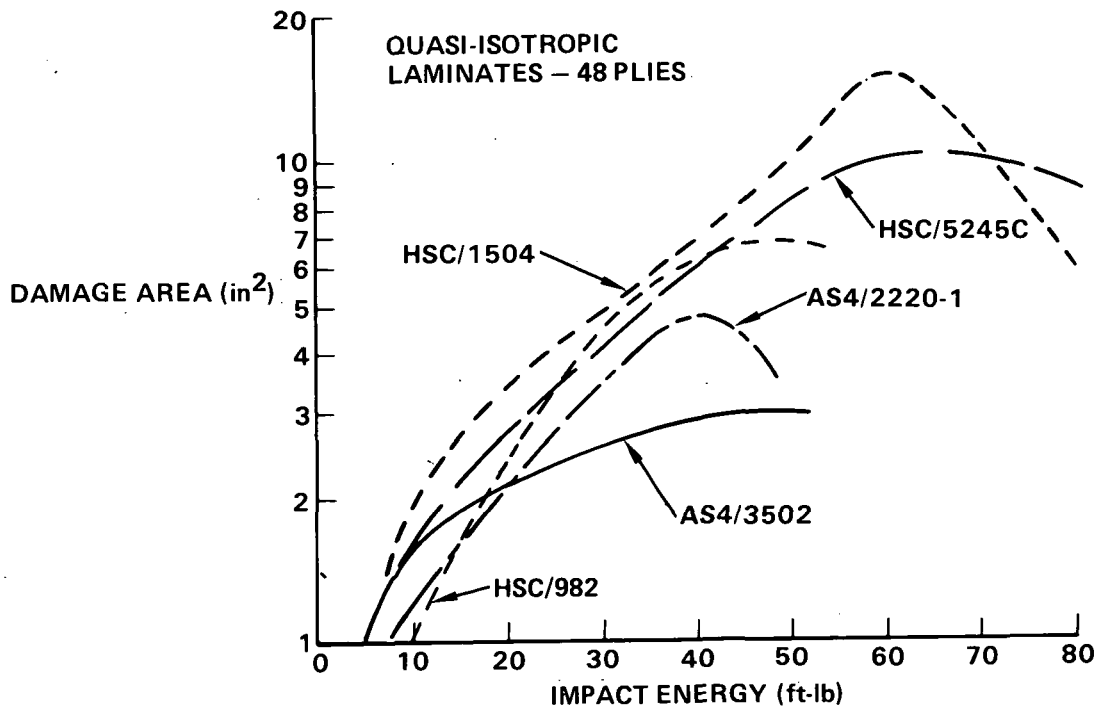
Figure 2. - Evaluation of toughened resin composites-impact response.

Quasi-isotropic panels, 48 plies thick were fabricated with each material and subjected to impact tests. For these tests, a 25- by 7-inch portion of the laminate was clamped to a steel plate with a 5- by 5-inch opening. The panel was struck in the center of the opening with a 12-pound impactor which had a 0.5-inch hemispherical diameter hardened steel tup. After impacting, the panels were inspected visually and ultrasonically to ascertain the amount of damage. Figure 2 presents the damage area versus the impact energy for several materials. In general, the panels constructed with the toughened

resins had greater damage areas than did the panel constructed with the untoughened 3502 resin. All panels displayed visual damage on the impacted side of the panel at energy levels of 20 ft-lb and greater. At energy levels of 50 to 60 ft-lb, the panels were punctured by the impactor.

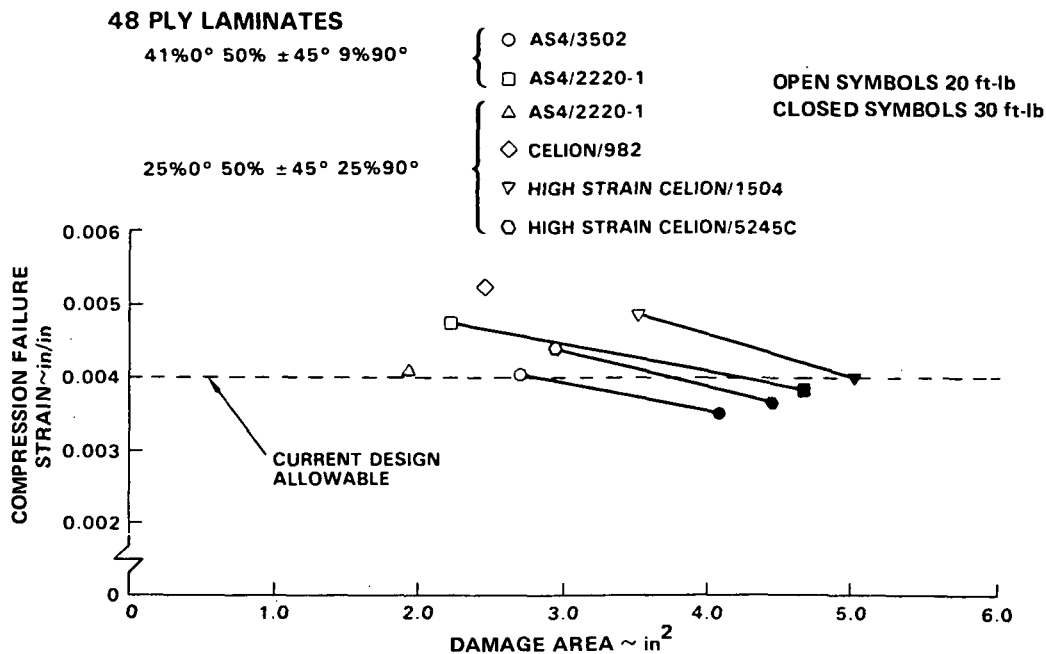
Figure 3. - Post-impact compression strain comparison.

A comparison of the post-impact compression strain at failure for the various materials evaluated in this program is displayed in Figure 3. For the tests conducted at an energy level of 20 ft-lb, the failure strain of the toughened systems was, in some cases, much better than the baseline 3502 material. At the 30 ft-lb energy level, the improvement in failure strain of the toughened systems over the baseline material was minimal. This can be attributed to the greater amount of damage in the toughened systems compared to the baseline material. Based on these coupon data, it would appear that none of the toughened materials offers major improvement in impacted compression strain-to-failure. Therefore, to substantially increase design allowable compression strains in structures will require improved materials and innovative design approaches.

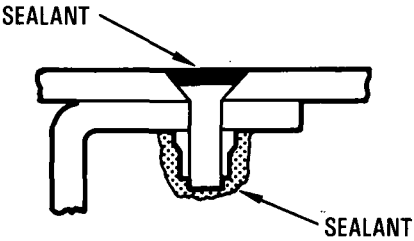
Topcoat and plastic cap

Of the various fastener treatments used to eliminate sparking, the plastic cap filled with sealant proved to be most reliable. Although in some tests the panels with topcoat alone did not spark, it was observed that the slightest pinhole or thin area in the topcoat would result in a spark during the test. Note that the plastic cap by itself was sufficient to prevent sparking as demonstrated by the tests on Panel 264.
