# Aeroplane Upset Recovery Training

## History, Core Concepts & Mitigation

**A Specialist Paper developed by**  
The Flight Operations Group (FOG)  
FOG Watch Publications  
Editorial team

From an original paper by Captain John M. Cox, FRAeS (SOS Inc)

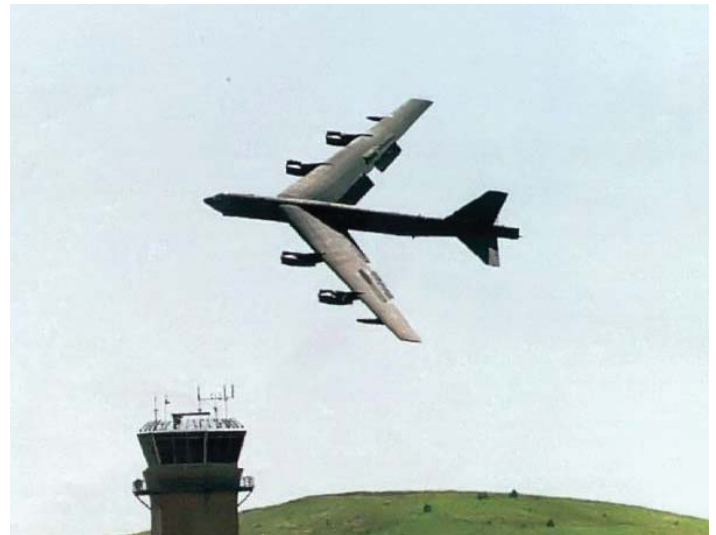
**The B-52 on its final steeply banked 360° turn, round the control tower, with flaps and spoilers deployed.** From Wikipedia, the free website encyclopaedia.

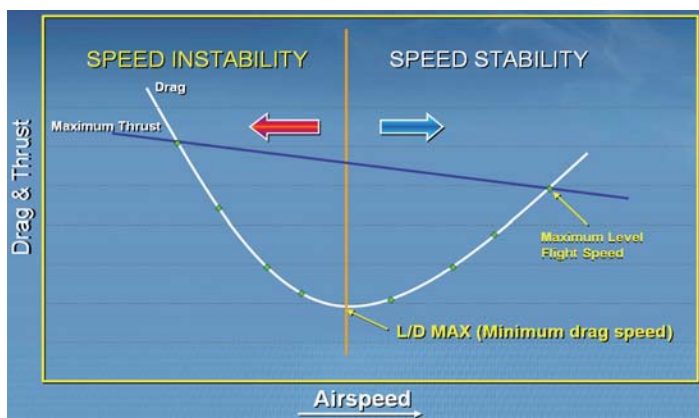
Figure 8.

Slow flight (slower than L/D max) is inherently unstable with respect to speed and thrust settings. When operating at a constant airspeed, with constant thrust setting, any disturbance causing a decrease in airspeed will result in a further decrease in airspeed unless thrust is increased. The lower speed subjects the aeroplane to increased drag. This increase in drag causes a further decrease in airspeed, which may ultimately result in a stalled flight condition (see Figure 8).
