EASA
European Aviation Safety Agency

Final Report EASA_REP_RESEA_2007_3

Study on visual inspection of composite structures

EASA-Research Project/2007/3 Final Report

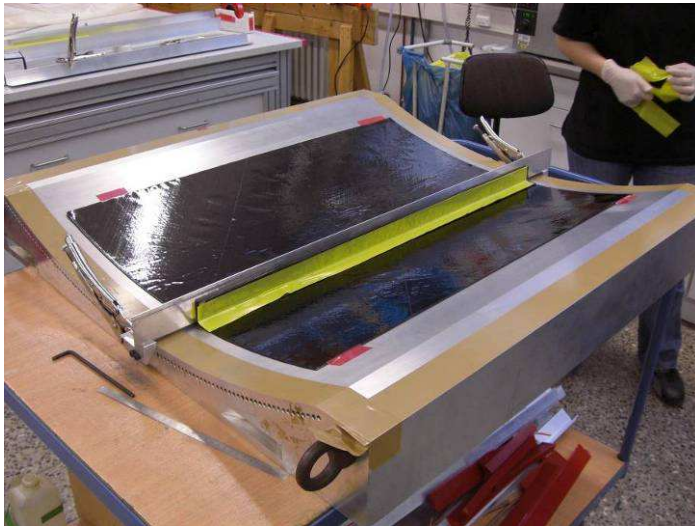
Figure 9: Placement of stringer on skin laminate. A tool with 1 m radius was used for the manufacturing test.

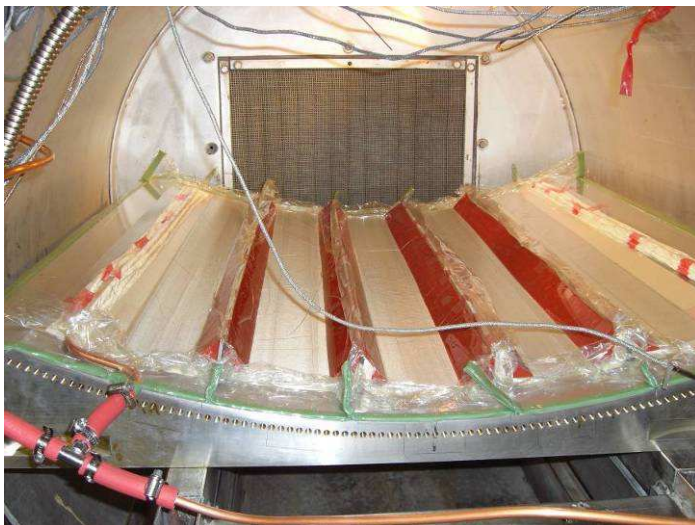
Figure 10: Stringers are supported by silicone cores (red pieces) with triangular cross sections to prevent the from collapsing during curing.

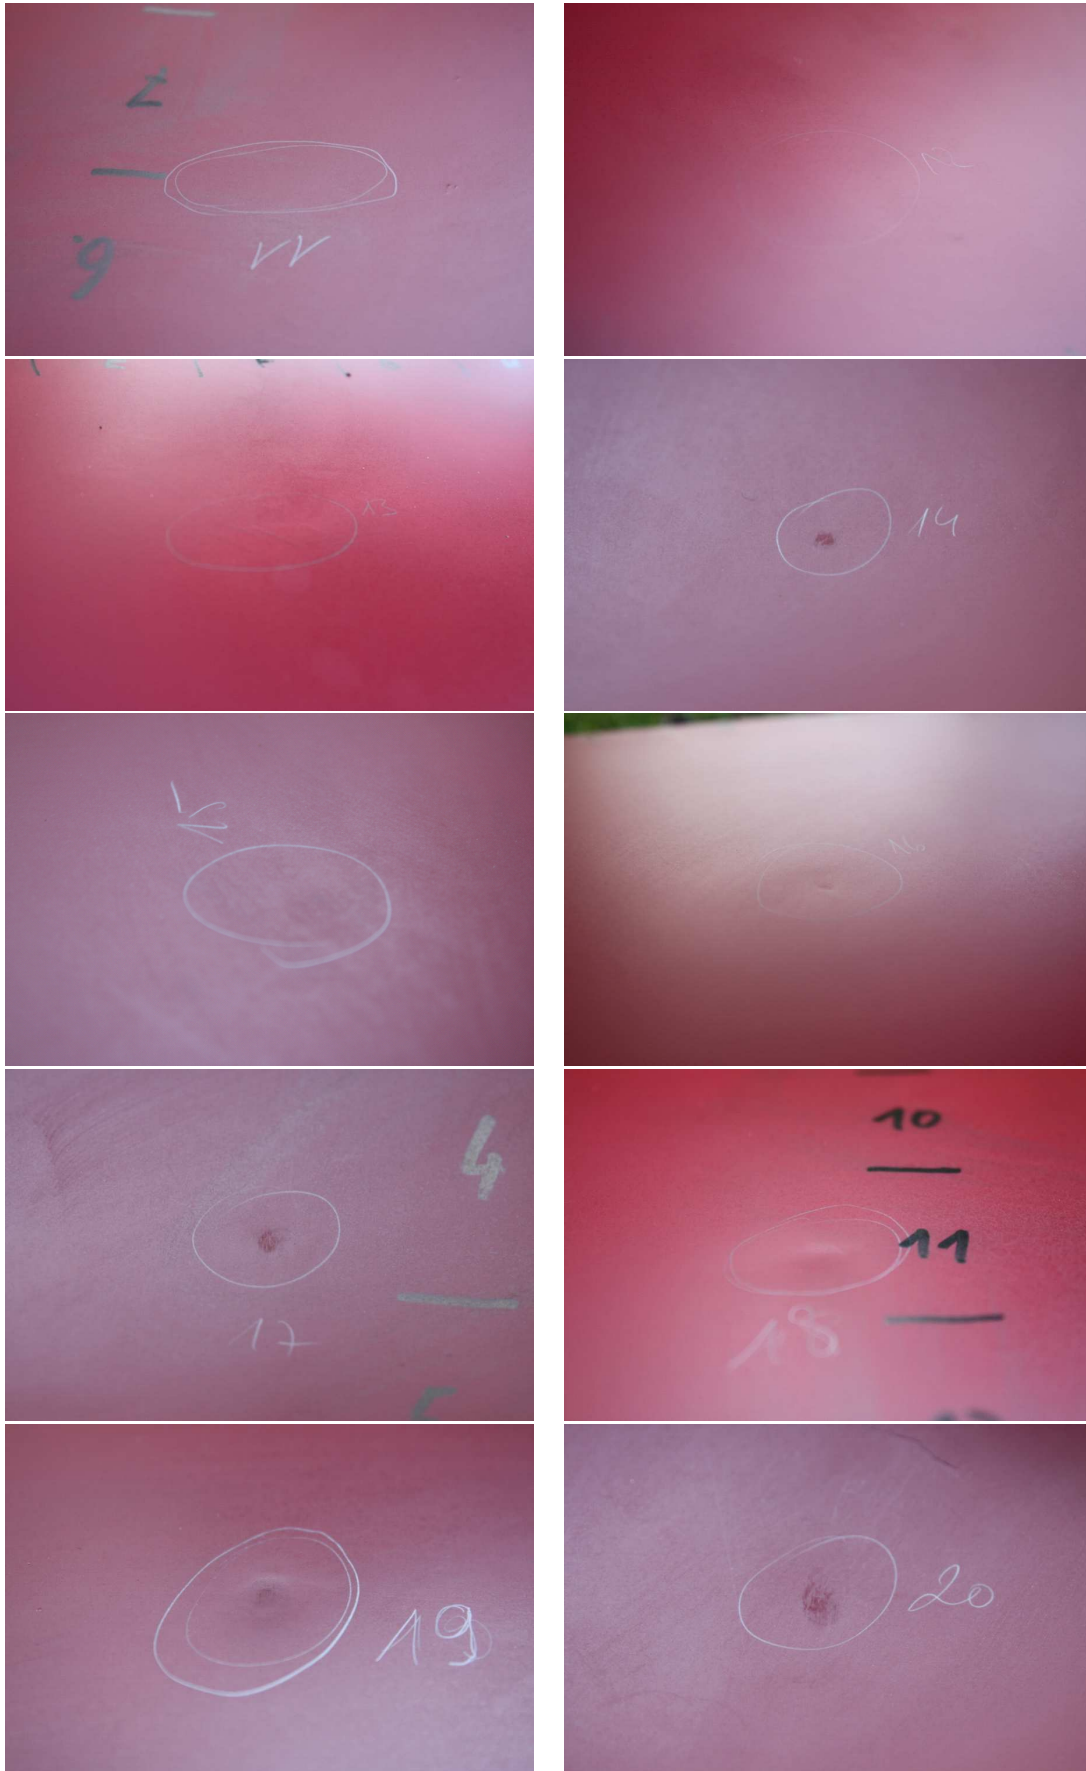
Figure 32: Impact locations 11-20 on panel 2 after impacting. The size of the markings on the panel does not correspond to size of internal damage.

Figure 31 and Figure 32 show photographs of the panels with marked impact locations after introduction of impacts 11 to 20. The different appearance of damages on the matt surface finish is readily apparent when comparing Figure 32 to Figure 21 – Figure 29.

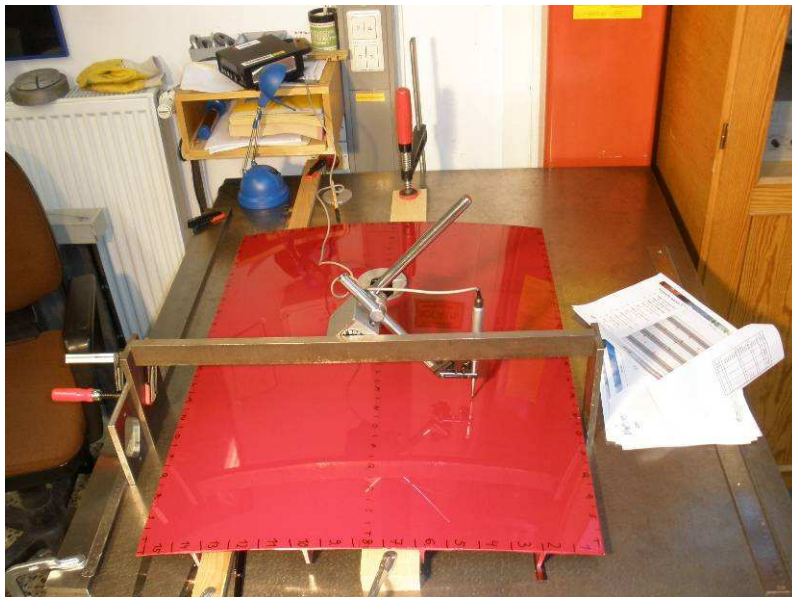
Figure 35: Set-up of dent depth measurements.

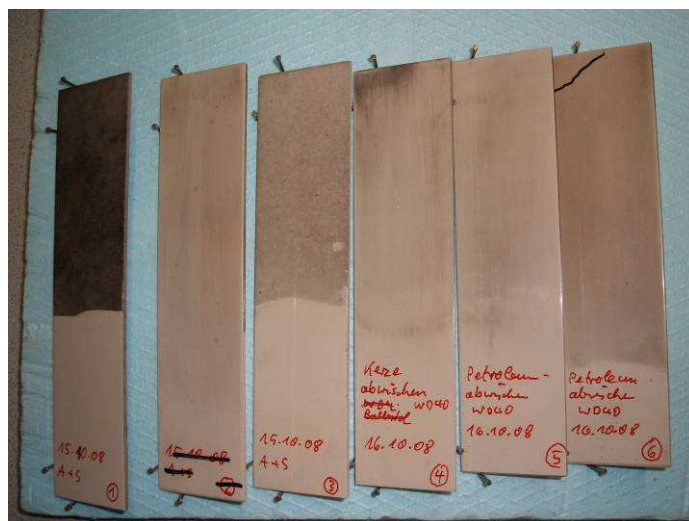
Figure 40: Trials for dirt application using acetylene soot for specimen 1 to 3, candle soot for specimen 4 and paraffin oil soot for specimens 5 and 6.

After application of different types of soot (acetylene flame, candle, paraffin oil) all specimens were completely covered with soot, like specimen 1 in (Figure 40) or even darker. Specimens 4 to 6 were sprayed with multifunction oil WD40 and wiped with a cotton cloth to adjust the amount of soot. It turned out, that the dirt film of paraffin soot / WD40 looks very much like a dirty aeroplane surface. The thickness of the dirt film is adjustable by the amount of wiping with a cotton cloth. The soot from acetylene does not stick to the specimen very well. It can be blown off the specimen

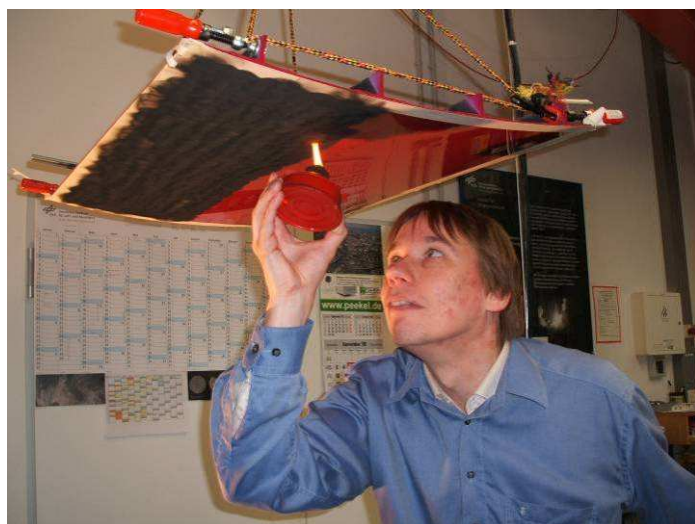
Figure 41: Application of paraffin oil soot on panel 1 with red glossy coating. The paraffin flame had no effect on the glossy coating.

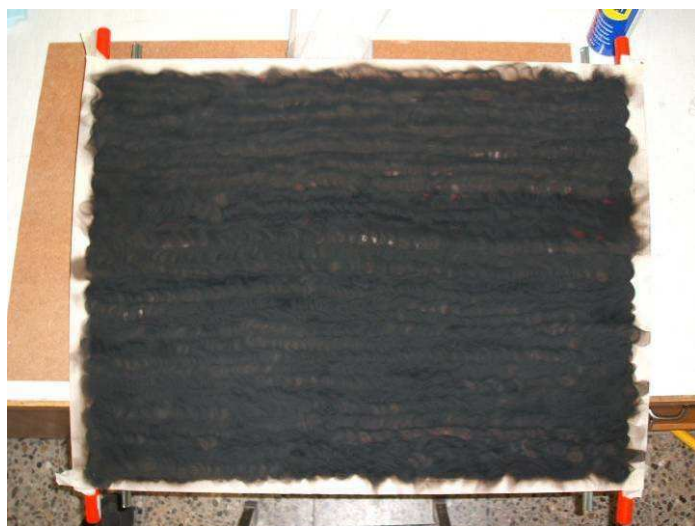
Figure 42: Panel 1 completely covered with soot from paraffin oil.

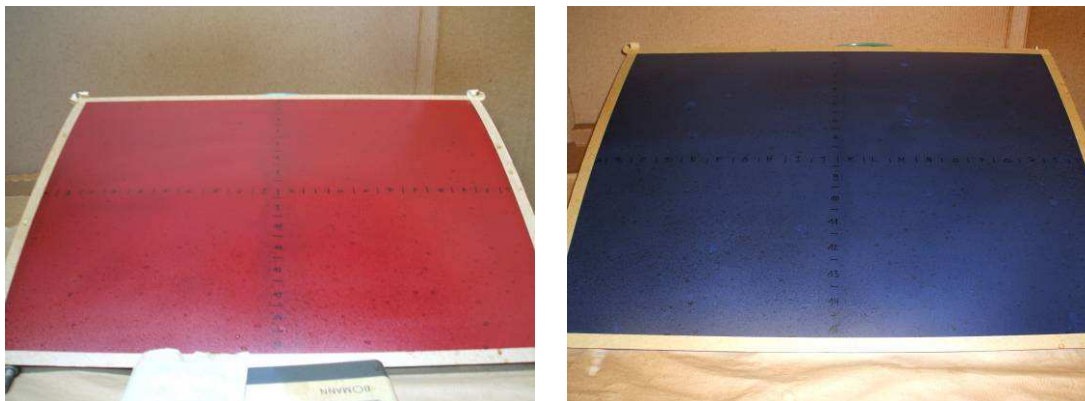
Figure 45: Figure 1 coffee stain on the blue / red matt panel surfaces.

Filter coffee was brewed with a coffee machine using standard paper filters to filter out coarser particles. The coffee was then sprayed onto the panels. Warm air heated up the panels in order to accelerate the evaporation of the water, leaving a film of coffee particles behind. The process of spraying coffee and subsequently drying the panels with warm air was repeated over the course of about an hour per panel for a moderate dirtiness level and 90 – 120 minutes for “worst case dirtiness”. The result was a rather dark, matt dirt film on the panels.

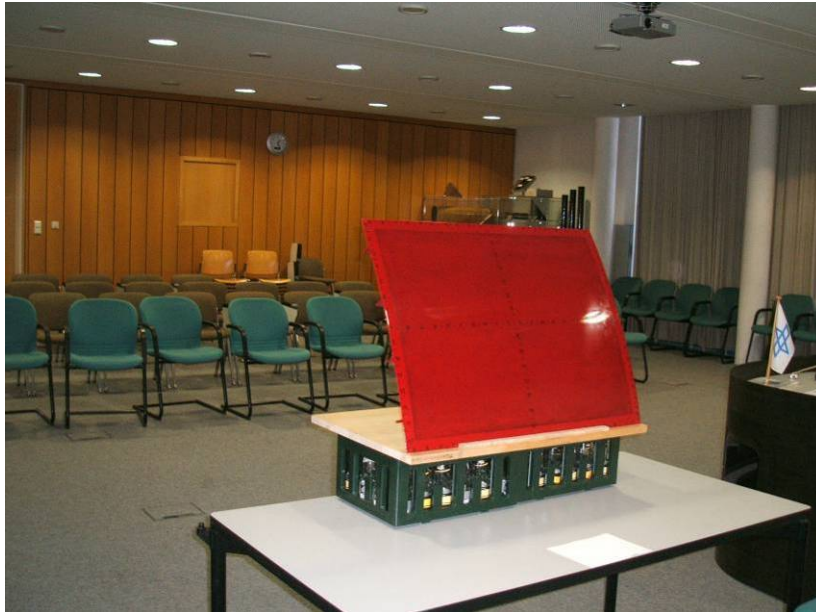
Figure 49: Lighting in meeting room 101 of Building 118 at the DLR Braunschweig site. Three light bulbs in each ceiling lamp provide around 400 lux on the table surface in the foreground.

Since the illumination of the DLR meeting room 101 also consists of point-source lighting from ceiling lamps the typical lighting conditions of a typical aircraft hangar are approximated reasonably well.

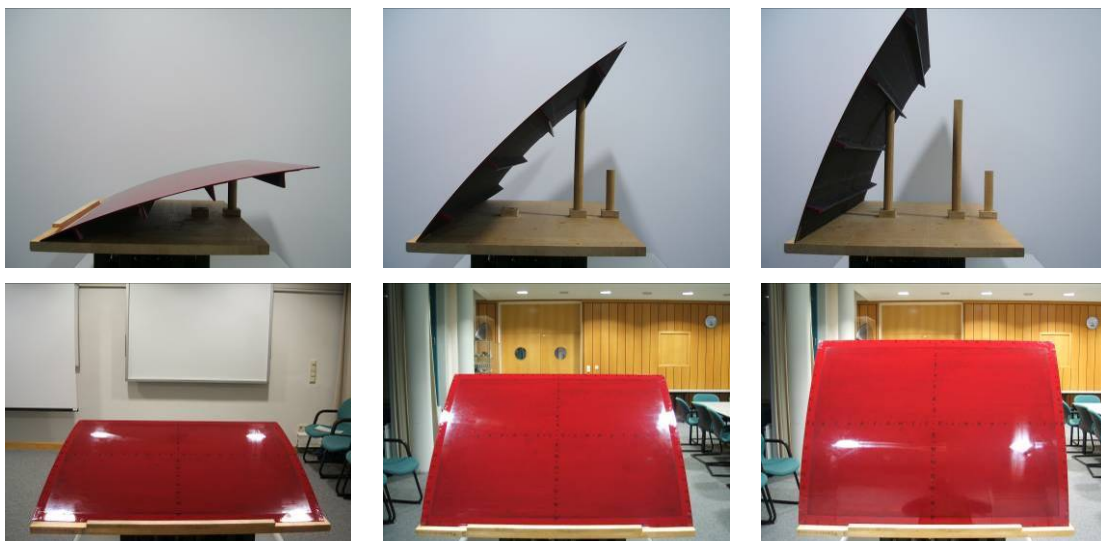
Figure 50: Inspection angles 15° (left), 45° (middle), 65° (right hand side)

For the 15° orientation four light sources in the ceiling are reflected by the panel towards the position of the inspector, facilitating damage detection on the glossy surface. For the 45° and 65° inspection angle, only two light sources are available for this purpose. This made damage detection more difficult.
