6
EXPERIMENTAL MEASUREMENT OF
PARACHUTE CANOPY STRESS DURING INFLATION.

9
TECHNICAL REPORT AFFDL-TR-78-53
Final Report 1 Jul 1975 - 30 Dec 1976

AIR FORCE FLIGHT DYNAMICS LABORATORY
AIR FORCE WRIGHT AERONAUTICAL LABORATORIES
AIR FORCE SYSTEMS COMMAND
WRIGHT-PATTERSON AIR FORCE BASE, OHIO 45433

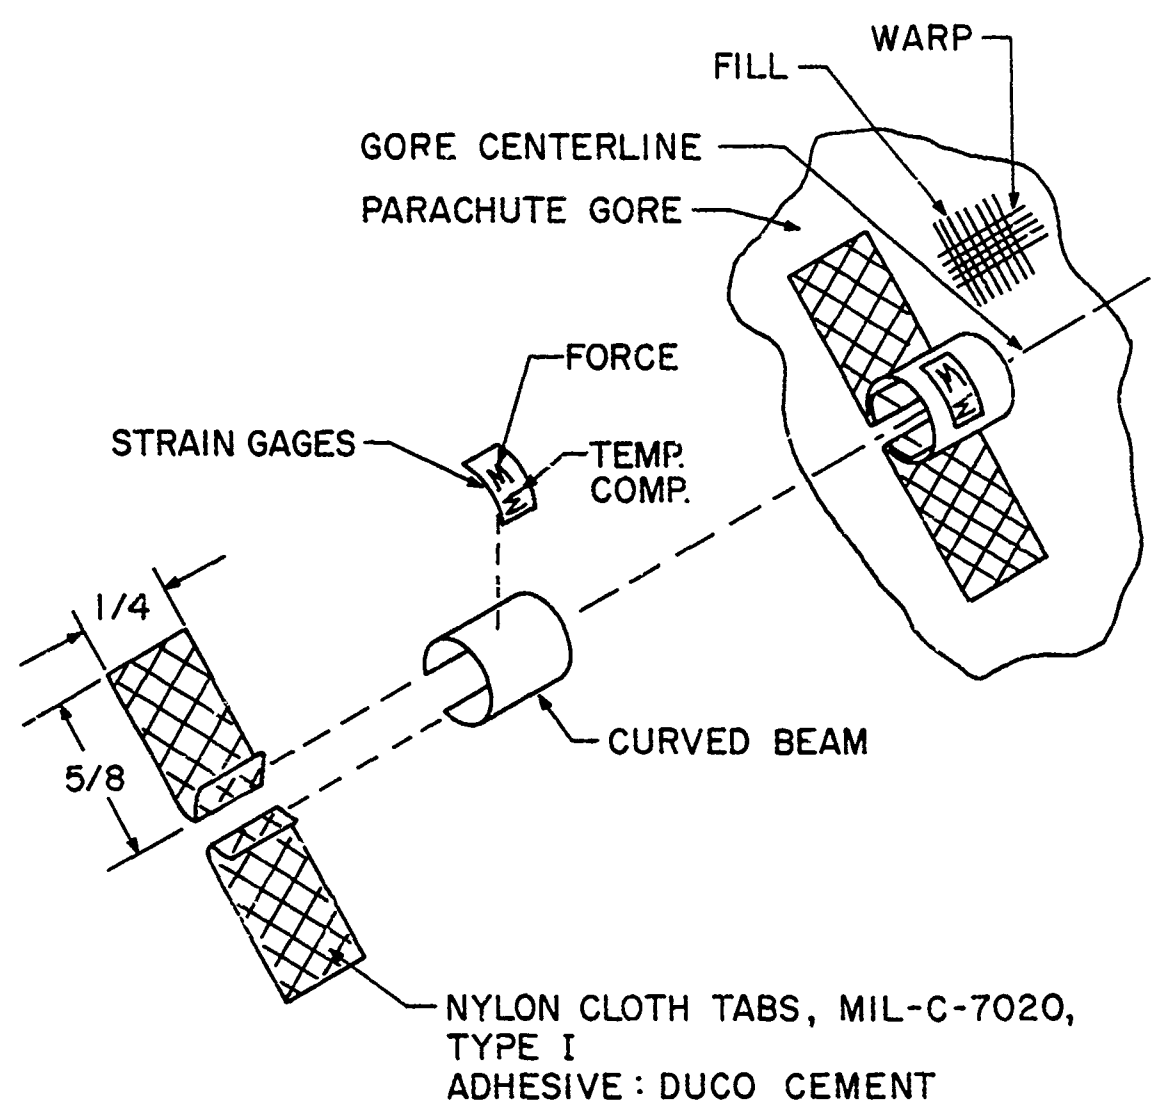
Figure 4. Original Omega Sensor.

The original Omega sensor of Reference 21 is shown in Figure 4. Modifications to the original sensor design were necessary due to complications of the tabs tearing during preliminary testing. While statically loading an Omega sensor, the tabs, which were bonded to the inside of the curved beam, were tearing along the edge of the

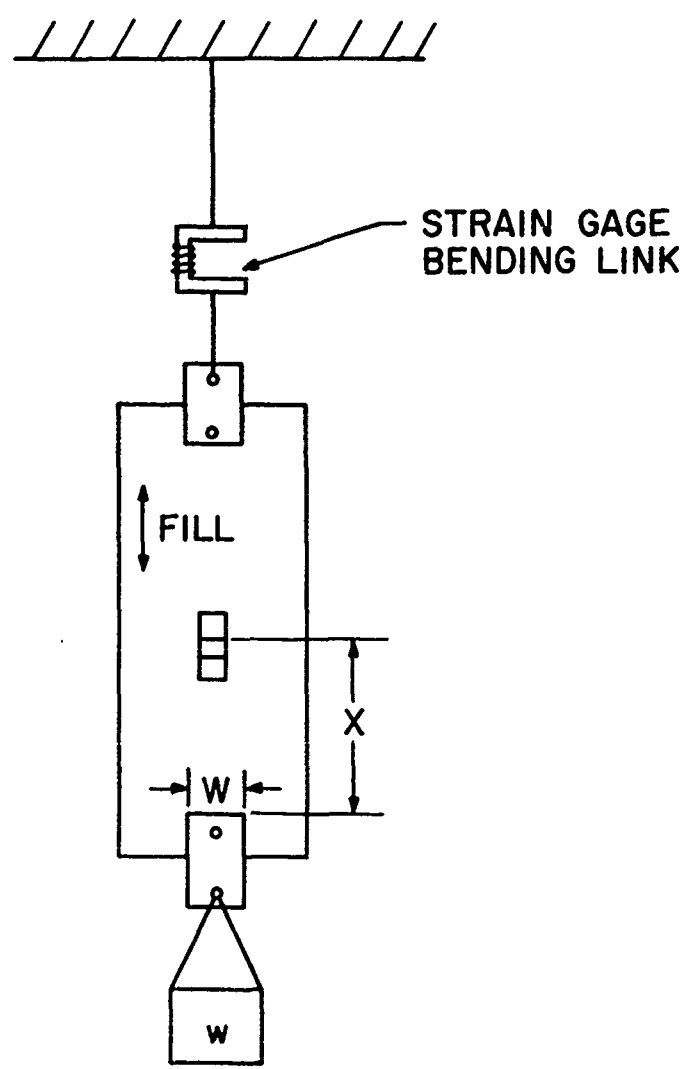
Figure A-2. Schematic of Fill Strip Test Arrangement

Two separate measurements were made for each load condition in order to determine the repeatability of the measurements and obtain valid average data.

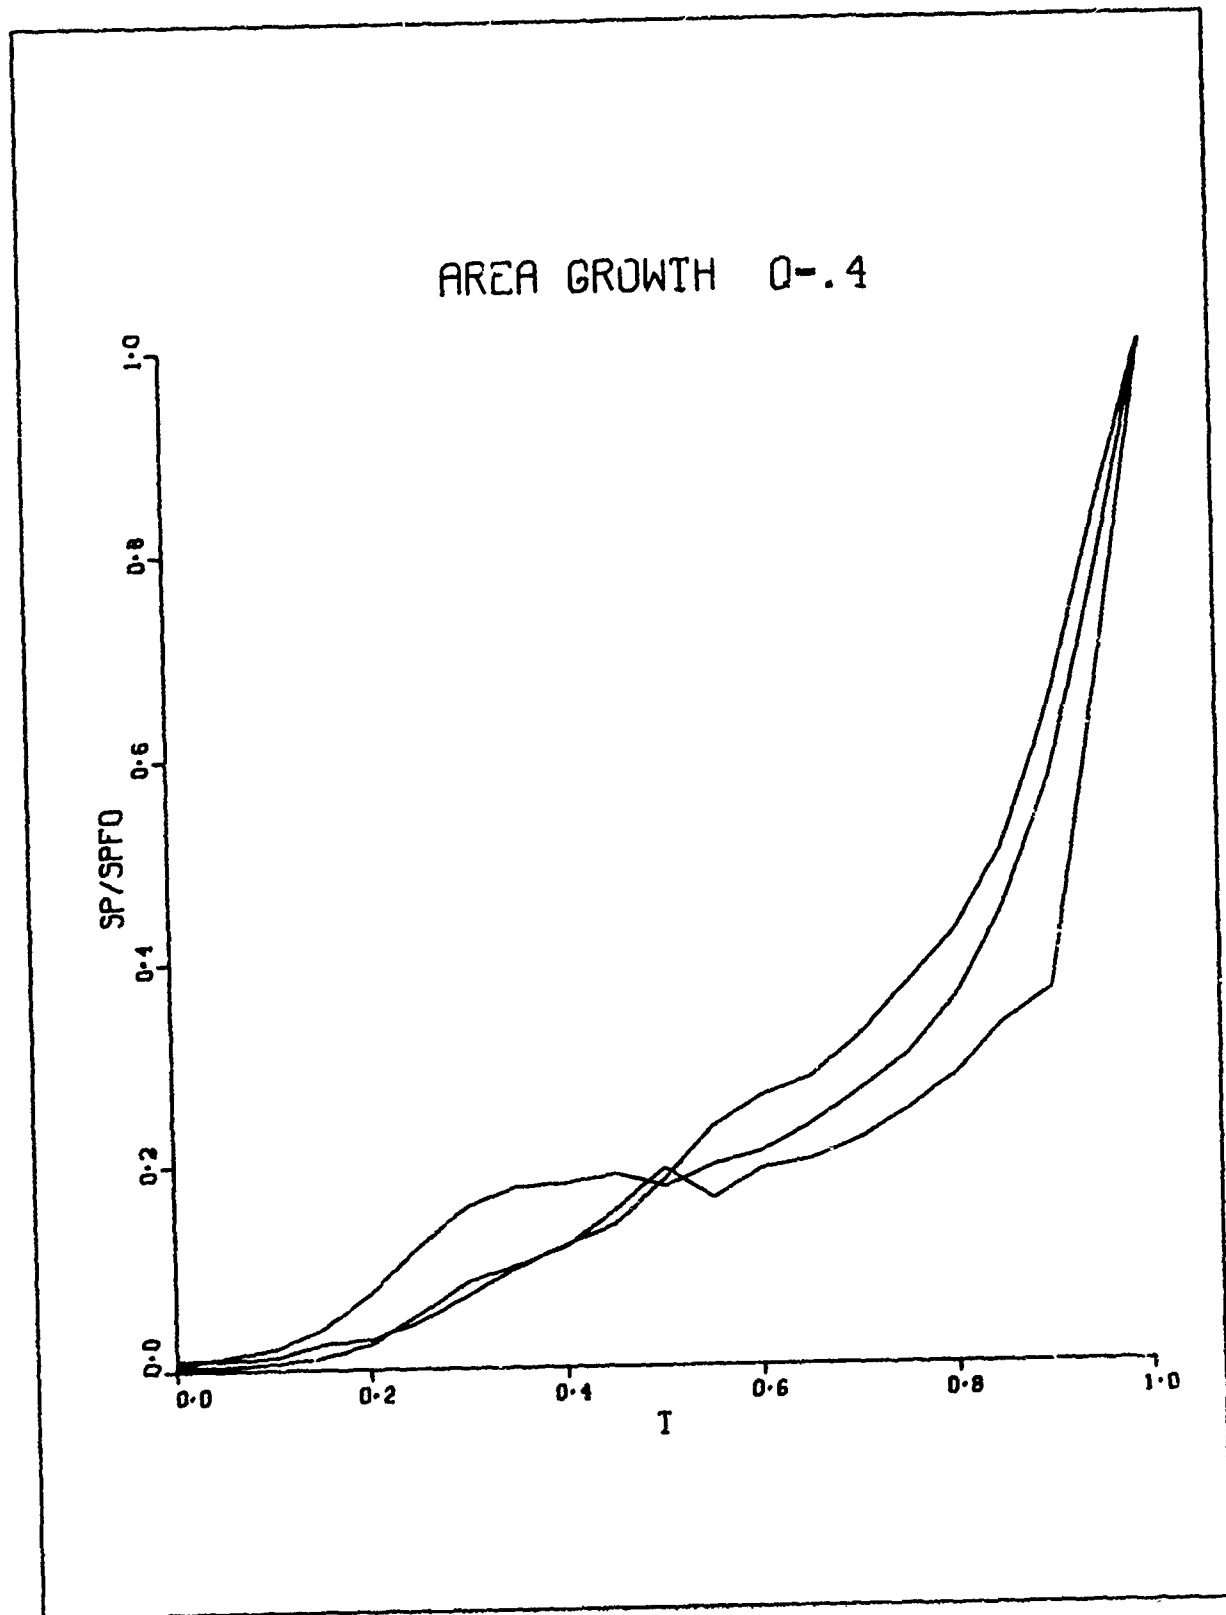
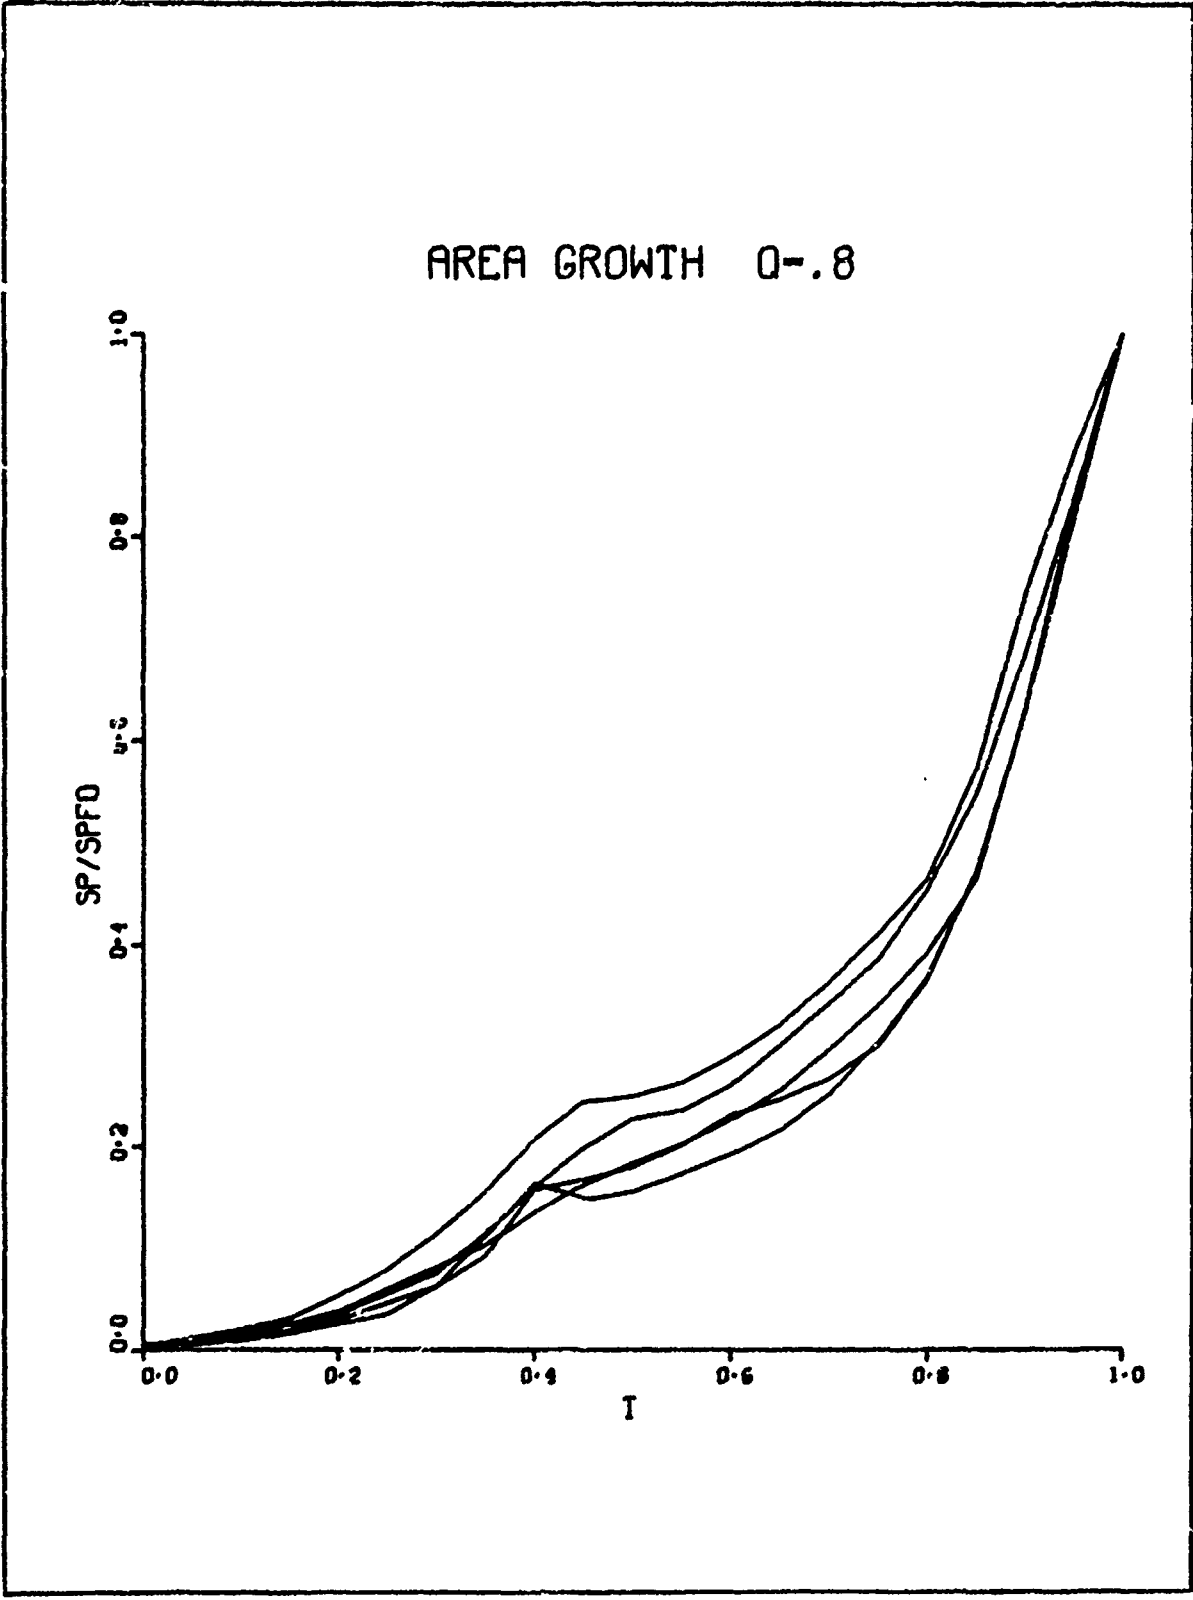
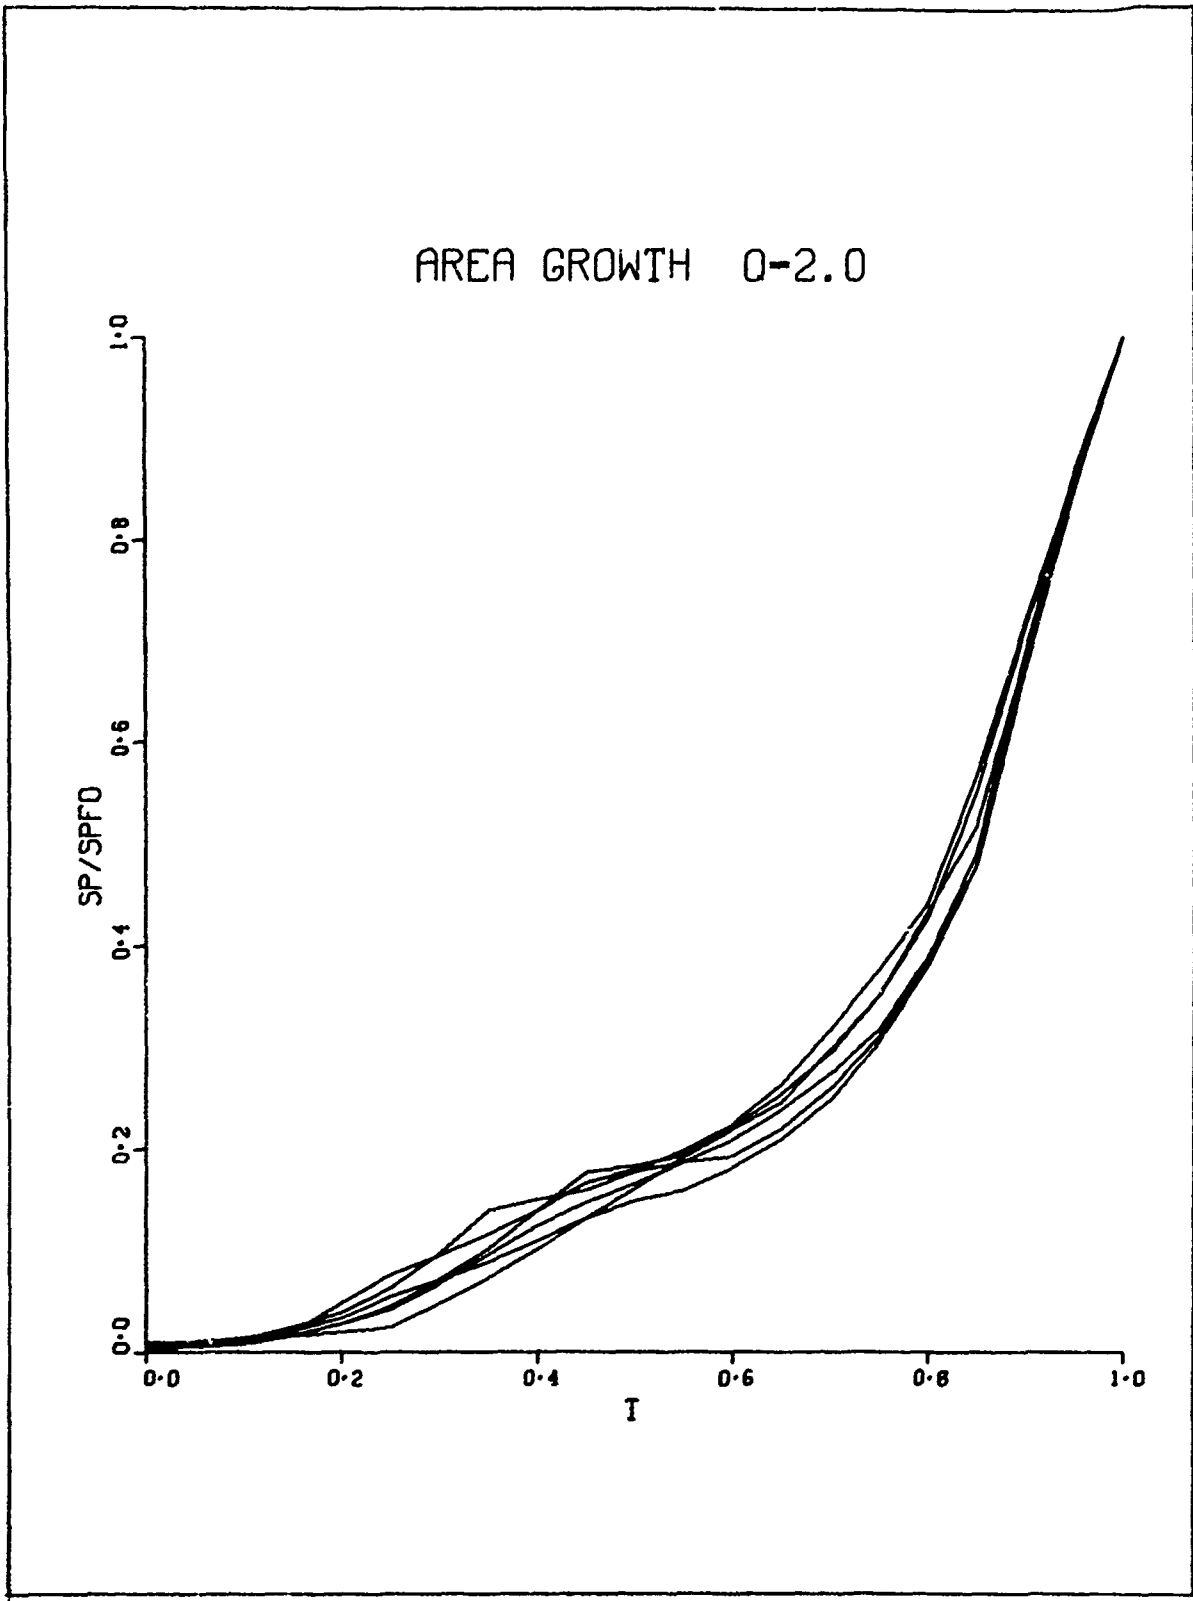
AREA GROWTH Q-.4

Absolute filling times of the canopy decreased with increasing deployment velocity. The relationship between projected canopy area growth ratio, SP/SPFO, as a function of nondimensional time is shown in Appendix C for each of the test conditions. The figures illustrate a gradual and fairly smooth canopy area growth. When examining the curves for each of the test conditions, there are no differences. The five deployment velocities exhibit the exact trend in the area growth pattern.
