**DOT/FAA/AR-03/74**

# **Bonded Repair of Aircraft Composite Sandwich Structures**

February 2004

Final Report

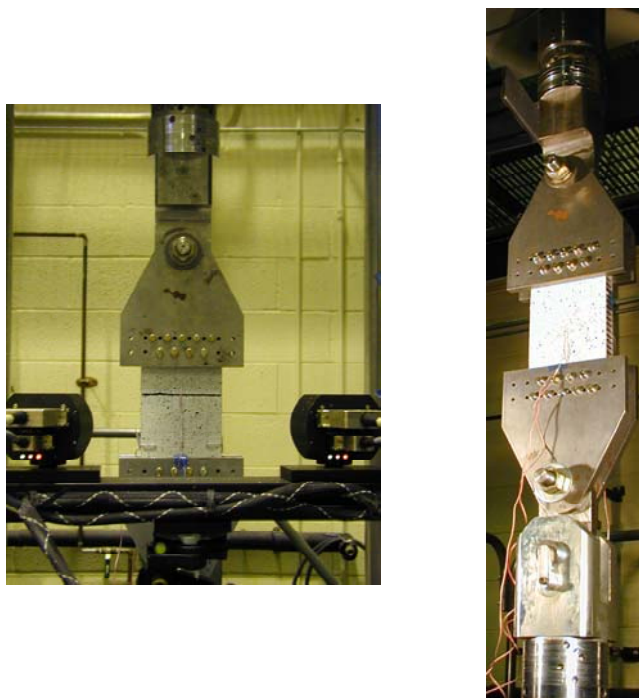
FIGURE 31. UNIDIRECTIONAL TENSION COUPON TEST SETUP

A Boeing fixture, shown in figure 31, was used for testing the unidirectional tension coupons. The fixture was mounted on clevises using cylindrical pins. The clevises were bolted to the load frame. The MTS hydraulic test machine used a 110-kip actuator for loading. As previously mentioned, the MTS machines were periodically calibrated according to the ASTM E4 standard so that the measured load was within 1% of the actual load.

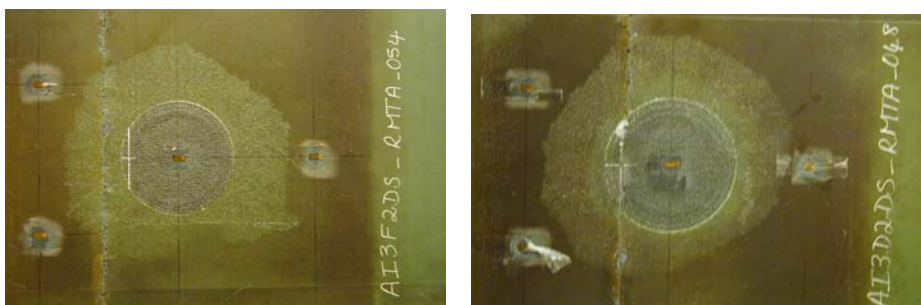
FIGURE 42. FAILURE MODES FOR THE 1/8-inch CORE IMPACTED LARGE FOUR-POINT BENDING BEAMS
