**DOT/FAA/AR-99/24**

# **Structural Integrity of Discontinuous Stiffened Integrally Braided and Woven Composite Panels**

March 1999

Final Report

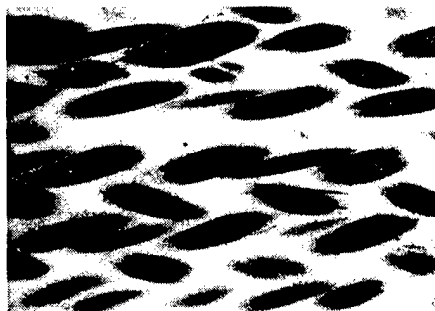
FIGURE 5. FIBER ARCHITECTURE IN BRAIDED COMPOSITE PANEL

(b) View of bottom surface of panel

volume percent of tows in the three directions for the braided composite used here is 46, 27, and 27. The volume percent of tows in woven preform is 50, 25, and 25 in the x-, y-, and z-directions. The fiber patterns revealed by sections of the panel in different orientations are shown in figures 5 and 6. The average fiber volume fractions of the braided and woven composites were 0.38 and 0.44, [3] respectively. Tension, shear, and compression test coupons extracted from the two-bladed panels were used to measure the in situ elastic properties of the panel material.

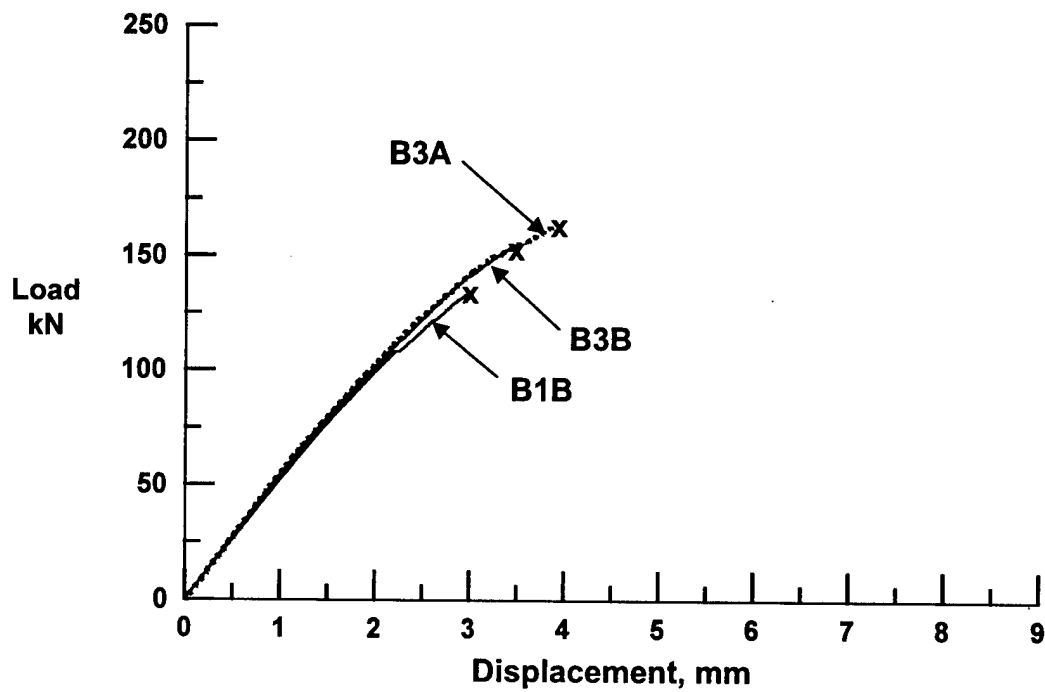
FIGURE 28. LOAD-DISPLACEMENT RESPONSE OF BRAIDED PANELS

The load-displacement responses of three braided and three woven specimens are shown in figures 28 and 29. The load-displacement response of braided and woven composite panels was initially linear and at higher loads became nonlinear. The nonlinearity was due to a number of microscopic failures initiating and progressing in the specimen.

The load-displacement responses of all braided panels were similar, but the B1B response was lower, as shown in figure 28. Most of the braided specimens showed the first failure around the notch root of the stiffener. As the load increased, the number of cracks increased both at the notch root and all along the notch section. Finally, specimens failed in net section tensile failure. Figure 30 shows a photograph of the failure mode.
