## REPORT NO. 829

# SUMMARY OF MEASUREMENTS IN LANGLEY FULL-SCALE TUNNEL OF MAXIMUM LIFT COEFFICIENTS AND STALLING CHARACTERISTICS OF AIRPLANES

By HAROLD H. SWEBERG and RICHARD C. DINGELDEIN

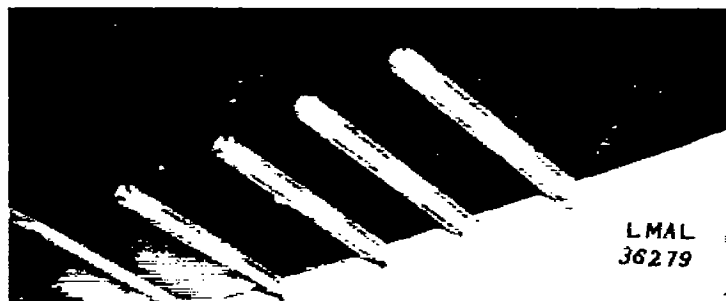
FIGURE 23.—Eighteen-inch barrel extension in low position on right wing. Airplane 11.
