TECHNICAL NOTE 2572

CERAMIC COATINGS FOR PREVENTION OF CARBON ABSORPTION  
IN FOUR HEAT-RESISTANT ALLOYS

By Joseph W. Pitts and Dwight G. Moore

National Bureau of Standards

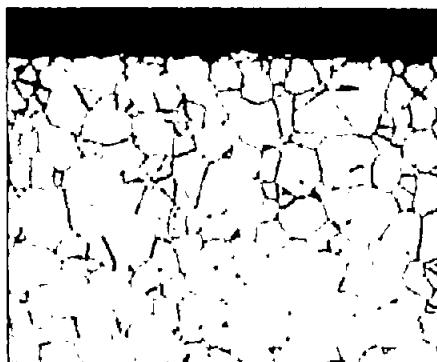
Figure 1.- Photomicrographs (X100, cupric-picral-nital etch) of sections through the surface of both coated (A-19H) and uncoated stainless-steel specimens after box carburizing for 4 hours at 1500° F.

Figures 1 and 2 are photomicrographs of sections taken through the surface of the three stainless steels after the carburizing treatments at 1500° and 1650° F, respectively. The upper picture in each case is the uncoated alloy while the lower picture is the same alloy that has been protected with A-19H. No carbide precipitation was noted with the Type 321 and Type 347 alloys after the carburizing treatment at 1350° F. The Type 304 steel did show the type of carbide precipitation that would be expected from an unstabilized steel after a sensitizing treatment of 4 hours at 1350° F. At the same time there was no evidence of a concentration of carbides near the surface such as would be expected if there had been an absorption of carbon.

Table 3 and figures 1 and 2 indicate that ceramic coatings qualify for this purpose. Of the three coatings studied, A-19H proved to be the most effective in preventing carbon absorption under all test conditions, but it should be pointed out that pack carburizing represents an extremely severe carburizing condition. In operation, carburizing gases from high fuel-air ratios are common in aircraft exhaust systems, especially during take-off and during flight at high altitudes. However, even under the highest fuel-air ratios encountered, the carburizing conditions would probably never reach the severity encountered in pack carburizing. Also, in aircraft exhaust systems, high gas velocities may cause flow of the coated material if the coating lacks sufficient refractoriness. For both of these reasons, the pack-carburizing treatment cannot be considered as a suitable test for coating selection and, at the present time, it is believed that the only reliable criterion for establishing the superiority of one coating over another is by the service testing of coated exhaust parts.

The Type 304 steel, which is unstabilized, showed carbide precipitation throughout its entire structure at all three carburizing temperatures. However, at 1500° and 1650° F there was evidence of carbon absorption into the steel surface and this was evidenced by a greater amount of carbide formation. As shown in figures 1 and 2, the line of demarcation representing the case depth due to carbon absorption was poorly defined, but the photomicrographs nevertheless illustrate that some carbon absorption has occurred with the uncoated steel. The same

figures show that this absorption has been prevented when the steel was protected with the A-19H coating.

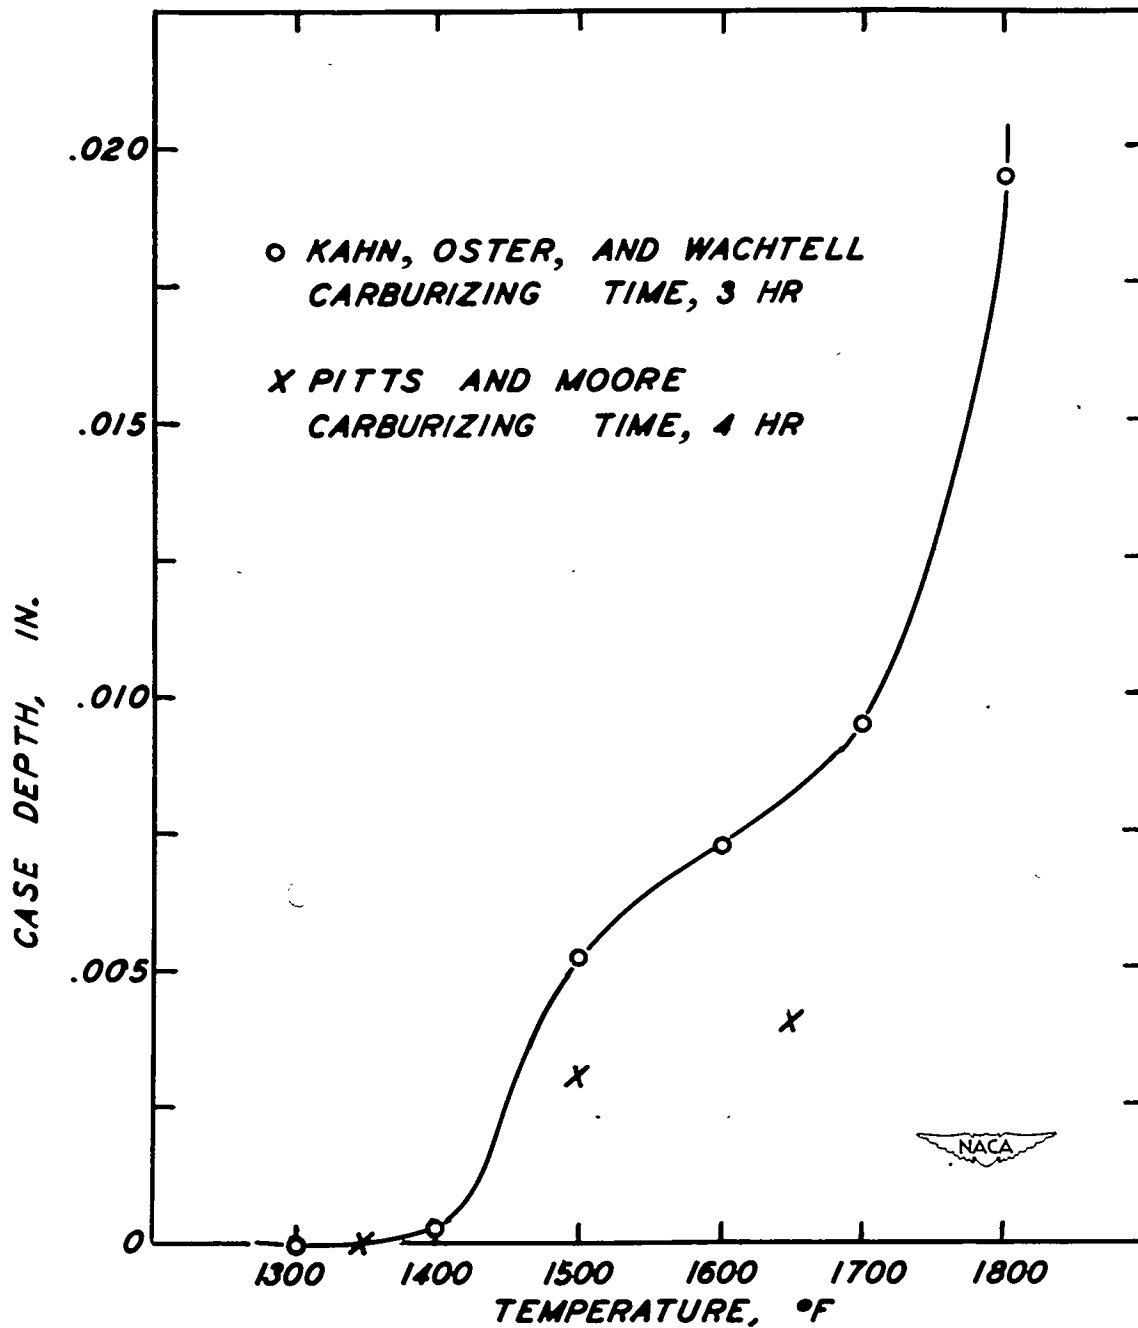
Figure 3.- Case depth plotted against temperature for AISI Type 321 stainless steel after box carburizing for the times indicated. Case depth represents average depth to which alloy showed carbide precipitation at grain boundaries.

Figure 3 is a curve of case depth plotted against temperature for Type 321 stainless steel as taken from the paper by Kahn, Oster, and Wachtell (reference 5). Points representing data from the present study are included for comparison.

promote carbon absorption in the alloys and the same etchant was used to bring out carbides. Figure 3 shows that only fair agreement was obtained for the Type 321 alloy which was the only alloy studied by the aforementioned authors. There is good agreement at 1350° F but at 1500° F smaller case depths were obtained in the present study although a longer carburizing time was used. The cause of this discrepancy may be due to differences in the carburizing compounds or to minor differences in the steels.
