NASA/TP—2011–216460

Comparison of Open-Hole Compression Strength and Compression After Impact Strength on Carbon Fiber/Epoxy Laminates for the Ares I Composite Interstage

A.J. Hodge, A.T. Nettles, and J.R. Jackson

Marshall Space Flight Center, Marshall Space Flight Center, Alabama

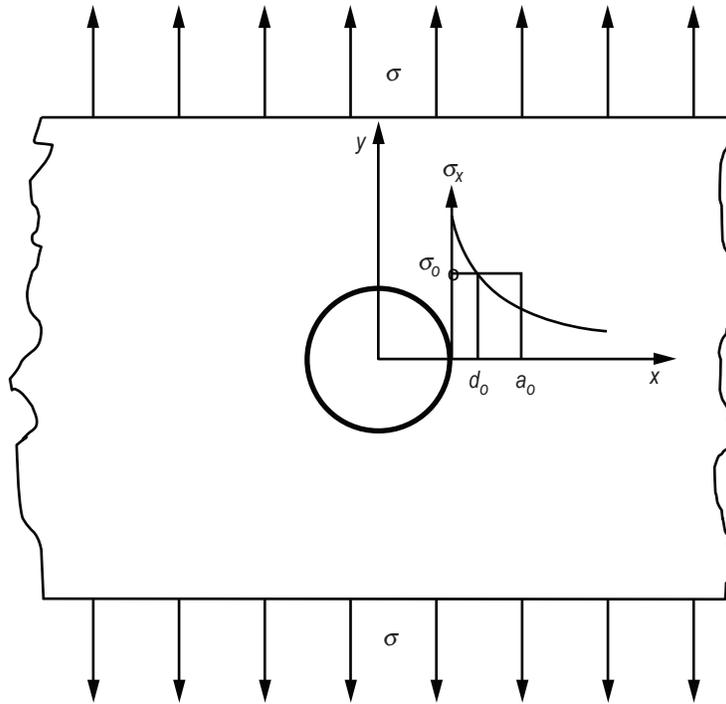
Figure 1. Schematic of stress distribution near a hole with characteristic distance (d_o and a_o) as applicable to the point and average stress criterion.

A failure prediction model of ‘notched’ composite laminates (i.e., laminates with a stress riser) has been an endeavor pursued for many years. Notches from holes or impact damage in a laminate are more detrimental to compression strength than the tensile strength.¹⁻⁶ In the 1970s, Whitney and Nuismer provided the average stress and point stress failure criteria for notched laminates based upon fracture toughness criteria.⁷ Originally developed for notched tension, this method has successfully been applied to notched compression. The stress concentration factor k_T is used in conjunction with a characteristic distance for the two criteria for the laminate to fit a curve to empirically derived data (fig.1). In the point stress criterion, failure occurs when the stress at a distance d_o away from the hole reaches the unnotched material strength σ_o . In the average stress criterion, failure occurs when the average stress over the distance a_o reaches σ_o . It was originally hoped that the characteristic distance parameters would be universal constants for all fibrous material systems and all layups. However, it has been shown that these values are dependent upon many factors including hole size and stacking sequence.⁸ Notwithstanding, the simplicity of application of the Whitney-Nuismer model adds appeal to any user and this predictive model is described in most textbooks. In the 1990s, Soutis et al. developed a cohesive zone model for predicting open-hole compression (OHC) strength based upon the kink band formation in zero-degree plies within the laminate.⁹ The model was further refined to predict CAI strength. Other researchers have continued to refine these approaches. Chen et al. modified the Whitney average stress criterion to calculate a characteristic length for tension and compression.¹⁰ The model agreed well for all laminates tested except those with a high percentage of zero-degree plies. Callus compared the point and average stress criterion models with a cohesive zone model.¹¹ The average stress criterion and cohesive zone model were almost identical for hole sizes zero to 0.25 in.

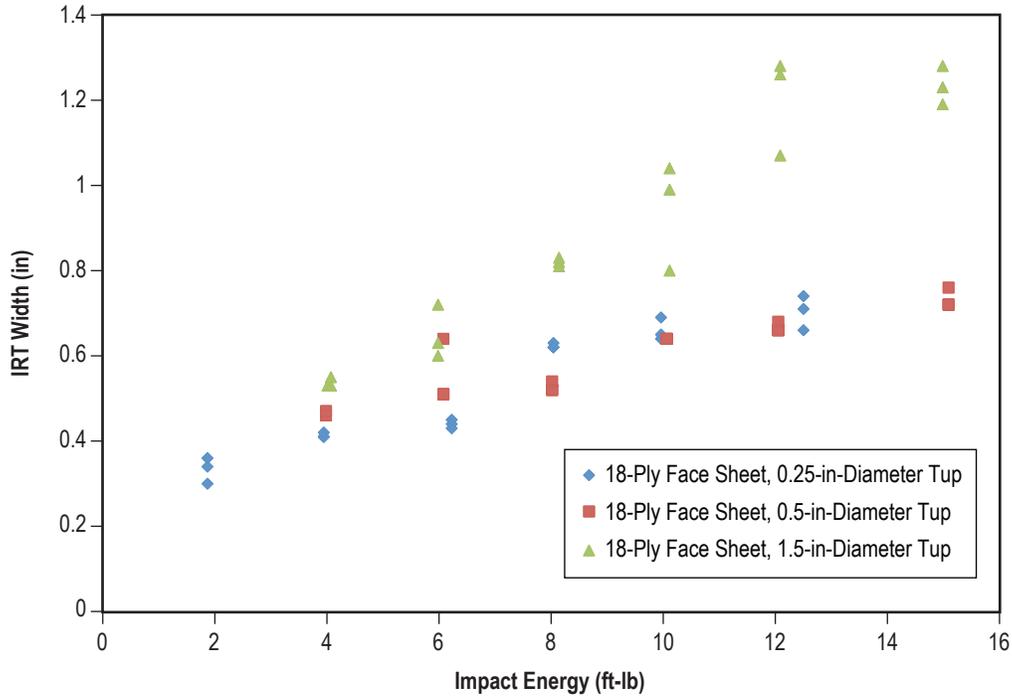
Figure 2. NDE indication width versus impact energy.

Impact testing was performed with three different impactor diameters (0.25, 0.5, and 1.5 in). Sandwich specimens (4 in wide by 6 in long) were impacted over a range of impact energies such as to cause damage ranges not visible to face sheet penetration. Post-impact damage sizes were obtained with nondestructive evaluation (NDE). Thin face sheet specimens were evaluated with infrared thermography (IRT) and thick face sheet specimens were evaluated with passed array ultrasonic testing (PAUT). The length and width of the NDE indication was noted for each specimen. Figure 2 illustrates the damage width indicated by NDE compared to the impact energy and impactor size. The 0.25-in-diameter impacting tup began to penetrate at 10 ft-lb with full penetration of the face sheet at 12 ft-lb. The 0.5-in-diameter tup began to penetrate the face sheet at 15 ft-lb. The 1.5-in-diameter tup did not penetrate the face sheet at the impact energies applied and produced little visible damage other than a dent. It is apparent from figure 1 that damage size is a function of impactor size, especially between the 0.5- and 1.5-in-diameter impactors.

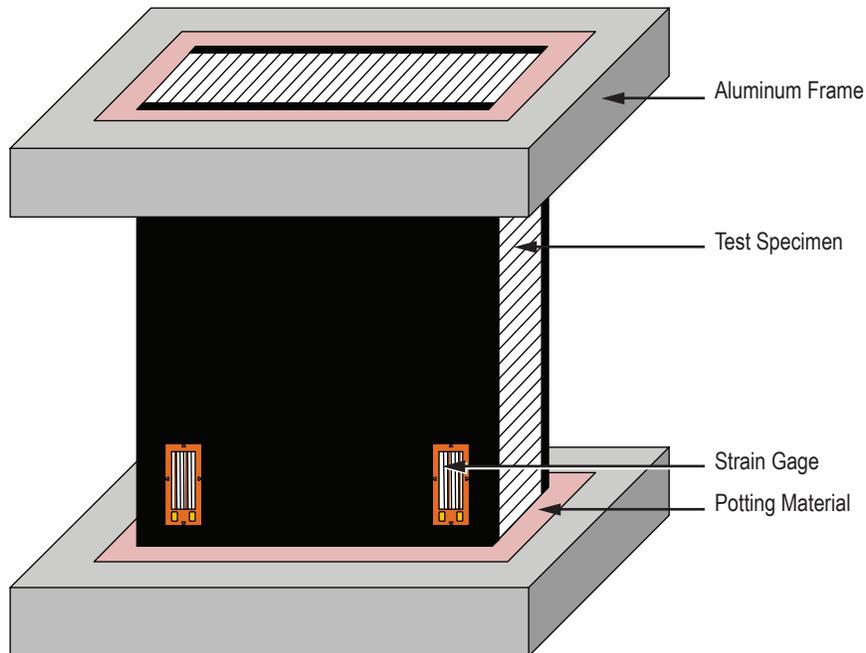
Figure 3. Sandwich edgewise compression.

CAI specimens were then potted with epoxy into a 1-in-thick Al frame on each loading end. The loading ends were machined flat and parallel to within 0.001 in. Strain gages were bonded to the front and back surfaces away from the damage zone to monitor alignment during mechanical testing. Figure 3 is a schematic of the edgewise compression test.

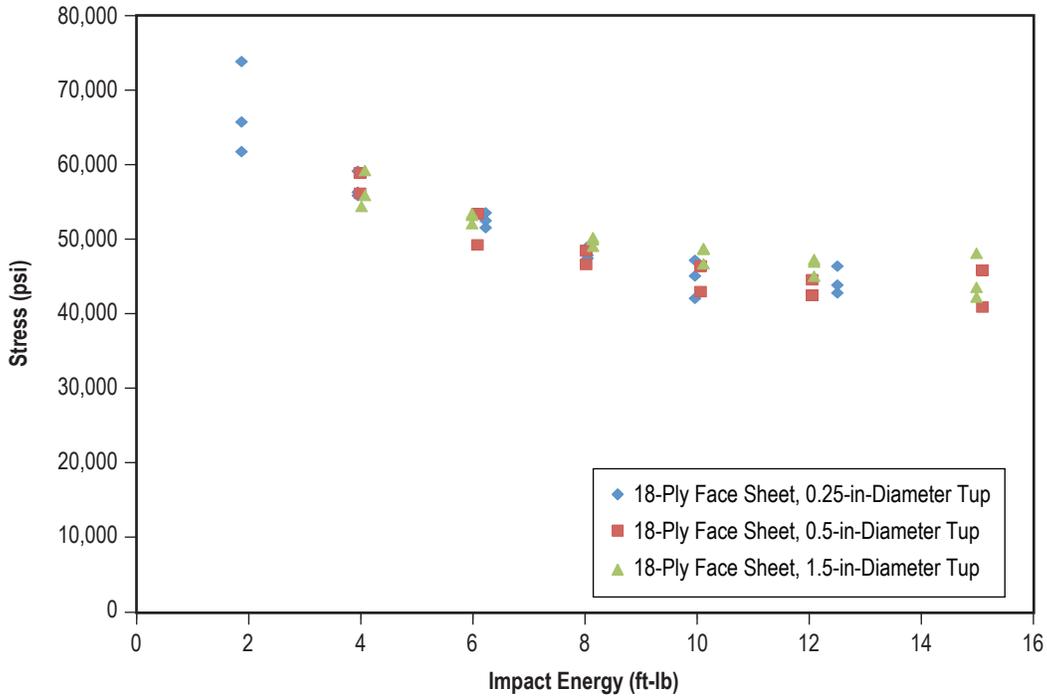
Figure 4. Residual compression strength versus impact energy.

In order to apply a uniform strain to both face sheets, the compression platens were fixed. The impacted sandwich specimens were loaded in edgewise compression at a constant crosshead rate until failure. Figures 4 and 5 illustrate the residual compression strength as compared to impact energy and damage width for the three impactor sizes used. It is apparent that the residual strength is dependent upon the impact energy and is independent of the impactor sizes used in this study. However, the residual strength appears to reach a plateau for a given critical impact energy, even if the damage size increases ($\approx 45,000$ psi at 12 ft-lb for the data presented here).

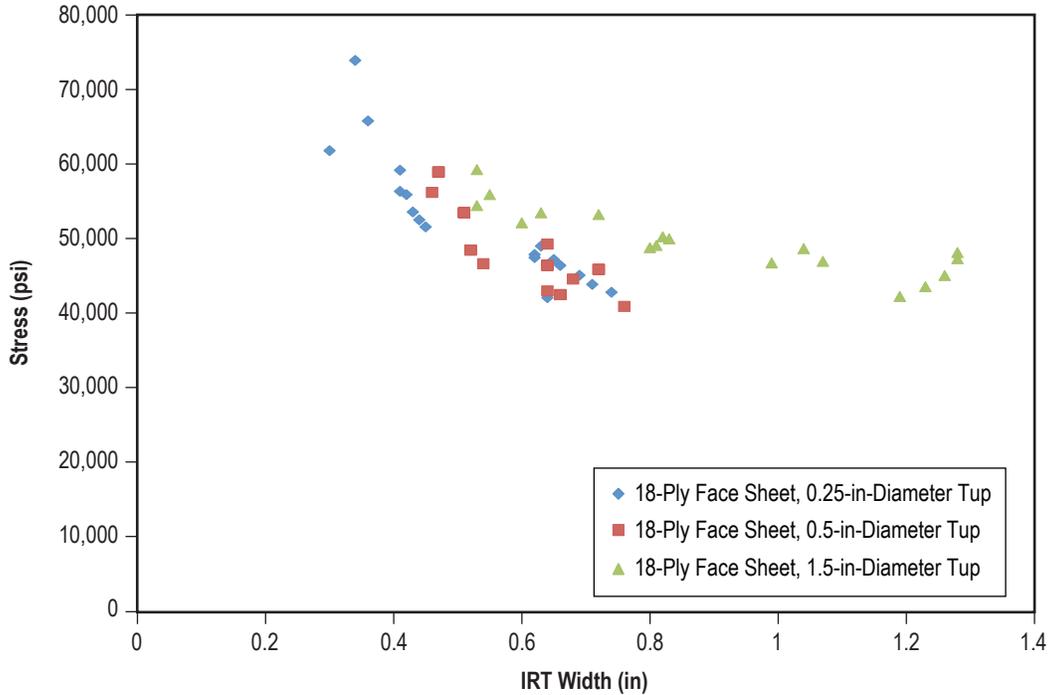
Figure 5. Residual compression strength versus NDE indication size.

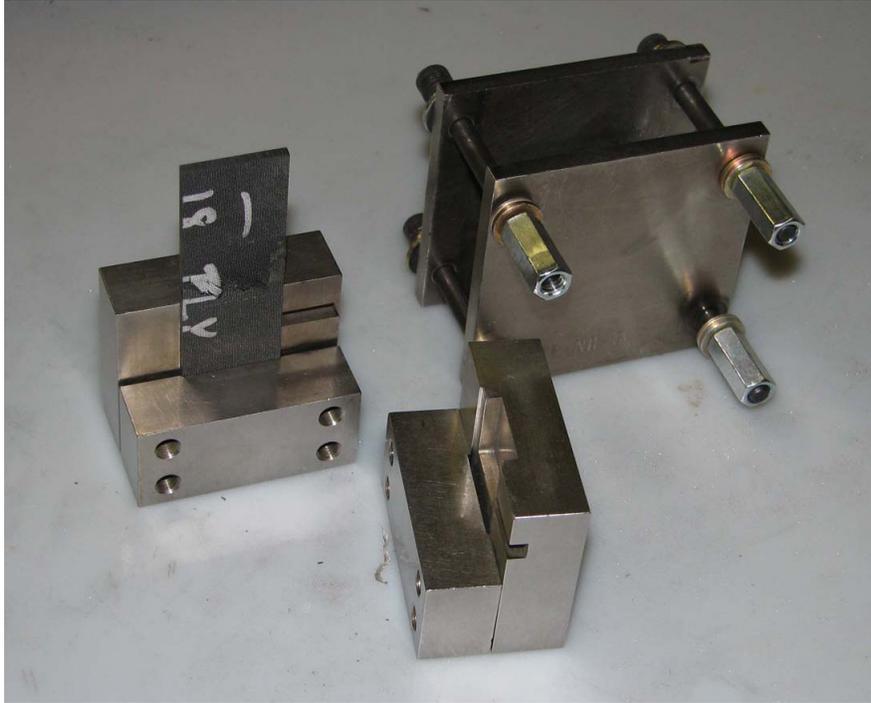
Figure 6. Northrop OHC fixture.¹⁶

OHC testing was performed on 18-ply flat laminates with the Northrop OHC test fixture and the Boeing CAI fixture. Figures 6 and 7 are schematics of the two fixtures. The Northrop fixture uses specimens 1 in wide by 3 in long. The Boeing fixture, also known as ASTM D7137, Standard Test Method for Compressive Residual Strength Properties of Damaged Polymer Matrix Composite Plates, utilized 4 in wide by 6 in long specimens.¹⁷

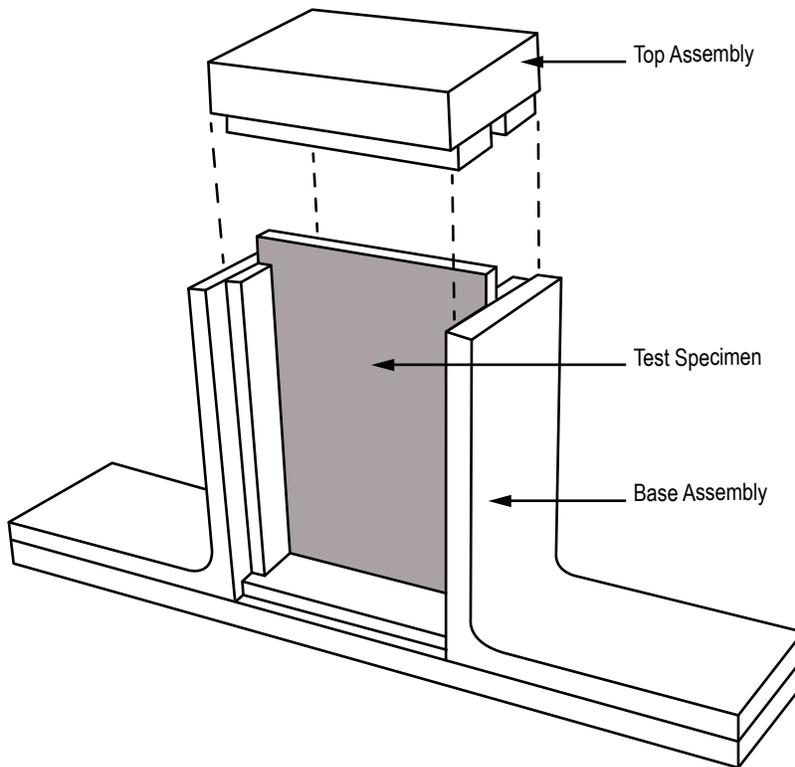
Figure 7. Boeing CAI fixture.¹⁷

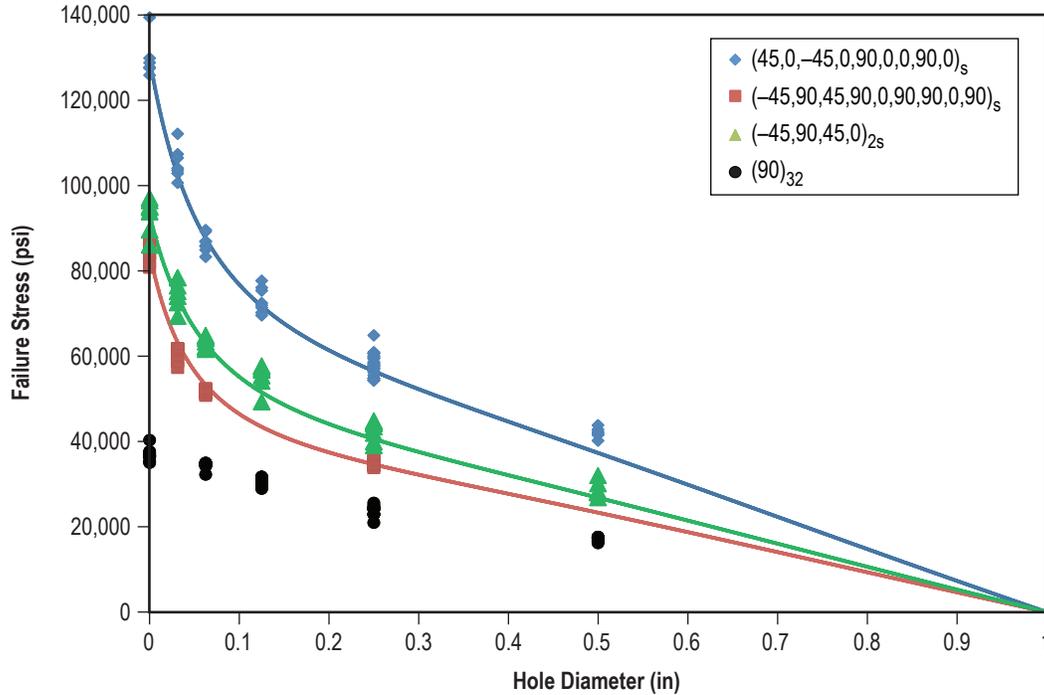
Figure 8. Laminate OHC results.

Three layups were tested: 18-ply orthotropic, 16-ply quasi-isotropic, and 32-ply unidirectional. The 18-ply and unidirectional laminates were tested in both the axial and transverse direction, making a total of five configurations. The 18-ply axially oriented coupons had the majority of fibers oriented in the loading direction with (56/22/22) representing the percentage of plies in the 0-, 45-, and 90-deg orientations. The 18-ply transverse specimens had a layup of (22/22/56). Quasi-isotropic specimens (25/50/25) were tested for comparison to the highly oriented laminates. Specimens with hole sizes ranging from 0.03125 to 1.32 in were tested. The zero-degree unidirectional coupons initially failed by in-plane shear parallel to the fibers at the hole edges prior to compressive failure. Thus, the ultimate failure strength showed no notch sensitivity since the test is reduced to a net section compression test. Because of the dual failure mode, the zero-degree data are not included in the figures. The 90-deg unidirectional coupons exhibited a much smaller notch sensitivity than the laminates. Figure 8 illustrates the OHC strength results for 1-in-wide coupons. As noted, prior researchers found both the cohesive zone model and average stress criterion to adequately fit OHC strength. The average stress criterion is shown as the solid lines in figure 8.

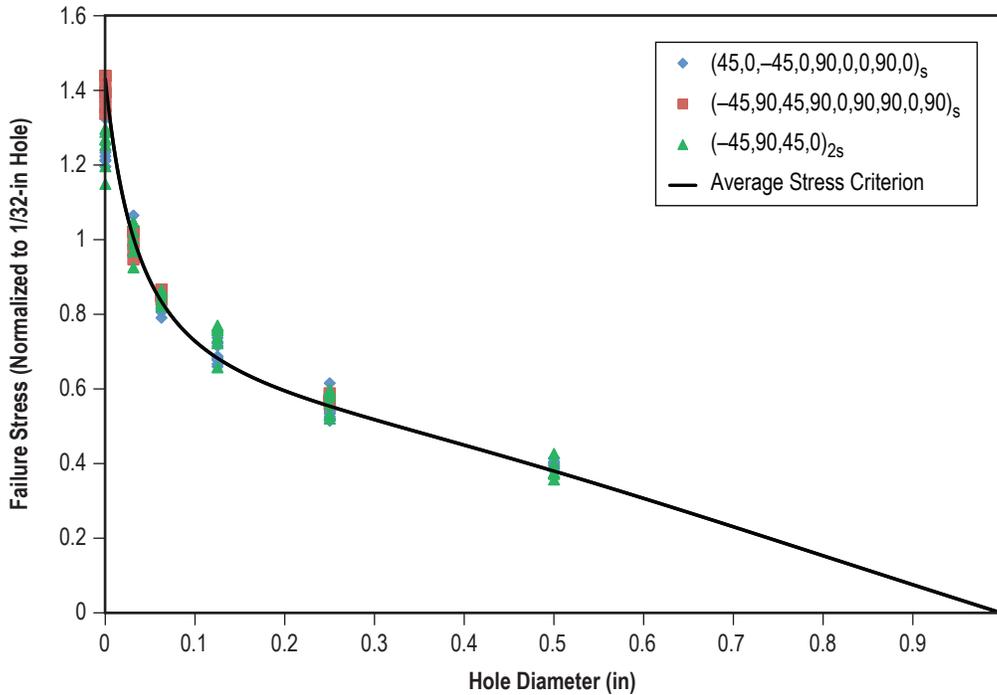
Figure 9. OHC normalized to 1/32-in-diameter hole.

When one considers all of the OHC strength values are fit to a model based on an unnotched strength, the importance of this parameter becomes apparent. It was found that if the OHC strength results are normalized to an arbitrary notch size (1/32 in, for example) the model then becomes predictive for unnotched strength. By removing the unnotched data from the equation, the predictive model can better fit the notched results of the three layups using only one stress concentration factor

and one characteristic distance (fig. 9). The line representing the average stress criterion utilizes a characteristic distance of 0.03 in and a stress concentration factor of 3.

When comparing the residual compression strength of the three types of stress risers as a function of defect size, it is obvious that the OHC bounds the CAI and the simulated delaminations. Figure 9 illustrates: (1) CAI strengths for the 18-, 40-, and the 56-ply sandwich coupons, (2) compression strength for the 18-ply simulated delamination sandwich coupons, and (3) the OHC strengths for the 18-ply laminate coupons. One issue with a comparison between the OHC and CAI results is the difference in structure. The OHC coupons were flat laminates and the CAI coupons were sandwich structure. Typically, laminates have a higher cure pressure than sandwich structures. However, for this study, all samples had the same cure pressure. A limited set of OHC was performed on the sandwich. Results compared well with the OHC laminate (see table 1 and fig. 10). The initial undamaged, or pristine, compression strength for the sandwich was lower than the undamaged strength for the laminate. This can be attributed to factors such as the dimpling of the face sheet during co-cure as well as the different test geometry. However, once a hole or impact damage was present, the notch seemed to overwhelm other factors.

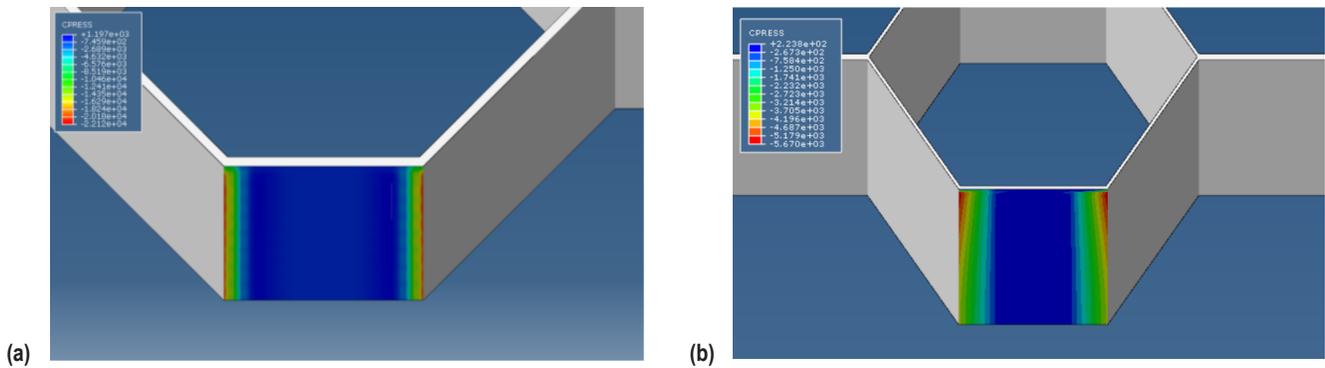
Figure 11. Finite element analysis model of residual thermally induced stresses in (a) 12 lb/ft³ core and (b) 6.1 lb/ft³ core.

exhibited excessive core node disbonds as evidenced by NDE. Cross-sectional analysis confirmed the node disbonds. Subsequent stress analysis confirmed high residual stresses incurred within the Al core during autoclave cooldown as a result of coefficient of thermal expansion mismatch between the face sheet and core. Tensile stress on the core node bondline is a function of foil thickness. Finite element analysis predicted twice the tensile stress in the node bond for the 12 lb/ft³ core compared to the 6.1 lb/ft³ core. Average tensile stress estimates across the node bondline were 2,300 psi average for 12 lb/ft³ core and 1,100 psi for 6.1 lb/ft³ core. When modeled with a fillet at each bend in the core, the average tensile stresses were reduced. However, the discrepancy in magnitude between the different foil thicknesses remained. The failure illustrates the importance of process development as well as multiple batch testing—batch 1 core did not exhibit the disbonds. It is recommended that Al core with a foil thickness as great as the 12 lb/ft³ material not be used in co-cure applications with carbon fiber face sheets. Figure 11 illustrates the stress model on the node bondline.

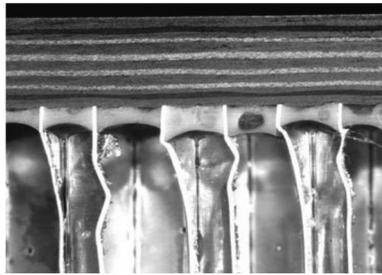
Figure 12. 1 ft-lb, 0.5-in-diameter impactor (no delamination).

Figures 12–24 are cross sections of the NDE correlation panel. The 18-ply sandwich panels were impacted at energy levels from 1 to 10 ft-lb. A replicate of each impact was conducted with both 0.5- and 1.5-in-diameter impactors. Two important observations regarding the induced damage were observed. First, the larger diameter impactor created a longer delamination than the smaller diameter impactor. Second, the damage induced by the smaller diameter impactor appeared to be more widespread through the thickness of the laminate than the damage induced by the larger diameter impactor.

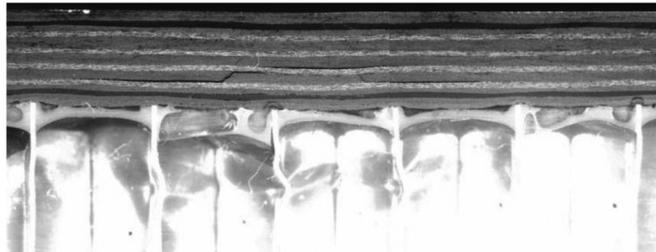
Figure 13. 2 ft-lb, 0.5-in-diameter impactor.

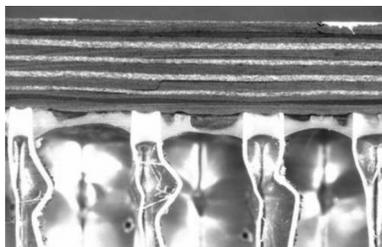
Figure 14. 2 ft-lb, 1.5-in-diameter impactor.

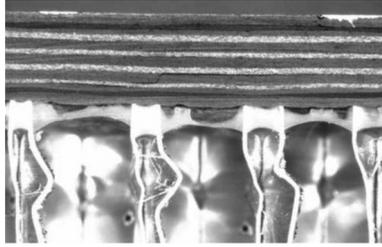
Figure 15. 3 ft-lb, 0.5-in-diameter impactor.

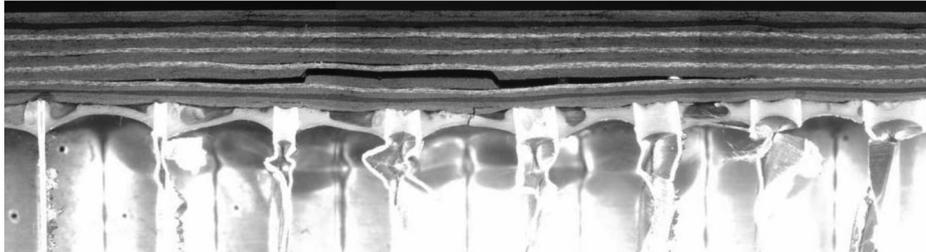
Figure 16. 3 ft-lb, 1.5-in-diameter impactor.

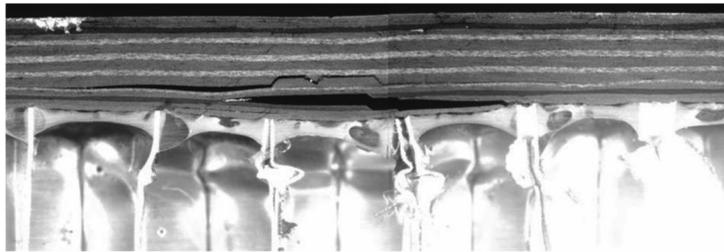
Figure 17. 4 ft-lb, 0.5-in-diameter impactor.

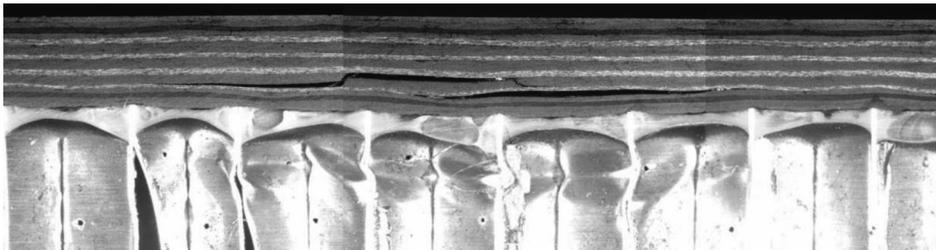
Figure 18. 4 ft-lb, 1.5-in-diameter impactor.

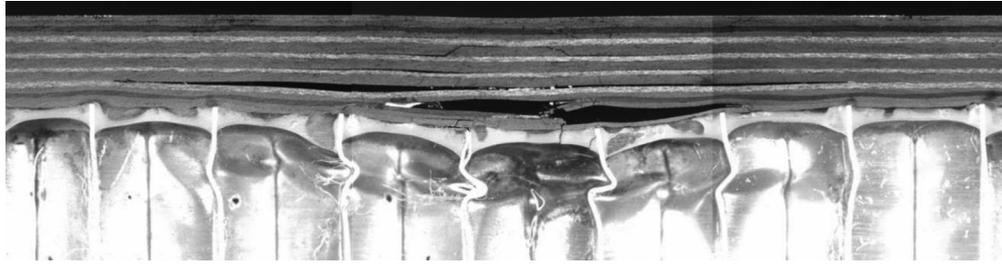
Figure 19. 6 ft-lb, 0.5-in-diameter impactor.

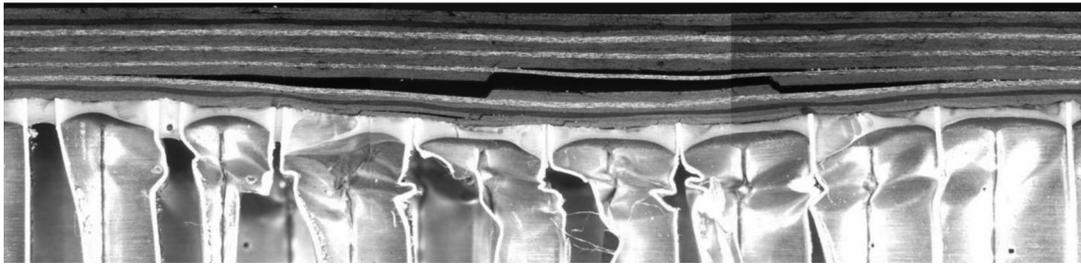
Figure 20. 6 ft-lb, 1.5-in-diameter impactor.

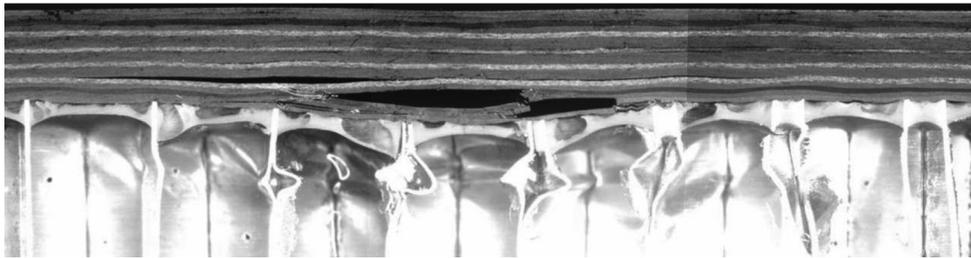
Figure 21. 8 ft-lb, 0.5 in-diameter impactor.

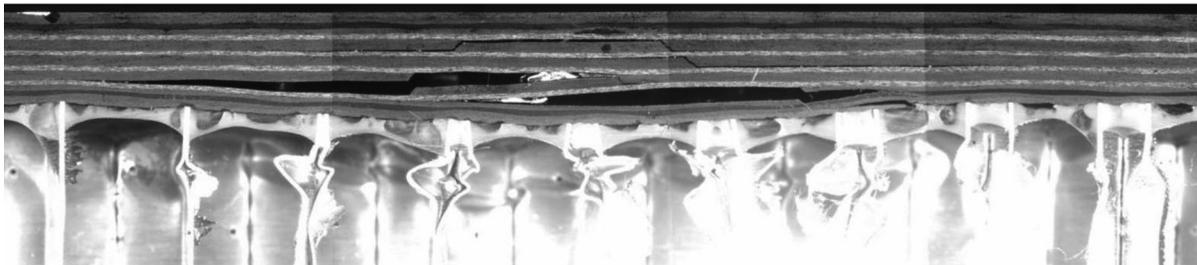
Figure 22. 8 ft-lb, 1.5 in-diameter impactor.

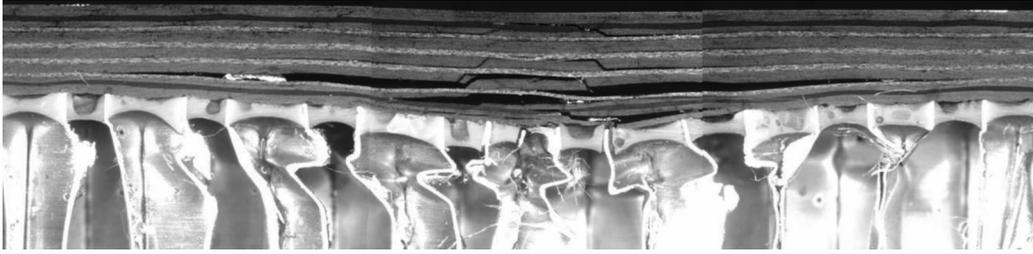
Figure 23. 10 ft-lb, 0.5 in-diameter impactor.

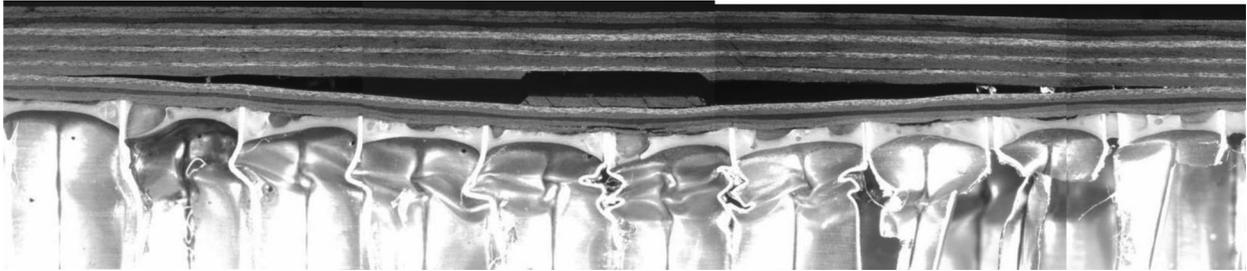
Figure 24. 10 ft-lb, 1.5-in-diameter impactor.
